Breast Imaging

Transient ipsilateral breast edema following COVID-19 vaccination

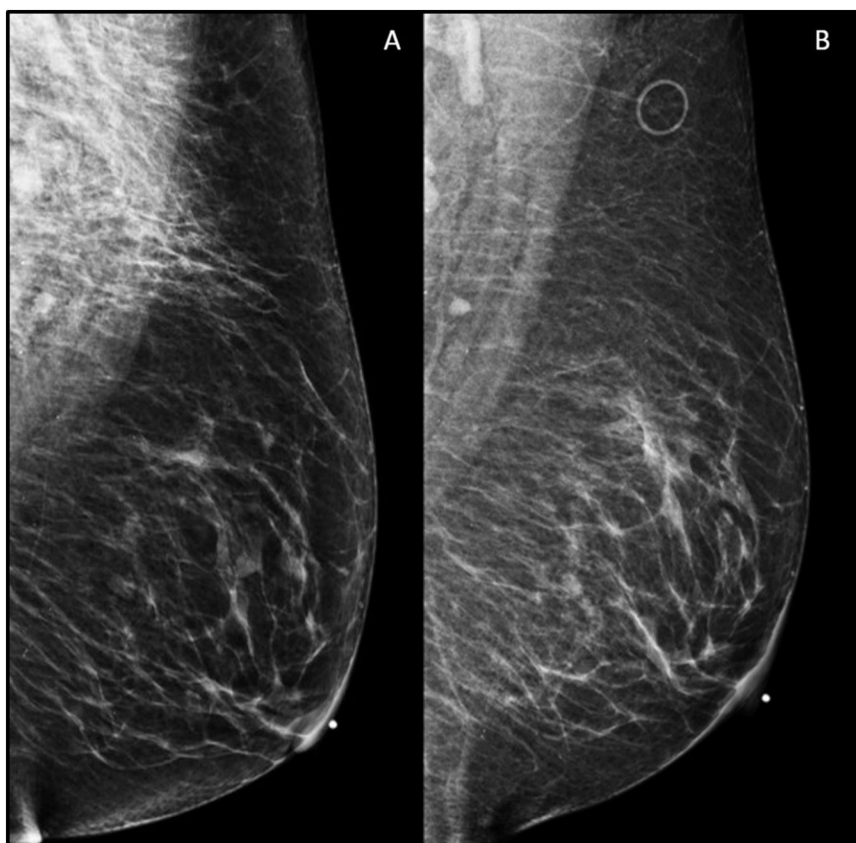
Fig. 1. A 60-year-old woman presented for screening mammogram and breast ultrasound two days following the 2nd booster dose of the Moderna COVID-19 vaccination in the left deltoid. (A) Mediolateral oblique view of the left breast obtained during screening mammogram demonstrated a new global asymmetry with trabecular thickening in the axillary region. (B) Mediolateral oblique view of the left breast thirteen days later at the time of diagnostic imaging demonstrated complete resolution of the asymmetry.

A 60-year-old asymptomatic woman presented for screening mammography two days after receiving the 2nd booster dose of the Moderna COVID-19 vaccination in the left deltoid. Screening mammography demonstrated a new global asymmetry in the left axillary region, comprised of trabecular thickening, suggestive of edema (Fig. 1). Concurrent whole breast screening ultrasound demonstrated diffuse increased echogenicity of the axillary adipose tissue, corresponding to the mammographic asymmetry. Prominent left axillary lymph nodes were also visualized with diffuse cortical thickening measuring up to 0.6 cm (Fig. 2). Although the findings were thought to be likely inflammatory in response to recent ipsilateral vaccination, the screening mammogram and ultrasound exams were assessed as

incomplete (BI-RADS 0) with the need for additional diagnostic imaging. The patient returned for diagnostic evaluation approximately 13 days later, at which point the mammographic and sonographic findings had resolved, including the lymphadenopathy (Figs. 1 and 2). At the time of diagnostic evaluation, the patient disclosed that, in retrospect, she had a palpable fullness and tenderness in her left axilla at the time of screening.

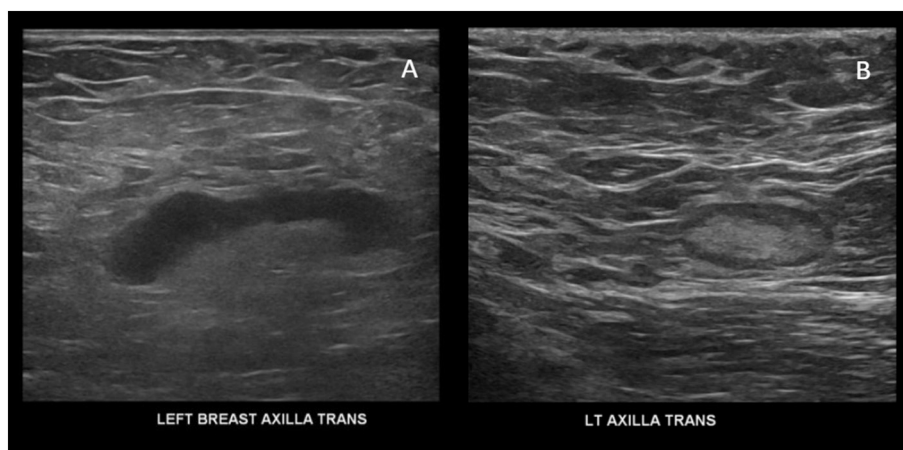
Fig. 2. (A) Static ultrasound images of the left axilla from screening breast ultrasound demonstrated diffuse increased echogenicity axillary adipose tissue, and prominent lymph nodes with diffuse cortical thickening measuring up 0.6 cm. (B) Static ultrasound image of the left axilla thirteen days later at the time of diagnostic imaging demonstrated complete resolution of the edema and lymphadenopathy.
