# Effect of metal conditioner on bonding of porcelain to cobalt-chromium alloy

**PURPOSE.** The purpose of this study was to evaluate the efficacy of two different metal conditioners for non-precious metal alloys for the bonding of porcelain to a cobalt-chromium (Co-Cr) alloy. **MATERIALS AND METHODS.** Disk-shaped specimens (2.5×10.0 mm) were cast with Co-Cr alloy and used as adherend materials. The bonding surfaces were polished with a 600-grid silicon carbide paper and airborne-particle abraded using 110 μm alumina particles. Bonding specimens were fabricated by applying and firing either of the metal conditioners on the airborne-particle abraded surface, followed by firing porcelain into 5 mm in diameter and 3 mm in height. Specimens without metal conditioner were also fabricated. Shear bond strength for each group (n=8) were measured and compared ( $\alpha=.05$ ). Sectional view of bonding interface was observed by SEM. EDS analysis was performed to determine the chemical elements of metal conditioners and to determine the failure modes after shear test. **RESULTS.** There were significant differences among three groups, and two metal conditioner-applied groups showed signifi

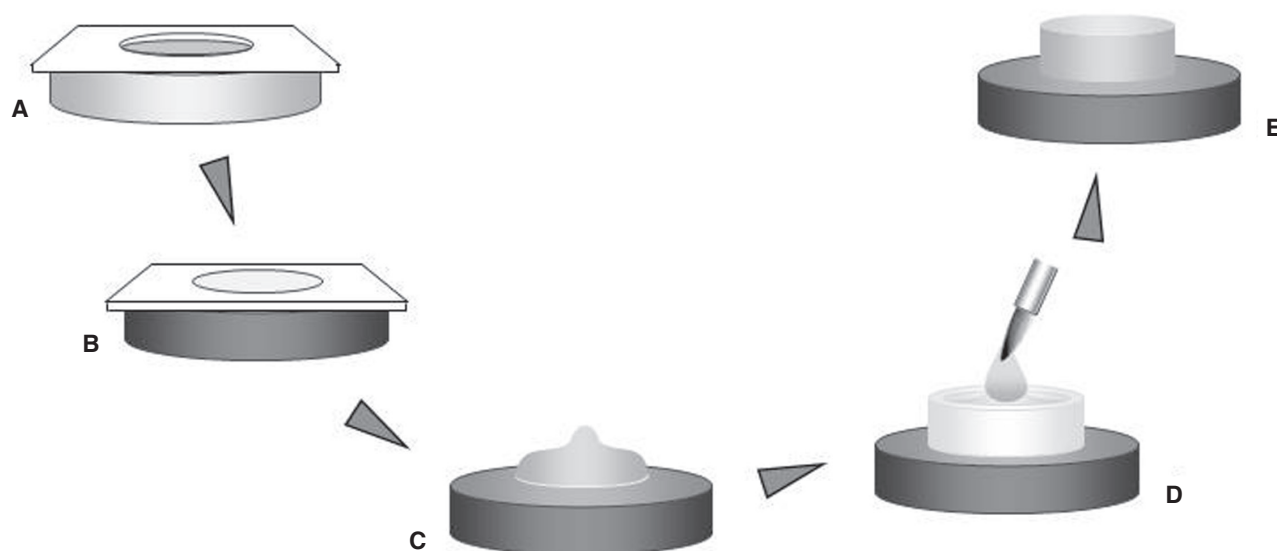
**Fig. 1.** Procedures of specimen fabrication for shear bond testing. (A) Application and firing of metal conditioner (repeated twice), (B) Application and firing of opaque porcelain (repeated twice), (C) Building-up and firing of dentin porcelain (repeated twice), (D) Final build-up of dentin porcelain in Teflon tube, (E) Firing and glazing of porcelain for the completion of shear specimen.

Procedures for fabrication of bonding specimens are presented in Fig. 1. A 30 μm-thick masking tape (Mending Tape; Kokuyo Co., Ltd., Osaka, Japan) with a 5 mm diameter opening was placed on the airborne-particle abraded surface to restrict the porcelain firing areas, and a thin layer of either of the metal conditioners was applied. The masking tape was removed and the metal conditioner was fired in the furnace (KDF Master Spirit 120, Denken Co., Ltd., Kyoto, Japan), according to the firing schedule presented in Table 2. Another sheet of masking tape was placed to fit the opening into the baked metal conditioner, then the second firing of each metal conditioner was achieved in the same manner (Fig. 1A).

After the firing of each metal conditioner, the masking tape was placed so that the opening is fit into the baked metal conditioner, the opaque porcelain paste was applied onto the baked metal conditioner. The tape was carefully removed and opaque porcelain was fired in the furnace, according to the firing schedule shown in Table 2. These procedures were repeated to layer the opaque porcelain

with two increments (Fig. 1B).

the specimen fabrication (Fig. 1E). Specimens without metal conditioner were also fabricated and used as controls. Eight specimens were fabricated for each of three groups, including two metal conditioner groups and a control group.

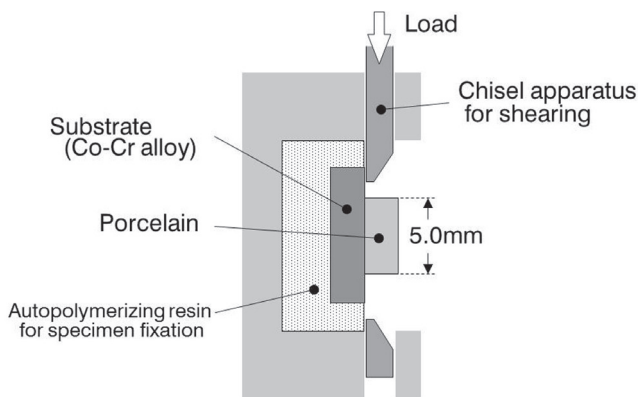
Fig. 2. Cross-sectional view of shear bond test.

Bonding specimens were embedded into an auto-polymerizing resin and mounted on a shear-testing device. Shear bond test was performed using universal testing machine with 5.0-kN load cell (AGS-5kNG, Shimadzu Corp., Kyoto, Japan) with a 1.0 mm/min crosshead speed until failure occurred. A cross-sectional view of shear testing is illustrated in Fig. 2. A unibevel-chisel apparatus made from stainless steel was used to produce a shear force adjacent and parallel to the bonding interface. The shear bond strength (MPa) was determined by dividing the maximum load (N) by the bonding areas (mm<sup>2</sup>). The data were statistically analyzed by a 1-way analysis of variance (ANOVA) and Bonferroni/Dunn test to identify the significant differences among the groups ( $\alpha = 0.05$ ). Statistical analyses were performed using IBM SPSS Statistics software, version 22 (IBM Corporation, New York, NY, USA).

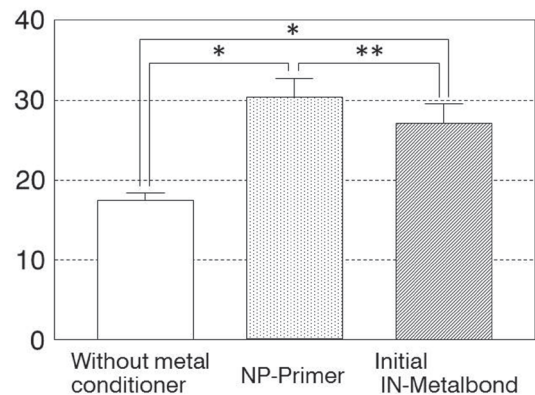
Fig. 3. Results of shear bond test.

\* :  $P < .01$ , \*\* :  $P < .05$

The results of the shear bond strength tests of each group and statistical analysis among groups are presented in Fig. 3. Two groups that used metal conditioners showed significantly higher shear bond strengths than the group that did not use metal conditioner ( $P < .0001$ ). For the comparison between two metal conditioner groups, the group using NP primer showed significantly higher shear bond strength than the group using Initial IN-Metalbond ( $P = .0153$ ).

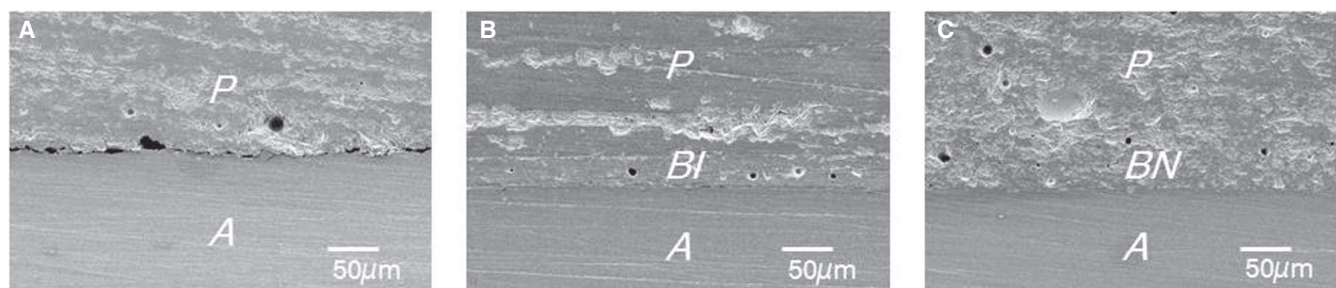
**Fig. 4.** Bonding interface of specimen (original magnification:  $\times 300$ ). (A) Specimen without metal conditioner, loose contact between porcelain and Co-Cr alloy surface and a gap formation at alloy-porcelain interface, (B) Initial IN-Metalbond-applied specimen, hermetic contacts at both the alloy-metal conditioner interface and metal conditioner-porcelain interface, (C) NP-Primer-applied specimen, hermetic contacts at both the alloy-metal conditioner interface and metal conditioner-porcelain interface.

*P*: Porcelain, *BI*: Metal conditioner (Initial In-Metalbond), *BN*: Metal conditioner (NP-Primer), *A*: Co-Cr Alloy.

The SEM observation for the sectional view of bonding interface for non-metal conditioner specimen revealed loose contact between porcelain and Co-Cr alloy surface and a gap formation at alloy-porcelain interface (Fig. 4A). On the other hand, Initial IN-Metalbond-applied and NP-Primer-applied specimens (Fig. 4B and Fig. 4C, respectively) showed hermetic contacts at both the alloy-metal conditioner interface and metal conditioner-porcelain interfaces. From the results of EDS analysis, NP-Primer mainly contained silicon (Si). In addition, sodium (Na), zirconium (Zr), aluminum (Al), potassium (K) and gold (Au) were also detected. On the other hand, Initial In-Metalbond mainly contained titanium (Ti) and Si. Na, Al, and K were also detected in Initial In-Metalbond.

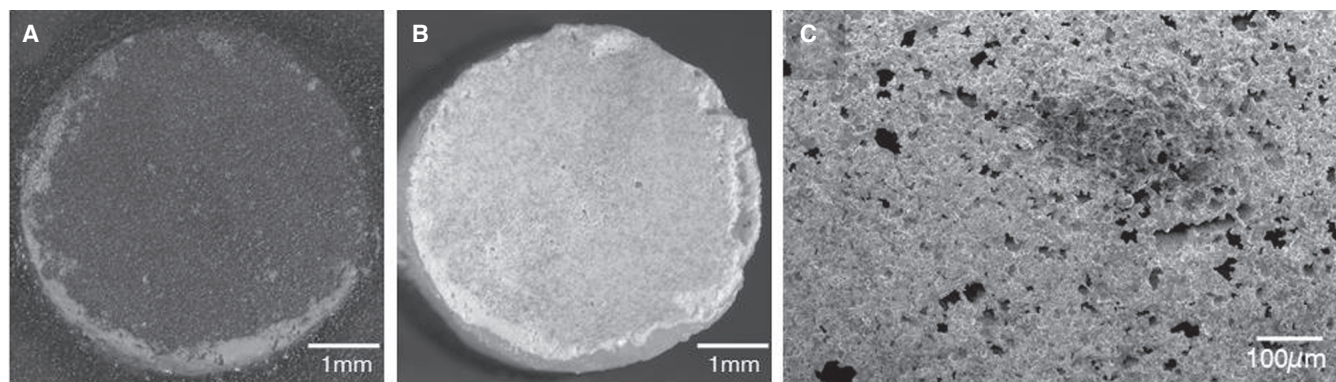
**Fig. 5.** Typical view of debonded specimen without metal conditioner. (A) Co-Cr alloy surface, (B) Porcelain surface, (C) SEM view of Porcelain surface (original magnification:  $\times 150$ ).

ed in Table 3. For the comparisons of failed surfaces, all the specimens showed mixed failure, which included cohesive failure of Co-Cr alloy, cohesive failure of porcelain and cohesive failure of metal conditioner. Non-metal conditioner specimens showed remnant of porcelain on the Co-Cr alloy surface (Fig. 5A) and numerous numbers of black spots scattered on the failed porcelain surface (Fig. 5B). SEM observation showed porous porcelain surface (Fig. 5C), and cobalt (Co) and chromium (Cr) were detected by EDS analysis. For the Initial IN-Metalbond-applied specimens, cohesive failure of both porcelain and metal conditioner were observed on the alloy surface (Fig. 6A) and black spots scattered on the failed porcelain surface (Fig. 6B). SEM observation showed entrapment of air-bubbles on metal conditioner surface (Fig. 6C), and Co and Cr were detected by EDS analysis. Regarding the NP-Primer-applied specimens, cohesive failure of porcelain and metal conditioner were observed on the alloy surface (Fig. 7A) and black spots scattered on the failed porcelain surface (Fig. 7B). SEM observation showed entrapment of air-bubbles on metal conditioner surface (Fig. 7C), and Co and Cr were detected by EDS analysis.

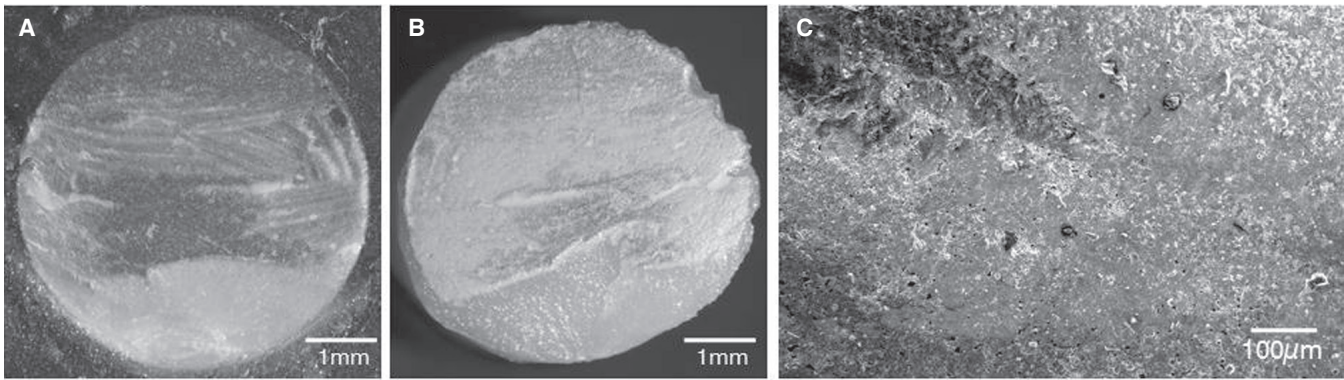
**Fig. 6.** Typical view of debonded specimen using Initial IN-Metalbond. (A) Co-Cr alloy surface, (B) Porcelain surface, (C) SEM view of Porcelain surface (original magnification:  $\times 150$ ).

tioner were observed on the alloy surface (Fig. 6A) and black spots scattered on the failed porcelain surface (Fig. 6B). SEM observation showed entrapment of air-bubbles on metal conditioner surface (Fig. 6C), and Co and Cr were detected by EDS analysis. Regarding the NP-Primer-applied specimens, cohesive failure of porcelain and metal conditioner were observed on the alloy surface (Fig. 7A) and black spots scattered on the failed porcelain surface (Fig. 7B). SEM observation showed entrapment of air-bubbles on metal conditioner surface (Fig. 7C), and Co and Cr were detected by EDS analysis.

Regarding the failure mode for both groups, Initial In-Metalbond applied group showed cohesive failure of both porcelain and metal conditioner on the alloy surface, and cohesive failure of alloy on the opposing failed porcelain surface (Fig. 6). Cohesive failures of porcelain on the alloy surface and of Co-Cr alloy on the failed porcelain surface (Fig. 7) were both observed in the NP-Primer-applied specimens. Both metal conditioner-applied groups revealed similar failure mode. Therefore, it is assumed that mechanical properties of Initial In-Metalbond, whose main component is Ti, must be inferior to those of NP-Primer. Differences in mechanical properties between the metal conditioners must have led to the difference in bond strength between the groups.
