# Surgical management of tibia refracture with a bent intramedullary nail: A case report and review of the literature

SAGE Open Medical Case Reports Volume 12: 1–5 © The Author(s) 2024 Article reuse guidelines: sagepub.com/journals-permissions DOI: 10.1177/2050313X231225338 journals.sagepub.com/home/sco

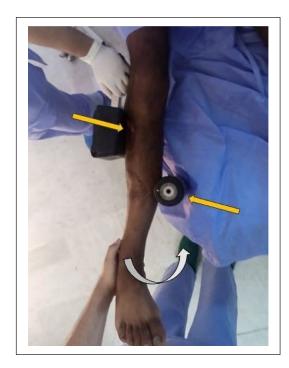
**Figure 3.** A well-padded bolster was fixed to the edge of the operating table at the level of the apex of the deformity. A second support against the lateral aspect of the right knee was used to counter the reducing forces (yellow arrows). A vigorous deforming force was applied on the lateral aspect of the ankle to try to straighten the bent nail (white arrow).

Under spinal anesthesia, with the patient in the supine position, a well-padded bolster was fixed to the edge of the operating table at the level of the apex of the deformity. A second support against the lateral aspect of the right knee was used to counter the reducing forces. A vigorous deforming force was applied on the lateral aspect of the ankle to try to straighten the bent nail (Figure 3). A substantial amount of force was necessary to reduce the uniplanar deformity of the

leg. The procedure was controlled both clinically and fluoroscopically. Fortunately, the deformity could be reduced without, however being able to completely straighten the nail.

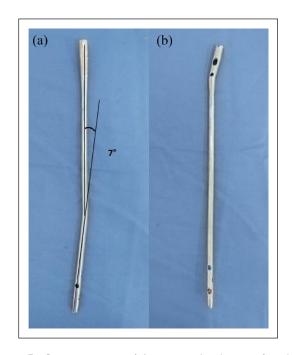
**Figure 5.** On examination of the removed nail, it was found that the deformity was brought down from  $25^{\circ}$  initially to  $7^{\circ}$  in the frontal plane (a), and there was no angulation in the sagittal plane (b).

On examination of the removed nail, it was found that the deformity was brought down from 25° initially to 7° (Figure 5). Postoperative follow-up was uneventful with no skin necrosis. Fracture consolidation was obtained at 4 months after surgery.
