Effect of Root Canal Preparation on Propagation of Dentinal Microcracks

Introduction: This study evaluated the propagation of dentinal microcracks and the root canal volume increase after being prepared with two endodontic instruments: ProTaper Next (PTN) and WaveOne Gold (WOG) by micro-computed tomography analysis. **Methods and Materials:** We selected 48 maxillary molars randomly distributed in two groups: PTN and WOG. The samples were scanned before and after instrumentation, and then the image analysis was performed to detect the propagation of pre-existing dentinal micro-cracks and calculate the pre- and post-instrumentation volume. The statistical analysis was performed using Student's t-test, Fisher's exact test, and ANCOVA ($P < 0.05$). **Results:** Dentinal microcracks were observed in 95.8% of the samples, both PTN and WOG instruments propagated microcracks after instrumentation, but there was no significant difference between the instruments ($P = 0.538$). In relation to the root canal volume there was no statistical difference between PTN and WOG systems for the mesiobuccal ($P = 0.426$) and distobuccal root canals ($P = 0.523$). **Conclusion:** We can conclude that b

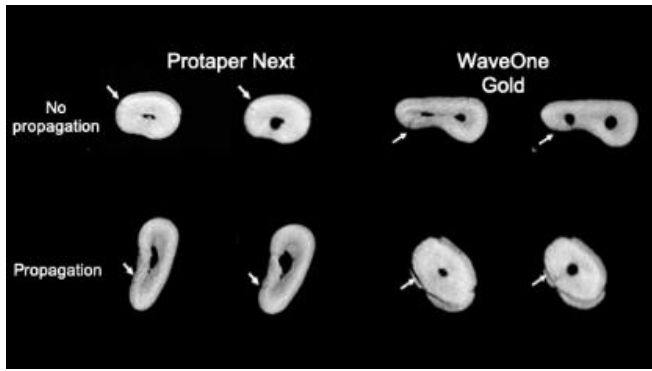
Figure 1. Dentinal microcracks propagation analysis after pre and post root canal preparation with different system: ProTaper Next (PTN) and WaveOne Gold (WOG)

Subsequently, the images of the corresponding cross-sections were also examined after post-instrumentation to verify the microcrack propagation observed in the pre-instrumentation image (Figure 1). In case of divergence, the observers examined the images together until an agreement was reached. The samples were divided into two groups: without propagation and with propagation of microcracks, and the results were expressed as a

Dentinal microcracks were observed in 95.8% of the samples, both PTN and WOG instruments propagated dentinal microcracks after root canal instrumentation ($P=0.538$). The null hypothesis tested that the probabilities of propagation are equal for the two instruments (PTN and WOG), versus the alternative hypothesis of different probabilities, for each canal (MB and DB), restricted to teeth that showed microcracks (Figure 1).

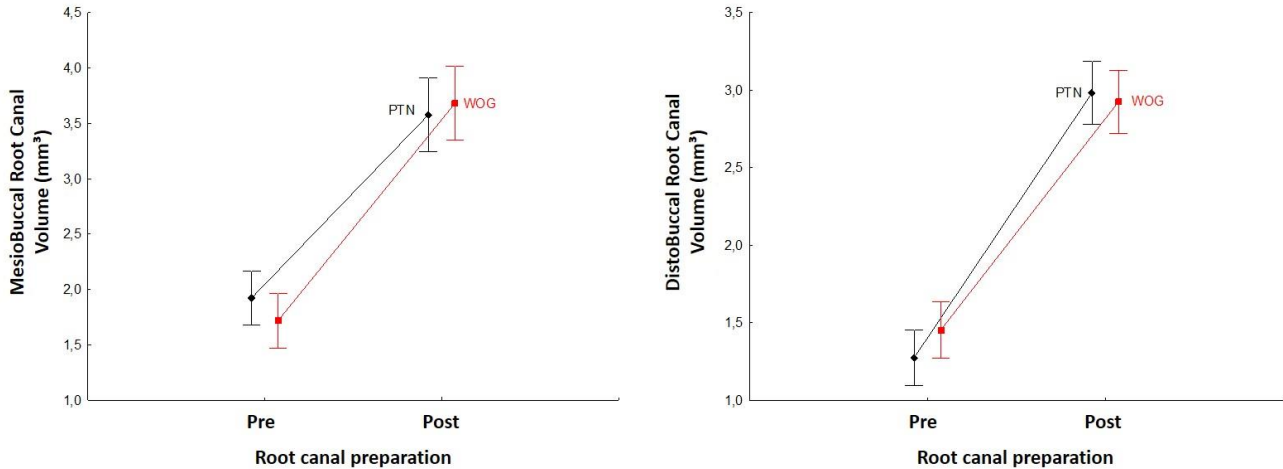
Figure 2. Mean (Standard Deviation) values for the volume (mm³) of the mesiobuccal and distobuccal root canals before and after root canal biomechanical preparation PTN: ProTaper Next, WOG: WaveOne Gold

In relation to the root canal volume, there was no statistic difference between PTN and WOG systems for the MB ($P=0.426$) and DB root canals ($P=0.523$) (Figure 2). Tables 3
