Journal section: Orthodontics
 Publication Types: Research

doi:10.4317/jced.54553
<http://dx.doi.org/10.4317/jced.54553>

Enamel evaluation by scanning electron microscopy after debonding brackets and removal of adhesive remnants

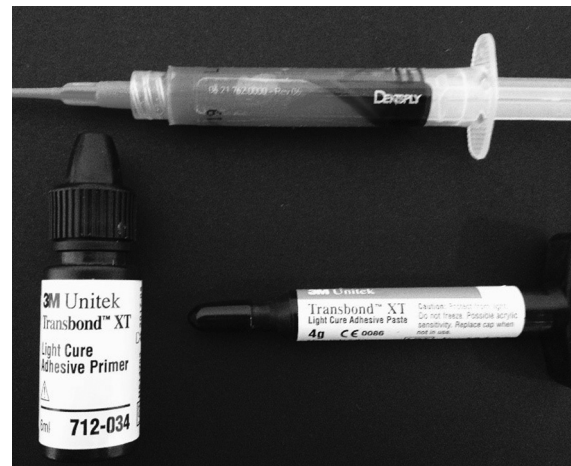
Fig. 1: Adhesive system for bonding brackets

After preparing the enamel samples, premolar brackets were bonded as prescribed by Edgewise Standart, slot .022" (Morelli Ortodontia, Sorocaba, SP, Brasil) using Transbond XT® (3M/Unitek) resin (Fig. 1). The amount

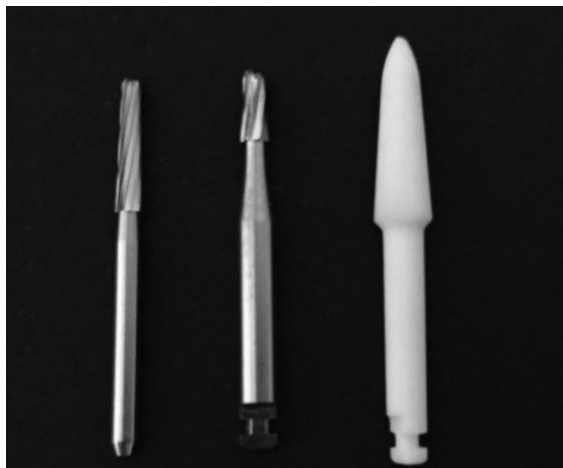
Fig. 2: Drills for removal of remaining adhesive.

After bracket debonding, the adhesive remnants were removed from the enamel surface in group 1 by using a tungsten carbide 24-blade high-rotation drill #CF 375R

(Orthometric, Marília, SP, Brasil); in group 2 by using a tungsten carbide 9-blade low-rotation drill #CB 27 (Orthometric); and in group 3 by using a Fiberglass® #2 TDV low-speed glass fiber drill (Fig. 2). In all three

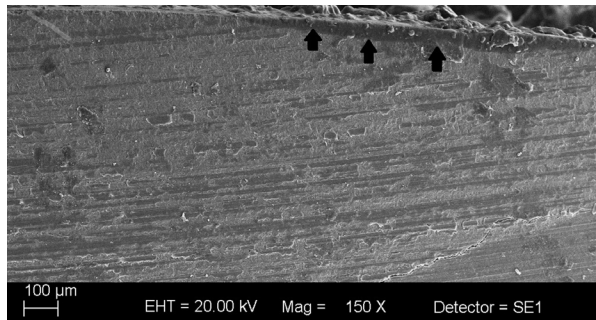
Fig. 3: Presence of adhesive remnants on the enamel surface.

The micrographs obtained by scanning electron microscopy demonstrated that, using the proposed protocols, all tested methods were inefficient, given the presence of adhesive remnants in all groups after cleaning the enamel surface using the drills corresponding to each group (Fig. 3).

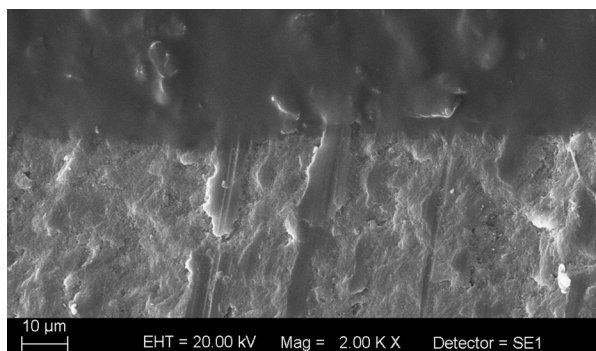
Fig. 4: Adhesive remnants on the enamel surface in group 3.

Group 3, in which a low-rotation fiberglass drill was used, presented the highest amount of adhesive remnants on the enamel structure, not only visible during microscopy analysis (Fig. 4), but also through visual inspection, which shows clinical inapplicability.
