The effect of various veneering techniques on the marginal fit of zirconia copings

PURPOSE. This study aimed to evaluate the fit of zirconia ceramics before and after veneering, using 3 different veneering processes (layering, press-over, and CAD-on techniques). **MATERIALS AND METHODS.** Thirty standardized zirconia CAD/CAM frameworks were constructed and divided into three groups of 10 each. The first group was veneered using the traditional layering technique. Press-over and CAD-on techniques were used to veneer second and third groups. The marginal gap of specimens was measured before and after veneering process at 18 sites on the master die using a digital microscope. Paired t-test was used to evaluate mean marginal gap changes. One-way ANOVA and post hoc tests were also employed for comparison among 3 groups ($\alpha=.05$). **RESULTS.** Marginal gap of 3 groups was increased after porcelain veneering. The mean marginal gap values after veneering in the layering group (63.06 μm) was higher than press-over (50.64 μm) and CAD-on (51.50 μm) veneered groups ($P<.001$). **CONCLUSION.** Three veneering methods altered the marginal fit of zirconia copings. Conventional layering tech

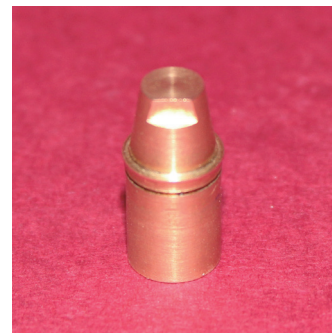
Fig. 1. Brass master die.

Ceramic materials investigated in this study were displayed in Table 1. A brass master die was machined to approximate dimension of a prepared molar for an all ceramic restoration with 7 mm height, 6 degree of occlusal convergence and a 90 degree shoulder of 1 mm wide finish line (Fig. 1). Preparation of master die was free of any irregular-

ities, and was done in accordance with the current standards of full ceramic restorations.³² An antirotational design was included in the axial surface to ensure reproducible seating of the coping on the master die. Eighteen points for measurement of vertical marginal gap at 20 degree intervals were marked on a groove 3 mm below the margin by means of a high speed handpiece and a diamond needle bur. Finally, the die was embedded in an acrylic block by means of a dental surveyor (Ney Dental Surveyor, Dentsply, Balalgués, Switzerland) to ensure its long axis was perpendicular to the horizontal plane.

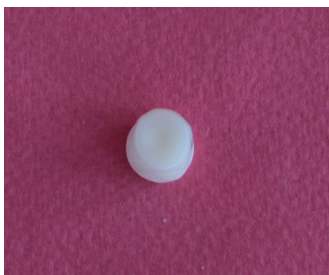
Fig. 2. Fabricated zirconia CAD/CAM coping.

In order to eliminate the effect of impression and pouring variations, the metallic die was used as the definitive die. The die was sprayed with scan spray and scanned using a 3D-laser scanner (3ShapeD810; 3Shape, Copenhagen K, Denmark). The data were transferred to CAD software (3Shape's CAD Design software; 3Shape, Copenhagen K, Denmark) in which the copings were designed with a uniform thickness of 0.5 mm around, considering 30 μ m spacer, and 1 mm short of the margin. In the occlusal surface a depression was designed to accommodate the tip of the holding device (Fig. 2). Thirty zirconia copings were milled from pre-sintered Y-TZP blanks (IPS e.max ZirCAD, Ivoclar Vivadent) in a milling machine (inLab MC XL, Sirona) in a

white state. The zirconia frameworks were then sintered (Programat S1, Ivoclar Vivadent). The frameworks were examined for any imperfections and rejected if any deformation was observed.

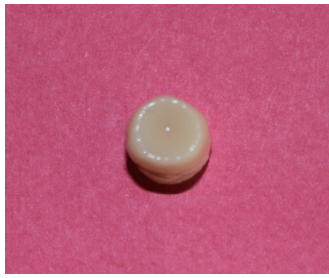
Fig. 5. Fabricated zirconia CAD/CAM crown.

Thirty copings were randomly divided into 3 equal groups. On each of them one of the following veneering techniques were performed (layering (L), press-over (P), and CAD-on (C) techniques). The first 10 copings were veneered using the traditional layering technique. A silicone index was used to standardize the shape and size of veneers with a homogenous veneering thickness of range between 0.7 mm at margins and 1.5 mm at occlusal surfaces. To veneer the copings with layering technique, the liner (IPS e.max, zirliner; Ivoclar Vivadent) was applied to the zirconia copings, and they fired in a compatible ceramic furnace (Programmat 700; Ivoclar Vivadent) at 960°C; then a nano-fluoroapatite glass ceramic (IPS e.max Ceram; Ivoclar Vivadent) was applied in dentin and enamel layers and processed at 750°C, followed by glazing and finishing procedures to complete the restorations. The occlusal surface of the crowns was accommodated to the holding device tip to

ensure the same seating of them as copings on the die (Fig. 5).
