Original Article

Bone properties of the humeral head and resistance to screw cutout

Lars Henrik Frich, Niels Christian Jensen¹

Please cite this article as: Frich LH, Jensen NC. Bone properties of the humeral head and resistance to screw cutout. Int J Shoulder Surg 2014;8:21-6.

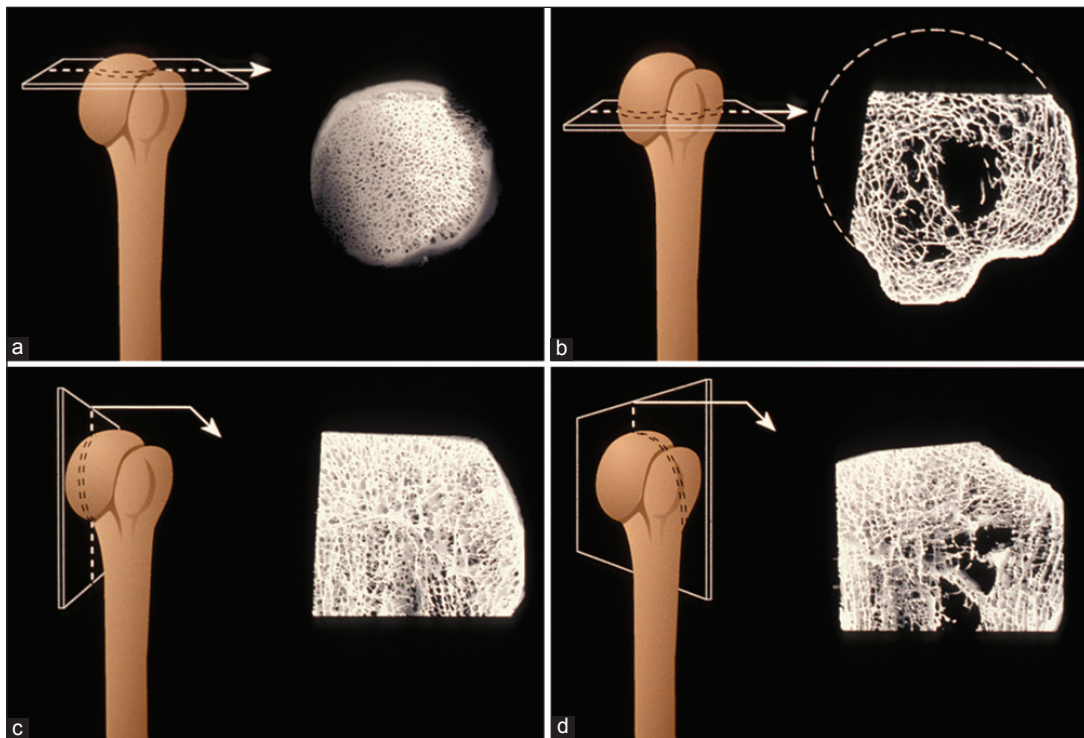
Figure 1: Graphical reconstructions of the humeral head. (a) The dense tubular arranged trabeculae formed the subchondral bone texture at the top of the head. Note the few connecting trabeculae. (b) The shift from plate-like trabeculae forming the greater tuberosity toward the center of the head is abrupt. (c) The wave-like remnants of the epiphyseal scar separates the subchondral bone from the trabeculae at the center of the head. (d) This section demonstrates the complex trabecular bone texture underneath the “footprint” of the rotator cuff tendons

composite architecture of the humeral head.^[6] Approximately 800 binary (black Epoxy resin and white bone) digital images of 1024×1024 voxel size were generated from each head specimen. Graphical reconstructions were used to qualitatively describe the bone morphology of each humeral head in three dimensions [Figure 1a-d]. The thickness of the subchondral plate was also assessed from these graphical reconstructions. In practice, the subchondral plate is not a completely solid structure, but contains vascular channels and small marrow spaces. The thickness of subchondral plate was assessed using a threshold of 95% bone volume defined from the binary images.

Studies of the trabecular bone texture revealed great variations from the humeral head surface to the lateral cortex [Figure 1a-d].

The humeral head is covered by a thin and convex subchondral plate. Thickness of the plate averaged 0.6 mm (range 0.3-0.8 mm), the plate being thickest centrally. The plate grows thinner toward the anchor site to cortical bone at the margins of the head. The subchondral plate overlies a transitional zone of cancellous bone [Figure 1a] characterized by strong architectural anisotropy [Table 1]. The main trabeculae in the central and medial section of the humeral head were orientated in a radial direction aiming from the subchondral plate toward the center of the humeral head. Our tests also demonstrated very few connecting trabeculae perpendicular to the main axis. The stable transitional zone of organized trabeculae was separated from the central part of the humeral head by remnants of the epiphyseal scar [Figure 1c].

In contrast to the head, the greater tuberosity comprises plate-like trabeculae mostly orientated in parallel to the lateral cortex of the humerus [Figure 1b and 1d].

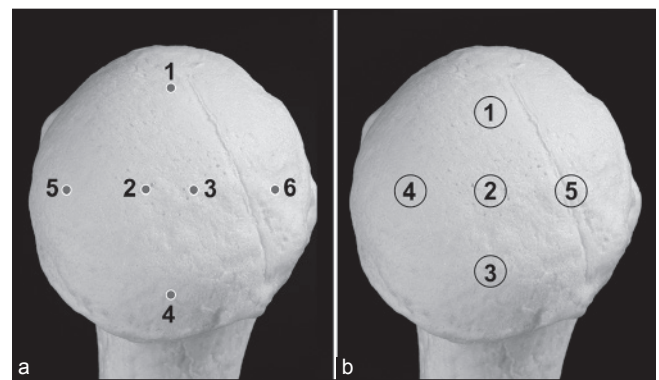
Figure 2: (a) Penetrometer test spots. (b) Location of bone cylinders harvested from the subchondral bone of the humeral head.

One-hundred (100) bone cylinders were harvested from 20 (10 pairs) humeral head specimens [Figure 2]. Seven (7) cylinders

were lost during testing procedures. The first cylinder was harvested from the very center of the head. The other 4 test positions were defined at a distance halfway between the center of the head and the rim of the humeral head. Drilling was started with the 7.0 mm trephine drill burr having circumferential contact with the cartilage of the humeral head. This technique ensured that the cylinders could be harvested orthogonal to the subchondral plate. Following harvesting, the cartilage and subchondral plate was cut 1 mm below the subchondral plate using an Exakt^R cutting grinding machine.

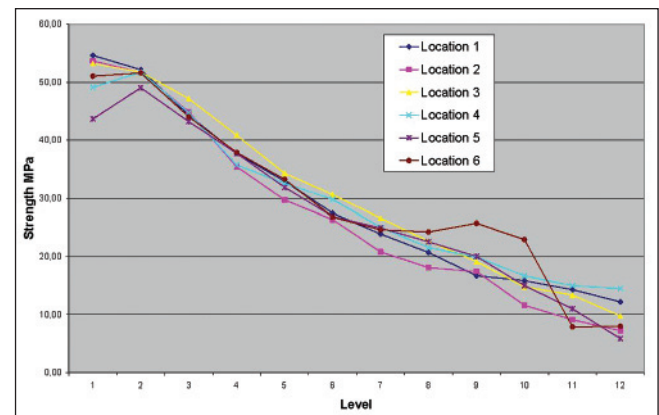
Figure 3: Penetration test curves with penetration strength from 6 different locations of a humeral head specimen from a 65-year-old male. The level markers indicate consecutive 1 mm depth intervals below the subchondral plate. Note that maximum strength is connected with the subchondral plate. Note also the rapid decline in bone strength below the subchondral plate. Locations 2 and 3 represent the center of the humeral head

A 4302 INSTRON^R materials testing machine equipped with a 10 kN load cell was used for indentation tests. A steel needle, with a base diameter of 2.5 mm and the needle shaft milled to 2.3 mm, was driven into the cancellous bone at a constant speed of 1 mm s⁻¹.^[13] During testing, the humeral head specimens were fixed to the distal steel column of the Instron machine using acrylic cement around the remaining parts of the proximal humerus. The resulting load-depth curves [Figure 3] yield an expression of the bone strength in Mpa.

Penetration tests revealed a characteristic profile of strength [Figure 3]. Penetrations strength decreased by 25% from level 1 at the level of the subchondral plate to a level 5 mm below the plate. Strength 7-8 mm below the subchondral plate was reduced by a factor 2 ($P < 0.000$).

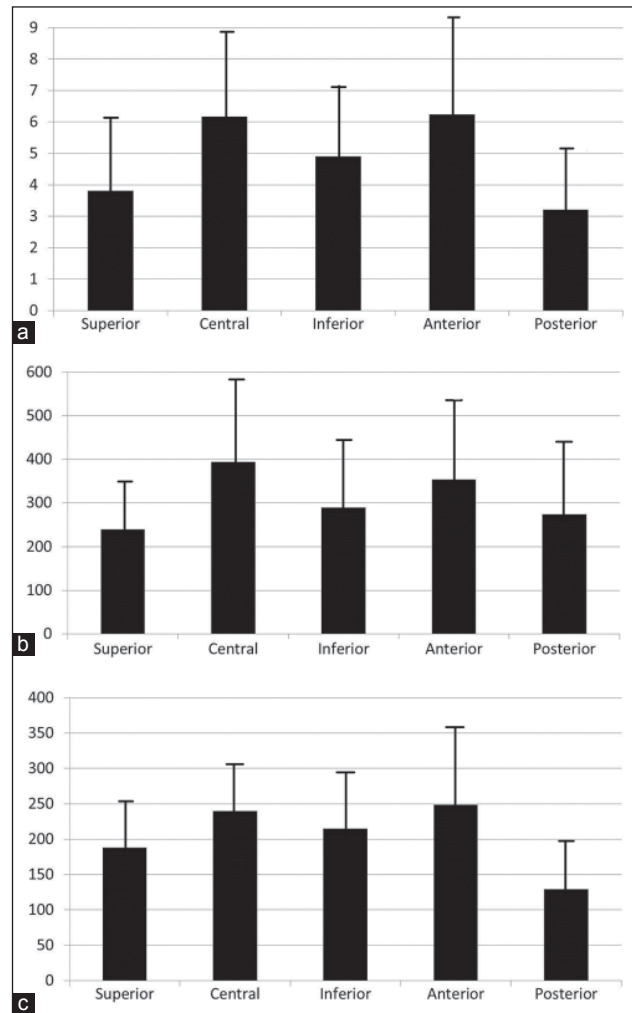
Figure 4: (a) Normalized strength (MPa) in loading of bone cylinders from 5 different sites at the humeral head (mean \pm SD). (b) CT-density (Hounsfield Units) from 5 different sites at the humeral head (mean \pm SD). (c) Stiffness (MPa) and in loading of bone cylinders from 5 different sites at the humeral head (mean \pm SD).

Mechanical tests of the bone cylinders from the humeral head revealed average ultimate strength values ranging from 3.21 MPa to 6.17 Mpa [Figure 4a]. The variations of CT-density [Figure 4b] expressed as average CT units (Hounsfield units) correlated (Pearson correlation) well with stiffness [Figure 4c] ($r = 0.64$) and strength ($r = 0.84$). The ultimate strength and CT-density measurements revealed that the humeral head was significantly stronger ($P < 0.001$) and more dense ($P < 0.01$) in the anterior and central regions. The weakest part of the humeral head was located posteriorly and inferiorly of the humeral head. This monocentric strength pattern was seen in all the tested specimens and therefore seemed to be independent of age. The measured strength and stiffness was not statistical different between left and right shoulders ($P < 0.001$)
