Evaluation of temperature of a full ceramic total knee arthroplasty during MRI examinations

Abstract

Background: A diagnosis by magnetic resonance imaging (MRI) is often necessary before surgery of degenerative spine diseases. This can lead to a possible conflict with an inserted implant of the hip or knee. Heat generation or movement could be caused by the magnetic field. The aim of this study is to investigate temperature development in vitro in a 1.5T MRI of a ceramic knee arthroplasty.

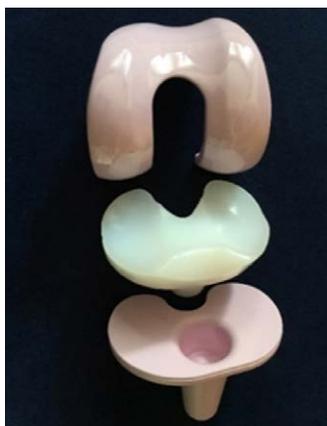
Figure 1. The complete metal-free non-constrained primary total knee arthroplasty made of an alumina/zirconia ceramic composite with an ultra-high-molecular-weight polyethylene insert.

A full ceramic, complete metal-free non-constrained primary total knee arthroplasty was investigated (Ceramic BPK-S Integration; Peter Brehm GmbH, Weisendorf, Germany). The bicondylar femoral component and the tibial component are made of an alumina/zirconia ceramic composite (BioloX@delta; CeramTec AG, Plochingen, Germany). The ultra-high-molecular-weight polyethylene insert may be rotating or fixed-bearing (Fig. 1). It is geometrically identical to the composite matrix material containing aluminum oxide counterpart of the same producer.^[11,14]

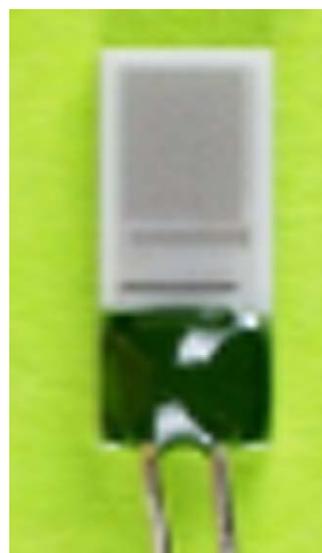
Figure 2. Platinum resistor used to measure the temperature change.

Platinum measuring resistors are used to measure the temperature change before and after each MRI sequence by electrical resistance. They change the electrical resistance as a function of temperature. The measuring sensors used are thin-film measuring resistors made by TESLA BLATNÁ. With a size of 1.8 mm × 4.2 mm they are very compact, have a very fast response time of 0.08 to 17 seconds depending on the medium used, react very quickly to changes in temperature and show a negligible self-heating of 0.4 K/mW at 0°C. The measuring resistors are designed as thin-film measuring resistors (Fig. 2).

The type PT1000 measuring resistors of class A (DIN EN 60751) with an accuracy of $\pm (0.15 + 0.0020 | t |)$ in the measuring range of -90°C to $+300^{\circ}\text{C}$ were used. PT1000 resistors have a resistance of 1000 Ohm at a temperature of 0°C and increase the resistance with increasing temperature.

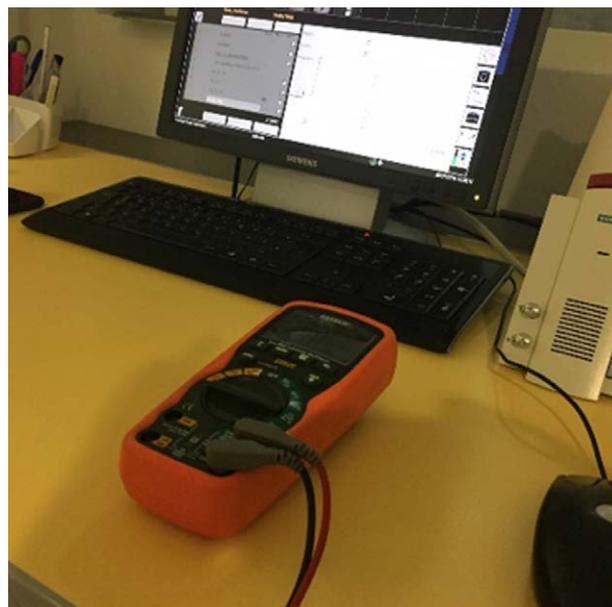
Figure 3. Voltcraft PTM-100 used as the measuring instrument.

A Voltcraft PTM-100 was used as the measuring instrument display for the PT1000 measuring resistor. This instrument has an accuracy of $\pm 0.1^{\circ}\text{C} \pm 1$ digit in the range from -20 to $+100^{\circ}\text{C}$, but the class A sensor used determines the accuracy and thus reduces it to $\pm 0.15^{\circ}\text{C}$. The accuracy of the sensor is therefore determined by the accuracy of the sensor (Fig. 3).

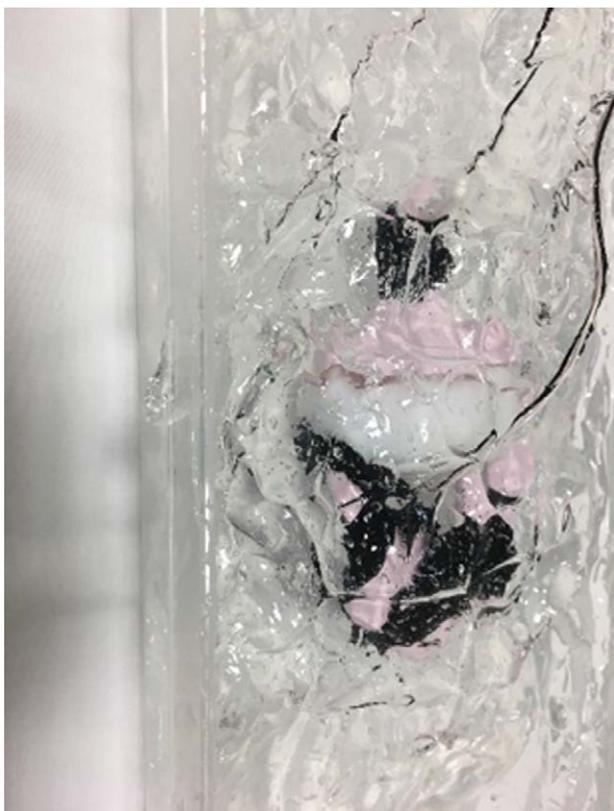
Figure 4. The position of the platinum resistors.

in the second step the container was completely filled with ultrasound gel (ultrasound gel 5, Megro, Wesel, D). The total of four standard knee sequences performed are listed in Table 1. The platinum resistors position was then always documented accordingly (resistor 1: at the ceramic head, resistor 2: at the stem neck, resistor 3: at the hip stem, resistor 4: at the bottom of the container away from the prosthesis, resistor 5: five in the middle of the MRT for air measurement). This arrangement was used the same for all experiments and is shown Figures 4 and 5.

A total of four standard knee sequences were run (Table 1). Temperature was measured before the first and after each sequence. There are 3 measurement points placed on the ceramic knee (point number one on the tibia, number two and three on the femur), number four in the ultrasound-gel and number five for room temperature (Fig. 4). The arrangement in the MRI is shown in Figure 5. The time for completing all sequences was 8 minutes and 19 seconds.

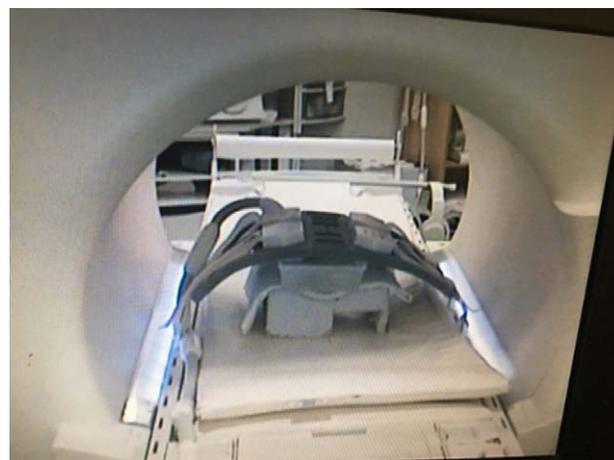
Figure 5. This arrangement was used the same for all experiments.
