Endovascular Removal of the Viatorr Stent-Grafts. Report of Two Cases

Wojciech Cwikiel^{ABDEF}, Magnus Bergenfeldt^{ACDE}, Inger Keussen^{ABDE}

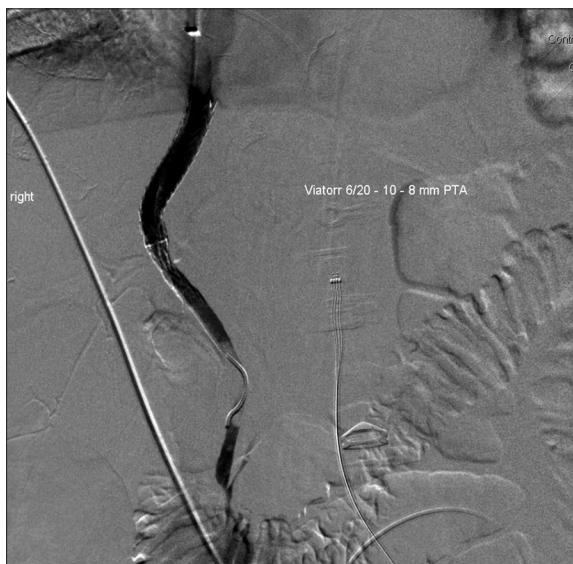
Figure 3. Viatorr connecting the bile duct with IVC.

During transjugular, transhepatic attempt to puncture PV, a bile duct was accidentally entered (Figure 3). That was misinterpreted by the physician performing the procedure, who placed a Viatorr connecting the bile duct to the right hepatic vein. The physician reported later that "the flow from the SMV was good, the gradient was=0 mmHg, and the TIPS was created successfully".

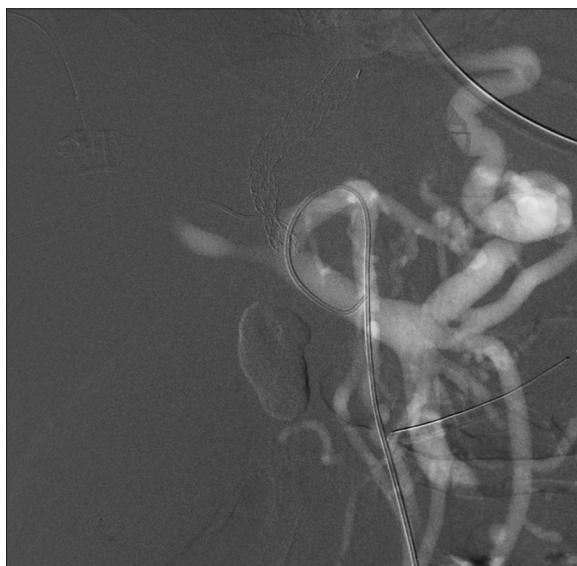
Figure 4. CO2 portography through the catheter placed through a paraumbilical vein.

the right portal vein branch. CO2 portography through that catheter showed a hepatofugal flow in the portal vein but no connection with the bile duct (Figure 4). The percutaneous biliary drainage catheter was removed over the guide-wire and replaced with a 8-F sheath. Through the left jugular vein, a 4-F Cobra catheter was introduced jointly with a 0.035-inch glide-wire through the Viatorr to the common bile duct. After confirmation of their position, the sheath was exchanged over the 0.035-inch Amplatz wire for a 45-cm-long 16-F sheath. The loop of the 15-mm GooseNeck Snare was placed over the wire. Subsequently, a 10×40-mm dilation balloon was advanced into the Viatorr in order to facilitate placement of the snare over the cranial edge of the Viatorr. However, only a part of the cranial portion of the Viatorr could be grasped with the snare.
