Case Report

## Paravalvular mitral valve leakage presenting as congestive heart failure, missed by TTE but diagnosed by TEE: a case report

Cases Journal 2008, 1:216 doi:10.1186/1757-1626-1-216

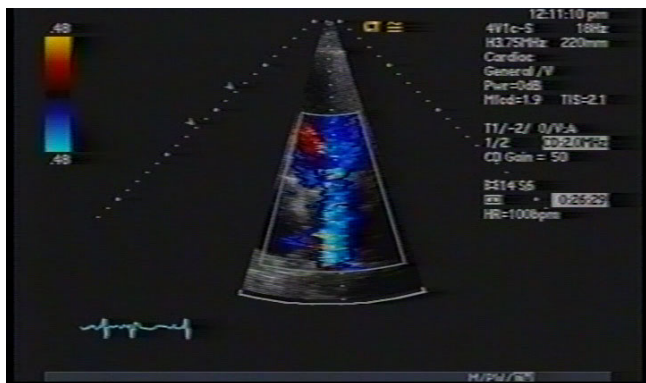
**Figure 1**  
Transthoracic Echocardiogram showing (arrow) possible mitral valve regurgitation.

(TTE) (Figure: 1) showed moderately decreased left ventricular systolic function with global hypokinesia and paradoxical septal motion consistent with open heart surgery, mild to moderate dilated left atrium, bio-prosthetic mitral valve with thickened leaflet, possible eccentric mitral regurgitation, pulmonary artery systolic pressure of 62 mm Hg, and a left ventricular ejection fraction of 30–35%. On Doppler interrogation E-velocity was high and color flow Doppler showed an eccentric mitral regurgitant jet. However as the assessment of the severity and the origin of the mitral regurgitation were not possible by TTE, a TEE (Figure: 2) was performed. The TEE showed a significant paravalvular leak of moderate severity around the bio-prosthetic mitral valve. Regurgitant orifice area of the paravalvular leak was 0.5 cm<sup>2</sup> by the PISA method, and regurgitant volume was 70 mL.

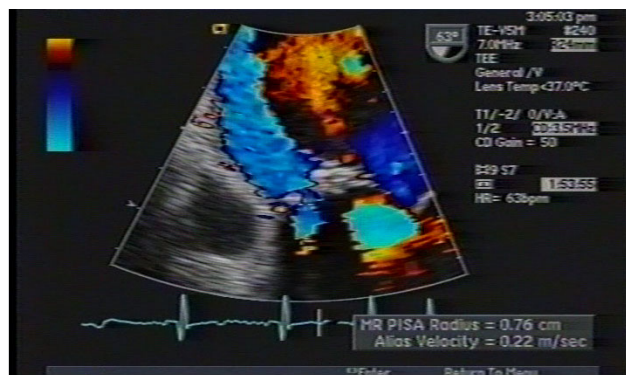
**Figure 2**  
Transesophageal Echocardiogram showing (arrow) a paravalvular mitral valve leak missed by the transthoracic echocardiogram.

Acoustic shadowing caused by the prosthetic material may limit transthoracic visualization of prosthetic leaflets. Prosthetic aortic valve regurgitation is usually well visualized on surface color Doppler imaging but prosthetic mitral regurgitation is frequently undetectable[9]. As in our patient, TEE is the imaging modality of choice when the TTE is suboptimal or when there are borderline findings on the TTE in a patient whom there is a strong clinical suspicion of malfunction [8]. The overall sensitivity and specificity for TTE is 57% and 63% respectively and for TEE it was 86% and 88% for the identification of morpho-
