Unusual mechanical complications of central venous catheterization

Objectives: To present an unusual major mechanical complication of central venous catheterization (CVC).

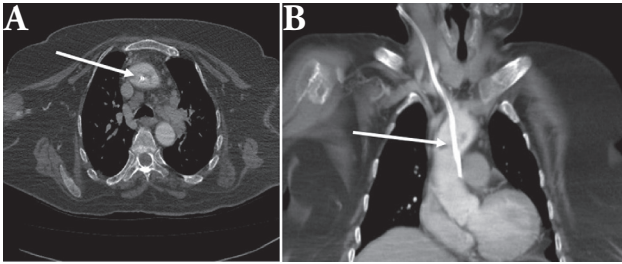
In our study, the most interesting complication occurred due to accidental aortic catheterization via the right carotid artery. One case was of an 80-year-old female patient who had chronic kidney disease and diabetes mellitus. She was admitted to the emergency department owing to the complaints of profound hypotension and arteriovenous fistula thrombosis. Due to this emergency situation, a central venous catheter was placed through the right jugular vein at the emergency unit of the hospital. After multiple hemodialysis sessions and medication, it was observed that the patient's blood pressure became normotensive, and then the central venous catheter pulsation became synchronized with the heartbeat. Thoracic computed tomography (CT) showed that the central venous catheter was inserted in the right carotid artery and that the catheter tip was placed in the arcus aorta (Figure 1). Interestingly, the patient did not experience any neurological complications or embolism.

Figure 1 - Catheter tip placed in the ascending aorta. **A)** axial plane, **B)** coronal plane of computed tomography images.

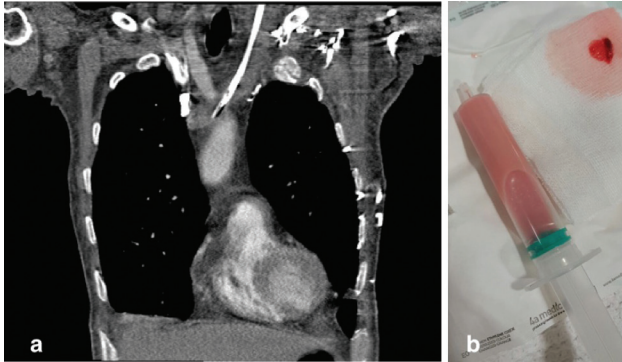
the hemodialysis unit. A nurse at the hemodialysis unit observed that initially, blood was drawn into the syringe from the catheter following which the color of aspiration fluid became clear and milky/pinkish white (Figure 2a). Thoracic CT showed that the catheter tip was placed at the ductus thoracicus. Because of brachiocephalic vein thrombosis, the aspiration material drawn from

the catheter was intensive lymphatic fluid mixed with blood (Figure 2b).

Figure 2 - Catheter tip placed at the **A)** ductus thoracicus, **B)** color of aspiration fluid was milky/pinkish white.

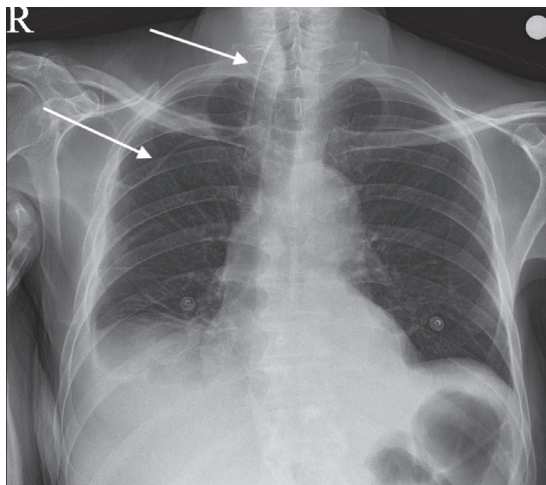
Figure 3 - Tip of subclavian catheter turned into jugular vein.

Intravascular or extravascular malposition of the catheter tip is another important unusual major mechanical complication of CVC. Intravenous misplacement of the catheter tip can lead to traumatic vascular complications, thrombosis, and impaired catheter function. In our study, 3 catheters tips had been incorrectly placed, which necessitated catheter removal. One of them, due to the brachiocephalic vein occlusion tip of subclavian catheter was turned into jugular vein (**Figure 3**), another femoral venous catheter tip was in the hepatic vein related catheter patient mismatch and catheter tip in ductus thoracicus. The function of the 3 catheters was impaired and thus all the catheters were removed. Deitel and McIntyre⁹ suggested that the
