## Case Report

# Accuracy of 3-Dimensional Transoesophageal Echocardiography in Assessment of Prosthetic Mitral Valve Dehiscence with Comparison to Anatomical Specimens

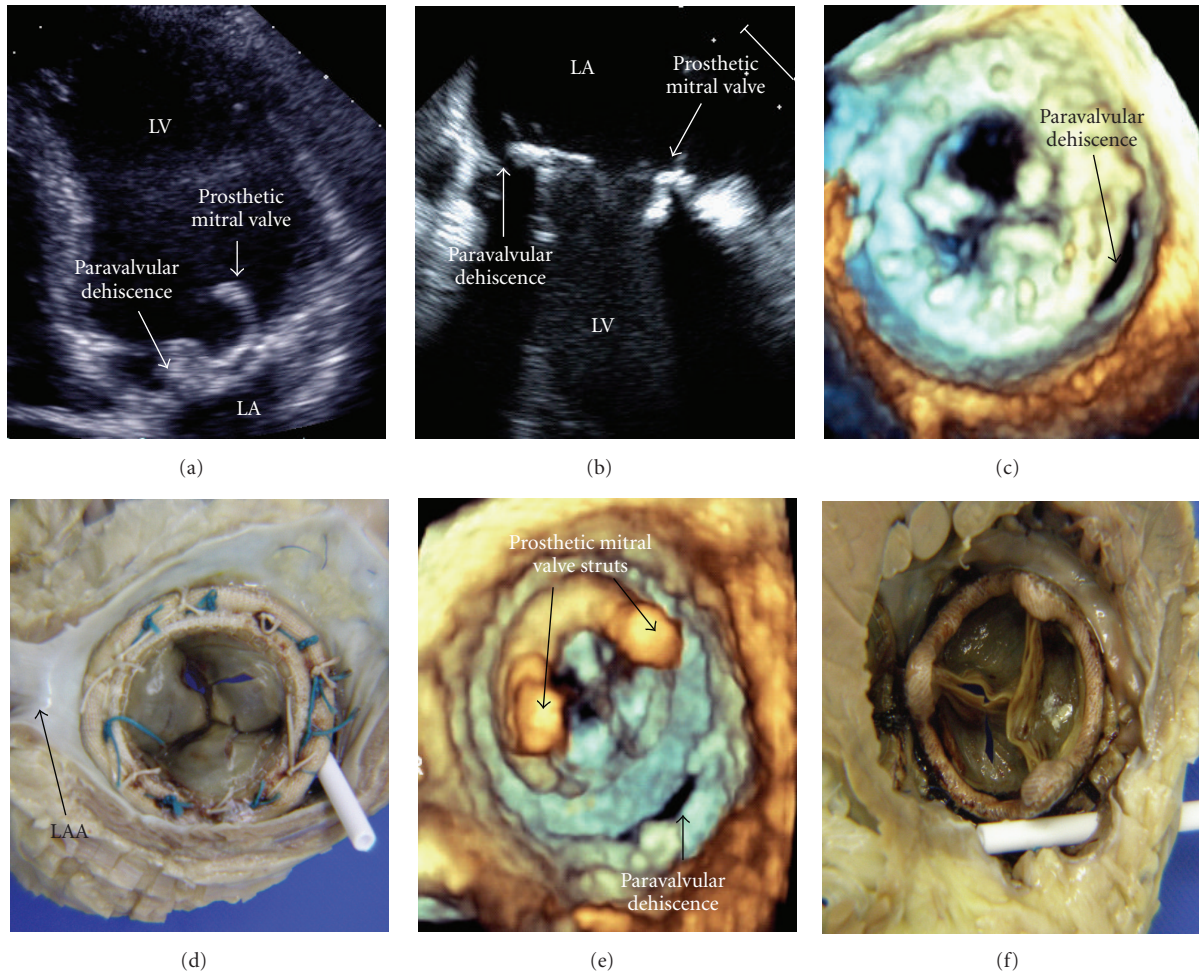
FIGURE 1: Comparison of prosthetic mitral valve dehiscence by differing echo modalities and direct comparison to postmortem specimens. (a) demonstrates the prosthetic mitral valve paravalvular dehiscence using 2D TTE (Online Video 1). The 3 mm defect is shown in more detail using 2D TOE (b) (Online Videos 2 and 3). Real-time 3D TOE clearly shows the crescent-shaped posteromedial paravalvular dehiscence from the atrial aspect (c) (Online Video 4) compared to the postmortem specimen (d) and the ventricular aspects (e) and (f) (Online Video 5). Also, note the two 4mm echo densities on the atrial surface of the prosthetic mitral valve on the 2D TOE (b) (Online Video 2) which were subsequently found to be sutures on the postmortem specimen (d). The 3D real-time colour Doppler TOE can be seen in Online Video 6. 2D: 2-Dimensional; TTE: transthoracic echocardiography; TOE: transoesophageal echocardiography; 3D: 3-Dimensional; LV: left ventricle; LA: left atrium; LAA: left atrial appendage.

Serial Figures 1(a)–1(f) and supplementary movies 1–6 (see supplementary movies in Supplementary Material available online at doi:10.4061/2010/750874) demon-

strate the increasing accuracy of diagnosis using 2-dimensional transthoracic echocardiography (2D TTE), 2D transoesophageal echocardiography (TOE), and real-time 3-dimensional (RT 3D) TOE.

This case illustrates the accuracy and details of real time 3D TOE in prosthetic mitral valve dehiscence when directly compared to the postmortem anatomical specimens.
