## Case Report

## High traffic congestion in right atrium

A 62-year lady presented with limb swelling and heart failure due to leads induced venous fibrosis and severe tricuspid stenosis, 33 years after pacemaker implantation. After undergoing surgical removal of all leads and tricuspid valve replacement under cardiopulmonary bypass, she regained a normal functional status and tricuspid and right ventricular functions.

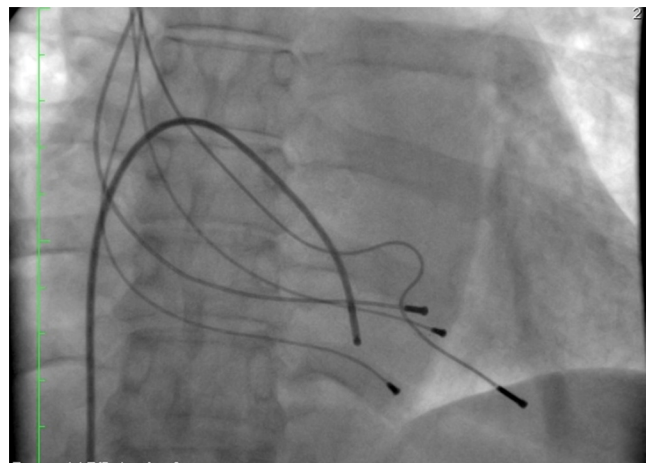
Fig. 1. Fluoroscopy showing four leads across tricuspid valve.

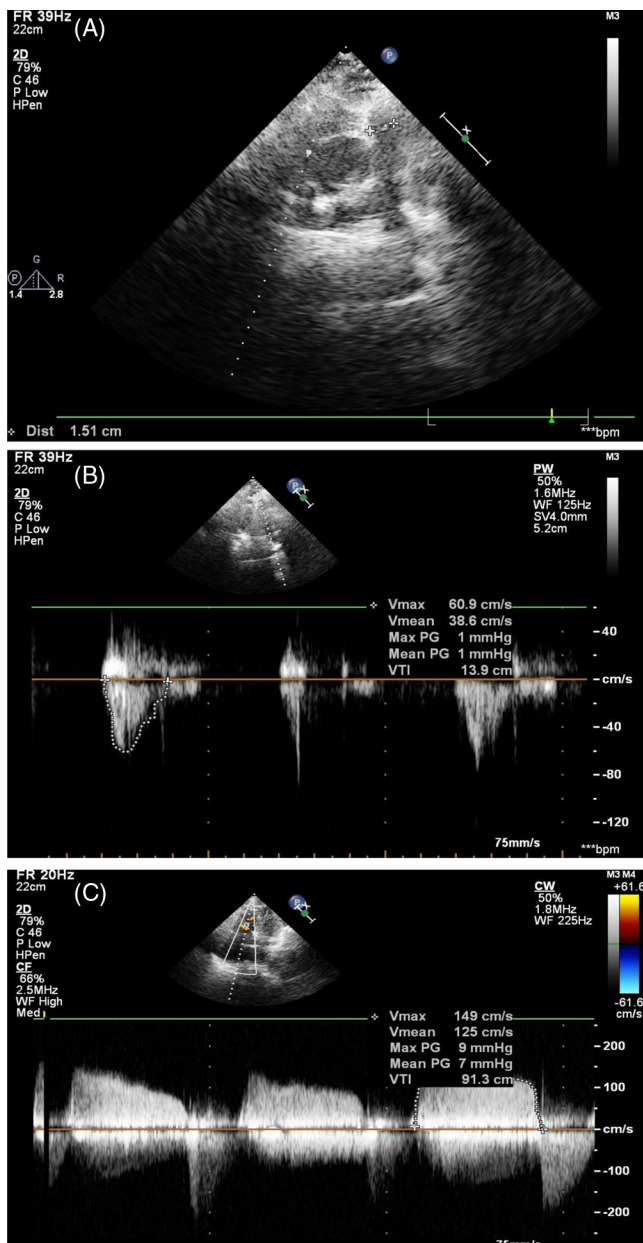
**Fig. 2.** (A) CW Doppler showing mean gradient across the tricuspid valve of 7 mmHg S/O severe T.S., tricuspid valve VTI was 91.0. (B and C) Calculation of stroke volume across RVOT.

(Fig. 2A–C). She was managed with diuretics and anticoagulation as the family refused surgery. In April 2015, 33 years later, she presented with lead fracture of ventricular lead. Venography (Fig. 3A and B) revealed bilateral subclavian and superior vena cava occlusion, which was confirmed on cardiac CT scan. Cardiac catheterization revealed transtricuspid mean gradient of 7 mmHg, mean pulmonary artery pressure of 15 mmHg, and normal coronaries. She underwent surgery for removal of pacing leads, tricuspid valve and superior vena cava reconstruction, and a new epicardial pacemaker implantation.

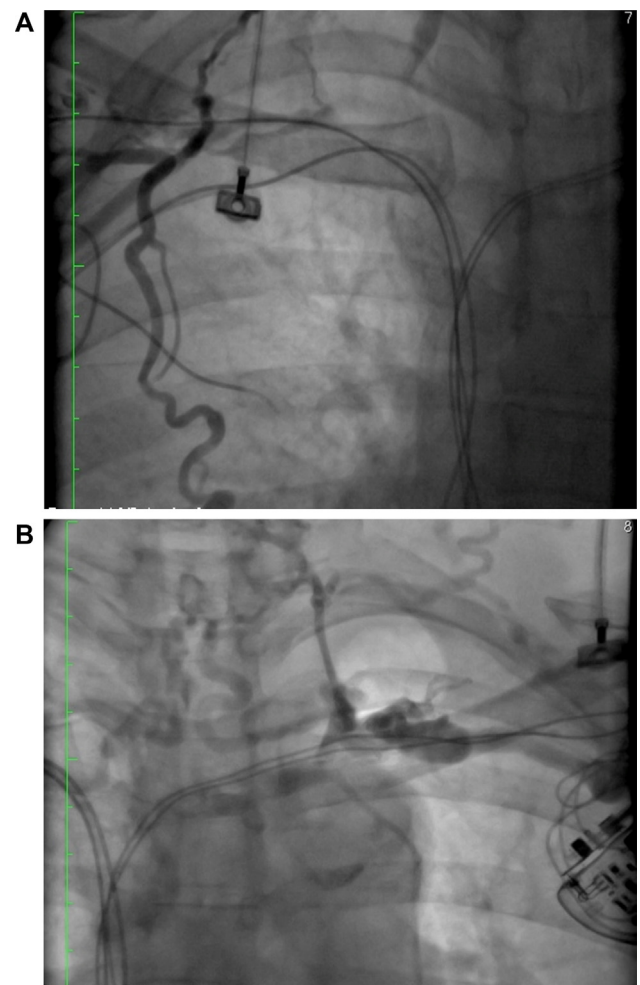
**Fig. 3.** (A) Venogram showing occlusion of right subclavian and internal jugular veins. (B) Venogram showing occlusion of left internal jugular and brachiocephalic veins with collaterals.

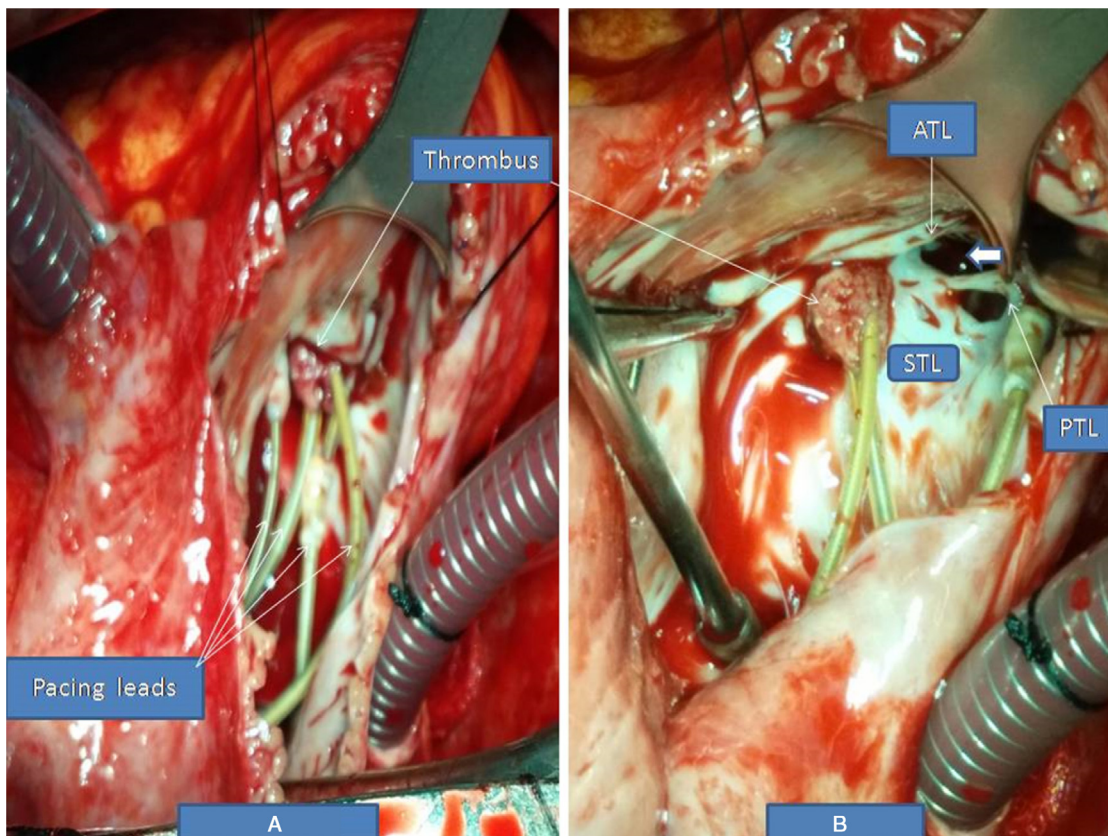
Fig. 4. Commissural fusion of septal and posterior leaflets, large thrombus on leads, and narrow tricuspid valve opening marked as arrow.

Following median sternotomy, superior vena cava (SVC) and right atrium (RA) were cannulated. Tricuspid valve was thickened, fibrosed, and significantly stenosed. The commissures of all three leaflets were fused. All four leads were trapped and fused with tricuspid leaflets (Fig. 4). Tip of all four leads were firmly embedded in RV with severe fibrosis, preventing their removal despite
