Prevalence of dental implant positioning errors: A cross-sectional study

Purpose: This study evaluated the prevalence of dental implant positioning errors and the most frequently affected oral regions.

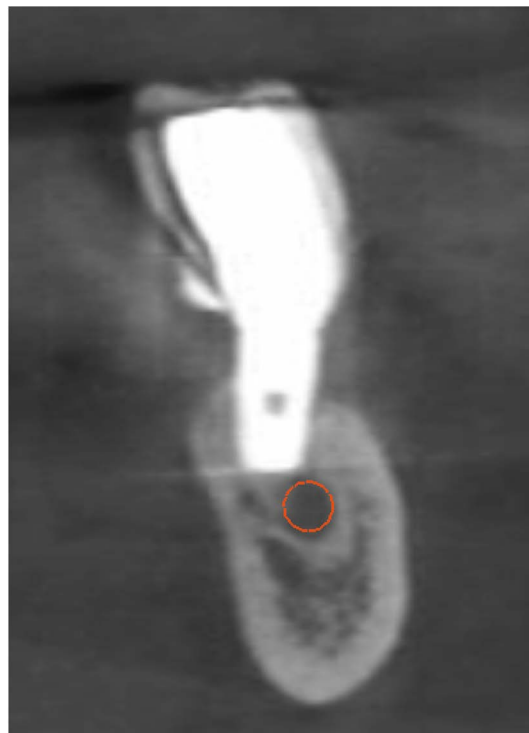
Fig. 1. Thread exposure on a cross-sectional image. The dental implant is positioned in the region at the right mandibular first molar, where it has no bone coverage in the cervical and middle thirds in the buccal region and in the cervical third of the lingual region. The mandibular canal is represented by the circle.

1. Thread exposure: presence of bone plate discontinuity (Fig. 1).
2. Violation of the minimum distance between the implant and adjacent tooth: any distance less than 1.5 mm (Fig. 2).
3. Violation of the minimum distance between 2 adjacent

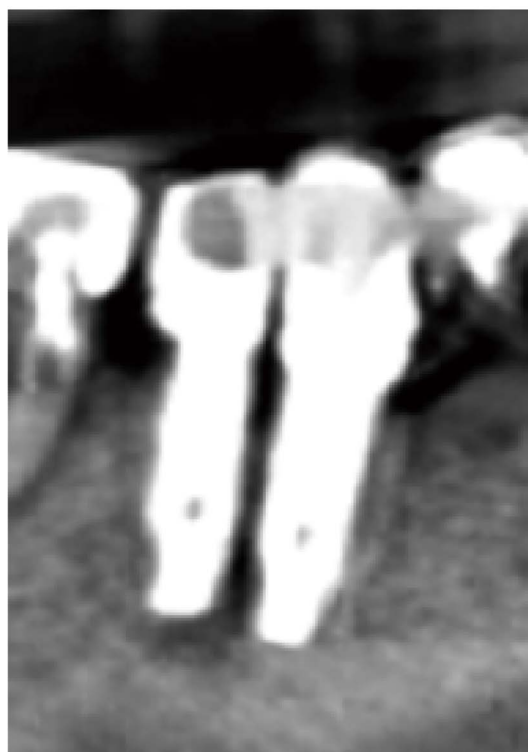
Fig. 3. Violation of the minimum distance between 2 adjacent implants on a panoramic reconstruction image. The dental implants are positioned in the region of the right mandibular first and second premolars, and the distance between them is 1.04 mm.

implants: any distance less than 3 mm (Fig. 3).
