Case report

Late posterior hip instability after lumbar spinopelvic fusion

Colin A. Mudrick, MD, J. Stuart Melvin, MD, Bryan D. Springer, MD *

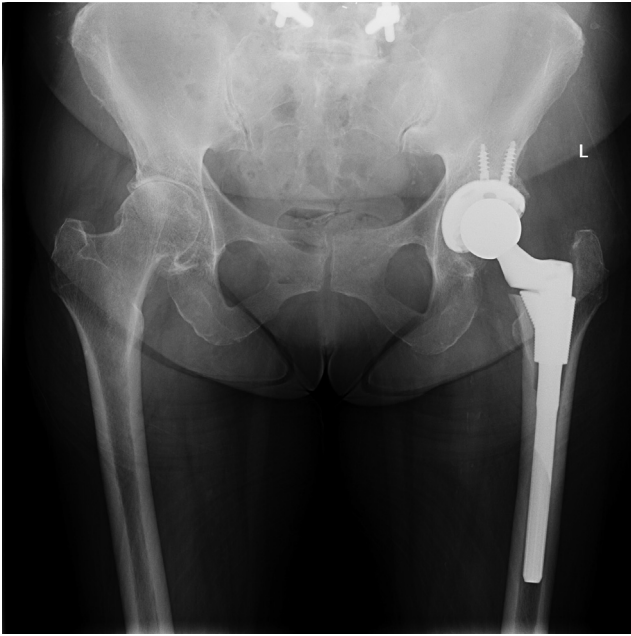
Figure 1. Standing AP pelvic radiograph after left total hip replacement.

A seventy-three year old female underwent left primary total hip arthroplasty through a posterior approach for end stage coxarthrosis secondary to femoral dysplasia and concomitant inflammatory arthropathy (Figure 1). Pertinent medical history included rheumatoid arthritis, type 2 diabetes, chronic obstructive pulmonary disease, and depression. Her prior surgical history included an L3–L5 posterior lumbar interbody fusion four years prior for degenerative spondylolisthesis with lumbar stenosis. She had an uneventful post-operative course following her left hip arthroplasty and progressed well with physical therapy. At her one and three-month follow up visits she stated that her left groin pain that she complained of prior to surgery had completely resolved.

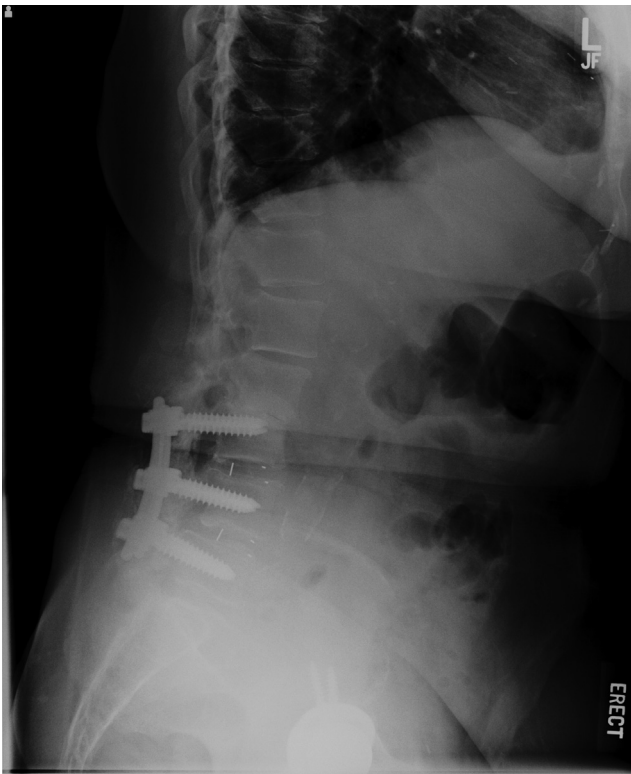
Figure 2. Standing lateral radiograph of the lumbar spine demonstrating previous L3 to L5 posterior fusion and development of adjacent segment disease and junctional kyphosis at L2.

The patient did, however continue to have discomfort in her lumbar spine as well as bilateral buttocks which continued to worsen over the following two years. Lateral lumbar spine radiographs revealed progressive proximal junctional kyphosis but she remained very satisfied with her hip surgery (Figure 2). After failure

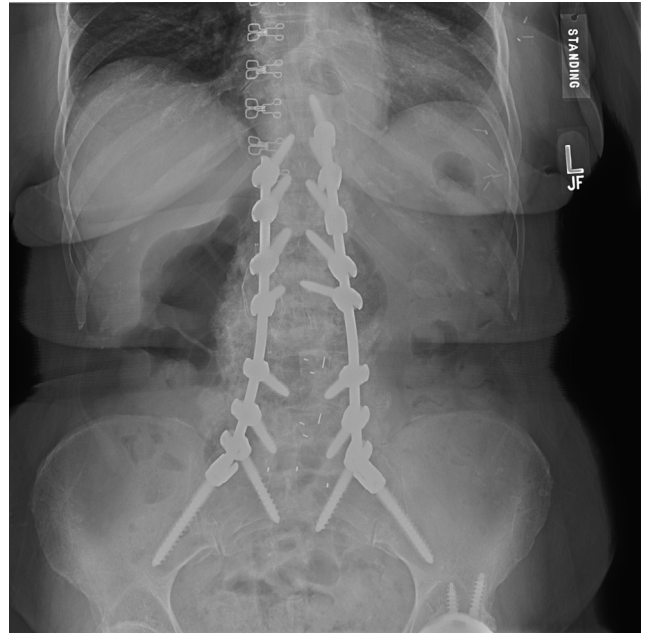
Figure 3. Standing AP Spine radiographs following instrumented T10 to Ilium fusion.

of all conservative management, she underwent revision lumbar surgery with an L3 pedicle subtraction osteotomy and instrumented fusion from T10 to ilium three years after her primary total hip arthroplasty (Figure 3). She was discharged home and had an uneventful postoperative recovery. However, five weeks after spine

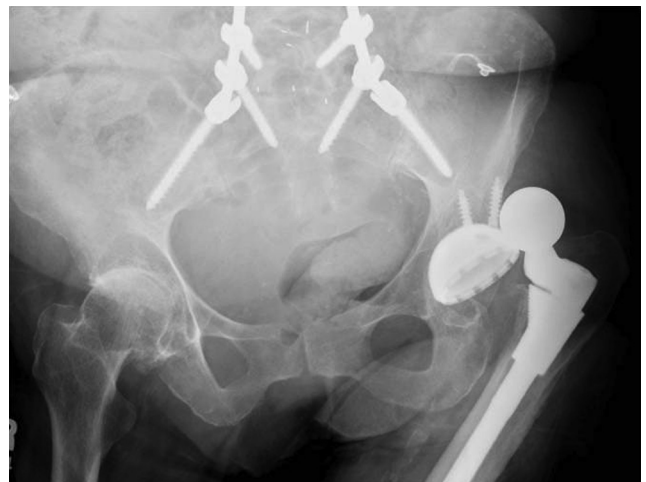
Figure 4. AP pelvic radiograph rays following posterior hip dislocation five weeks after lumbopelvic fusion.

surgery she sustained a posterior left hip dislocation while squatting in her bathroom (Figure 4). She underwent closed reduction under anesthesia and was placed into a knee immobilizer. Her knee immobilizer was removed after 4 weeks and she presented two weeks thereafter with a subsequent posterior dislocation which was also closed reduced. The only pertinent change in this patient's history over this timeline was her revision lumbar pelvic fusion resulting in a fixed, increased lumbar lordosis. A long discussion was held with her and together we elected to attempt continued conservative management. Despite a soft abduction brace and reinforcement of posterior hip precautions she sustained three additional dislocations over the following two months. At this point revision surgery was again discussed and the patient elected to proceed.

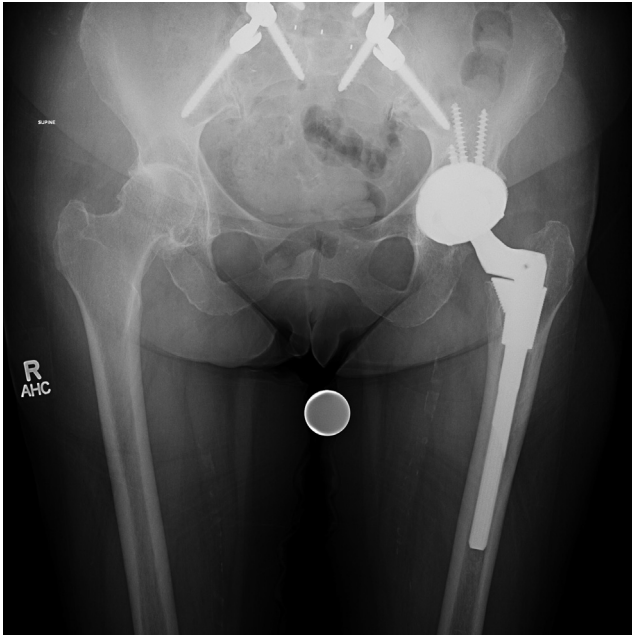
Figure 5. Postoperative AP pelvis radiograph following acetabular revision.

the SROM (DepuyWarsaw, IN) femoral component was noted to be appropriately anteverted however the hip was noted to dislocate with less than 5° of internal rotation. The position of the cup was marked and the cup was then explanted. A revision shell was placed and trialed with approximately twenty degrees of increased anteversion. Stability was noted to be significantly improved. Because of the previous five dislocations there was minimal posterior capsular tissue to repair and thus the decision was made to place a dual mobility head ball and liner to minimize the chance of future dislocation (Figure 5). Weight bearing was initially protected and gradually increase over the first six weeks post-operatively. At her three and six month visits she was doing very well with no further dislocations.

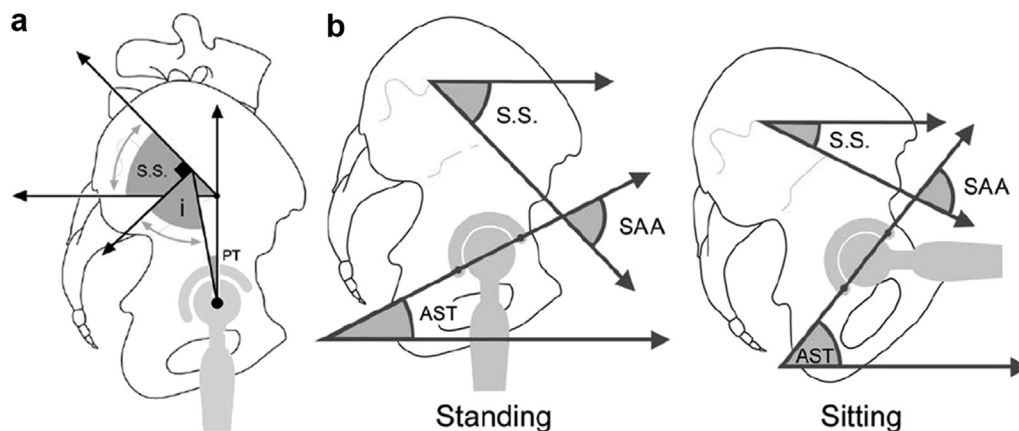
Figure 6. Lateral pelvis drawings demonstrating a) measurements of sacral slope (SS), pelvic incidence (I), and pelvic tilt (PT) and b) change in SS, acetabular sagittal tilt (AST) and sacroacetabular angle (SAA) in a patient with a normal lumbar spine as they move from sitting to standing position [1].

As referenced in Figure 6a [1], pelvic incidence is a patient specific parameter that contributes to lumbar lordosis and three dimensional pelvic orientation. It is determined by pelvic tilt (angle subtended by a vertical line to the center of the sacral end plate and a line to the center of the femoral head) and sacral slope (angle between a horizontal line and a line tangent to the cranial sacral end plate). Acetabular sagittal tilt (angle between a horizontal line and a line tangent to the acetabulum/acetabular component) is thus affected by changes in pelvic tilt and sacral slope. During normal activity in a flexible lumbar spine, pelvic incidence and thus acetabular tilt changes from the sitting to standing position (Figure 6b [1]). In the present case, revision of

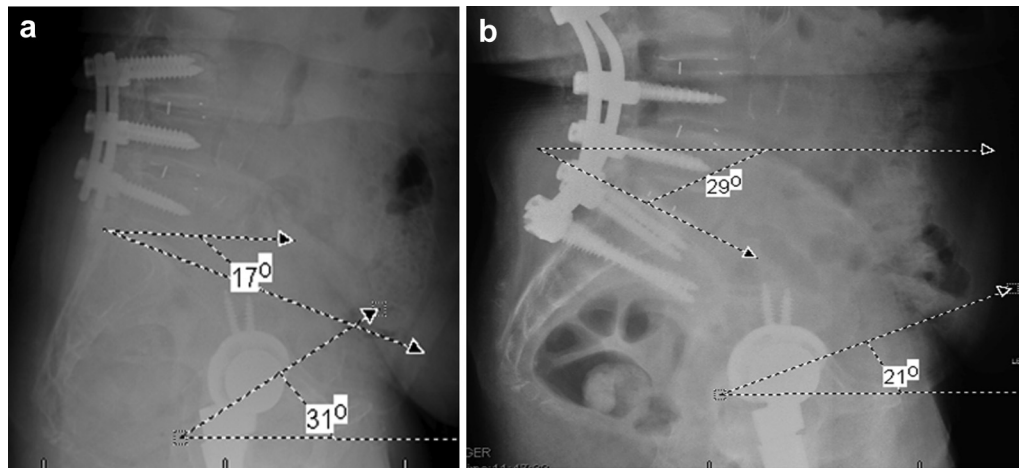
Figure 7. Lateral lumbar spine radiographs a) before and b) after lumbar spine-to-pelvis fusion. These radiographs demonstrate a change in the patients' sacral slope from 17 to 29 degrees and this resulted in a concomitant decrease in her acetabular sagittal tilt from 31 to 21 degrees.

her lumbar fusion from T10-Ilium led to a significant change (increase) in her sagittal balance resulting in a fixed increase in lumbar lordosis. She was noted to have a change in her sacral slope from 17° to 29° resulting in a concomitant decrease in her acetabular sagittal tilt from 31° to 21° (Figure 7a and b). The effect of this increased fixed lumbar lordosis was a resultant relative retroversion of the acetabular socket noted in Figures 5 and 6 that manifested itself as a new onset of recurrent posterior hip instability.
