IMAGES IN EMERGENCY MEDICINE

An unexpected ultrasound finding in a woman who passed out

S. Russ Richardson MD, MS | Jonathan Hardin DO | Casey Wilson MD

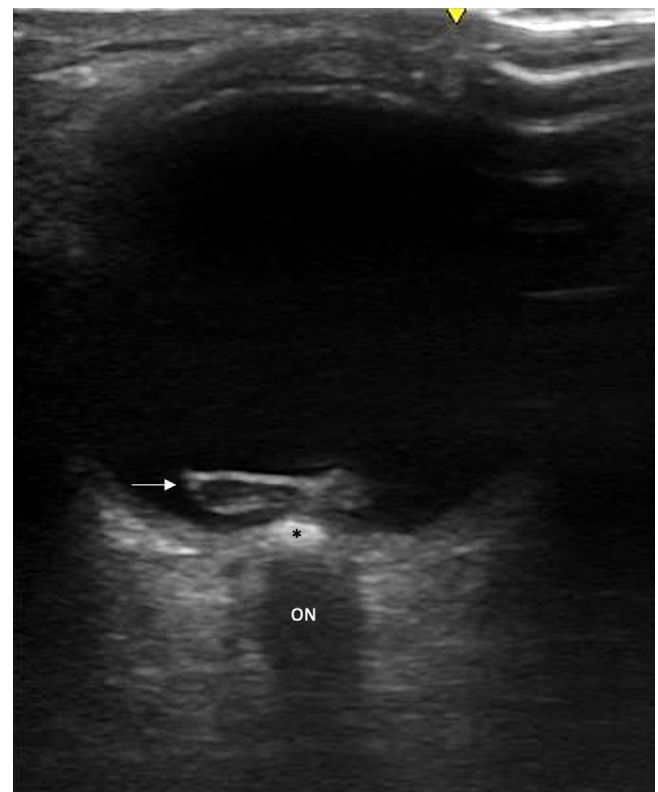
FIGURE 1 Ocular ultrasound of the left eye. A hyperechoic density (arrow) consistent with hemorrhage and clot can be seen in the posterior pole of the eye overlying the optic nerve (ON). Bulging of the optic disk, known as the crescent sign, was also noted (asterisk)

A 35-year-old female presented to the emergency department (ED) in pulseless electrical activity arrest after suddenly losing consciousness during intercourse. In the ED, return of spontaneous circulation was obtained but the patient remained obtunded. Point-of-care ocular ultrasounds were obtained to evaluate for optic nerve sheath swelling as an acute intracranial process was highly suspected. Bilateral ultrasounds revealed well-defined, echogenic material just anterior to the optic disk, which itself appears to be bulging into the posterior chamber (Figure 1; Video 1).

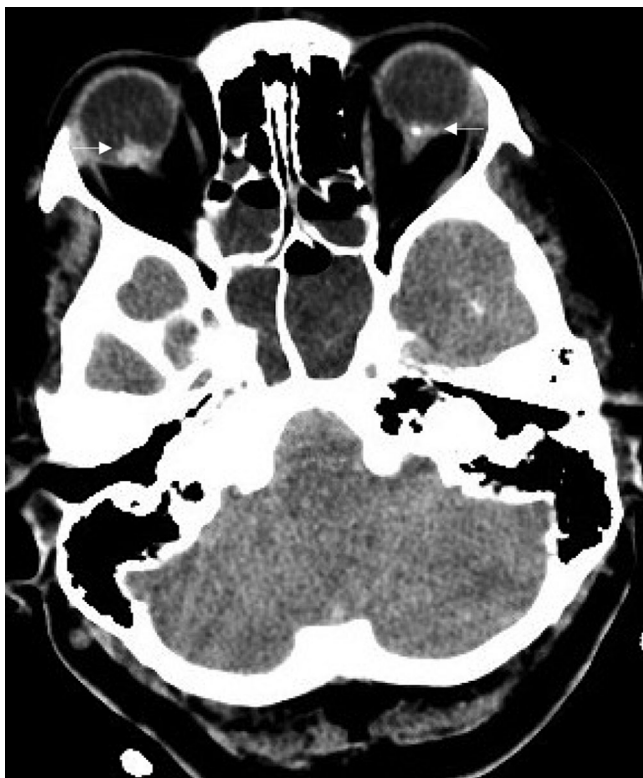
FIGURE 2 Hyperdense material consistent with hemorrhage adjacent to the optic disks can be seen in the posterior aspect of the eyes (arrows) on this non-contrast computed tomographic image of the head

A non-contrast computed tomography (CT) of the head confirmed the diagnosis of diffuse subarachnoid hemorrhage with intraventricular extension and also visualized the hyperdense material in the posterior globes that were seen on bedside sonography (Figures 2 and 3). This patient's ocular ultrasounds had sonographic findings consistent with Terson syndrome, which is the presence of intraocular hemorrhage secondary to intracranial hemorrhage or traumatic brain injury. Roughly 15% of patients with intracranial hemorrhage will have associated Terson syndrome, and it is often undiagnosed for months after initial neurological injury and can result in permanent changes in vision.¹ It typically develops within a few hours of the initial insult, but in some cases can occur days to weeks later. The pathophysiology of Terson syndrome is still up for debate, but is likely caused by a rapid increase in intracranial pressure resulting in retinal venules rupturing or from direct blood communication from the brain to the orbit through the optic nerve sheath.^{2,3} The gold standard for diagnosing Terson syndrome is through fundoscopy, but if direct visualization is not possible,

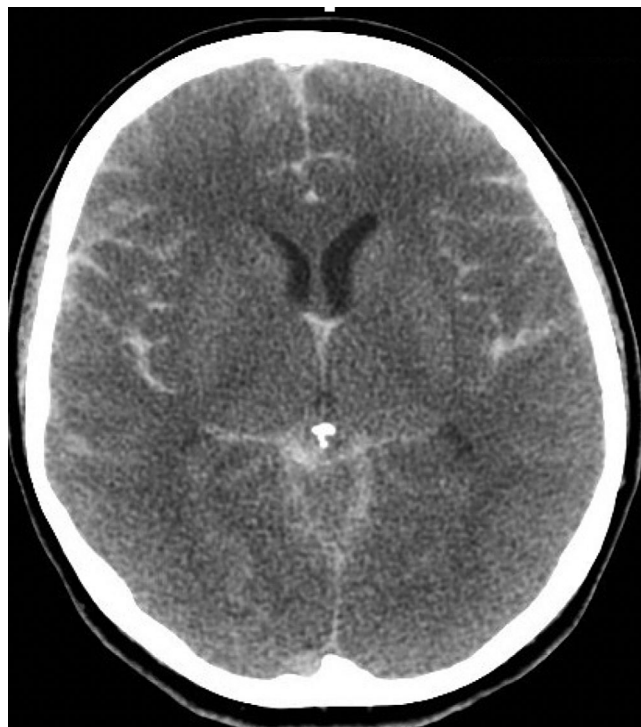
FIGURE 3 Non-contrast computed tomographic image demonstrating this patient's diffuse subarachnoid hemorrhage
