Simple geometry tribological study of osteochondral graft implantation in the knee

Proc IMechE Part H:
J Engineering in Medicine
2018, Vol. 232(3) 249–256
© IMechE 2018

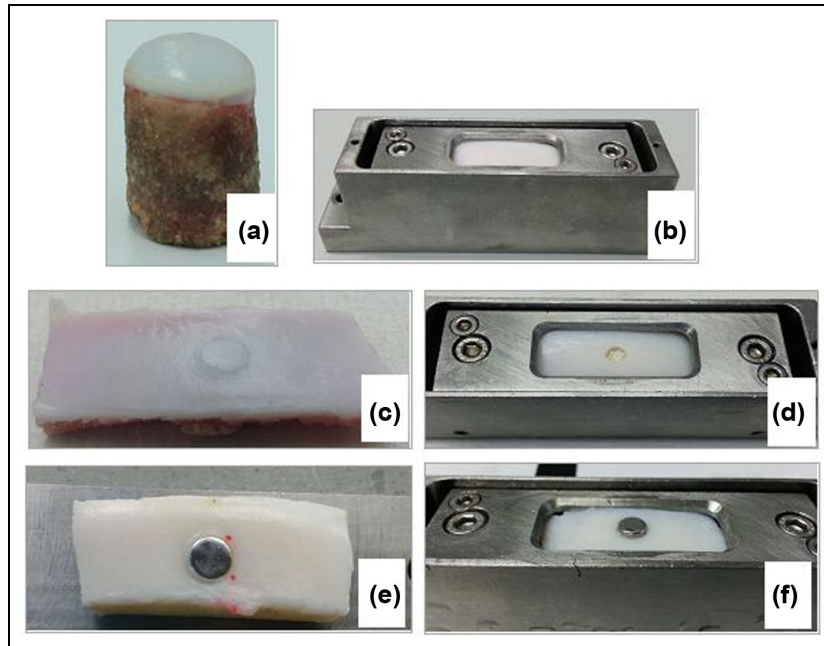
Figure 1. Images of the 12 mm diameter reciprocating pin (a): an osteochondral plate with no graft/defects inserted (negative control group) within the lubricant bath (b); xenograft group (c); cartilage defect group (d); Positive control group 1 (stainless steel pins inserted flush) (e); Positive control group 2 (stainless steel pins inserted 1 mm proud) (f).

pin, reciprocating against a flat bovine osteochondral plate (Figure 1).

Each osteochondral plate and reciprocating pin pair were initially run under the test conditions described later as a negative control for a duration of 3 h (Figure 1). Following this, the specimens were allowed to recover unloaded for 1 h before either a 6 mm diameter xenograft, a cartilage defect or a stainless steel pin was inserted in the centre of the osteochondral plate (Figure 1). The negative controls consisted of an osteochondral plate with no pins, defects or interventions inserted (native state; $n = 24$). Test samples were then run as either a positive control or one of the experimental groups for a further 3 h. Positive control groups consisted of stainless steel pins inserted flush with the articular surface of the osteochondral plate (Positive control group 1; $n = 6$) and 1 mm proud of the articular cartilage surface (Positive control group 2; $n = 6$) (Figure 1). A further two experimental groups were tested: Experimental group 1 – cartilage defects inserted down to subchondral bone ($n = 6$); Experimental group 2 – porcine xenografts inserted flush with the articular cartilage surface ($n = 6$). All experimental and control group tests were performed in a lubricant of PBS + 25% (v/v) newborn calf serum (Gibco Life Technologies, Paisley, UK) for a duration of 3 h.

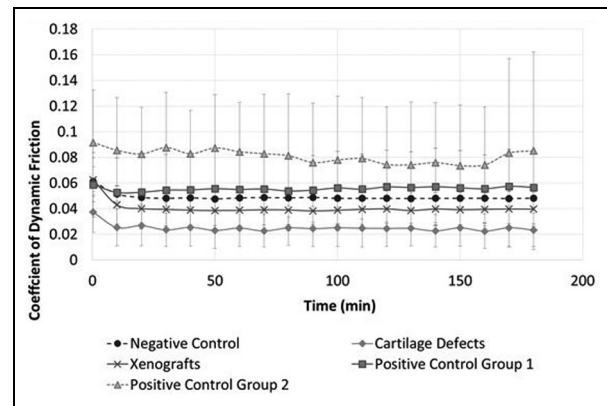
Figure 2. Mean coefficient of dynamic friction plotted at 10 min time intervals (mean \pm 95% confidence limits; $n = 6$ per group).

The dynamic friction coefficient was recorded at 60 s intervals; for clarity, the data in Figure 2 are plotted at 10 min intervals as the mean \pm 95% confidence limits. The means of each paired negative control and the associated experimental or positive control group were compared using a paired students t-test at time intervals of 60, 120 and 180 min to determine any significant difference ($p = 0.05$) in coefficient of dynamic friction.

The negative control samples maintained a low constant coefficient of dynamic friction (0.049 ± 0.007) throughout the test duration following a small initial decrease during the first 10 min (Figure 2). No significant differences ($p > 0.05$; paired t-test) in dynamic friction were recorded between the negative controls and any of their paired experimental or positive control group tests at any time point analysed (60, 120 and 180 min).

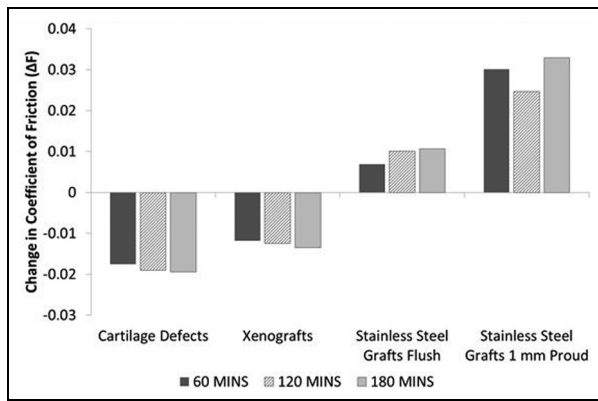
Figure 3. Mean change in coefficient of dynamic friction between the negative control tests and each paired experimental or positive control group test at 60, 120 and 180 min ($n = 6$ per group). Change in dynamic friction (ΔF) calculated as experimental friction (F_E) minus negative control friction (F_C).

The mean change in the coefficient of dynamic friction between the negative control groups and their paired experimental or positive control group is presented in Figure 3. A positive increase in dynamic friction was recorded for Positive control group 1 (stainless steel pins inserted flush) and Positive control group 2 (stainless steel pins inserted 1 mm proud) at time points 60, 120 and 180 min when compared to the paired negative control tests. Positive control group 2 exhibited the greatest overall change in recorded friction across all groups. The mean coefficient of friction for the cartilage defect and xenograft groups was lower than the negative controls; the largest decrease in coefficient of

dynamic friction was recorded in the cartilage defect group at 180 min (-0.019).

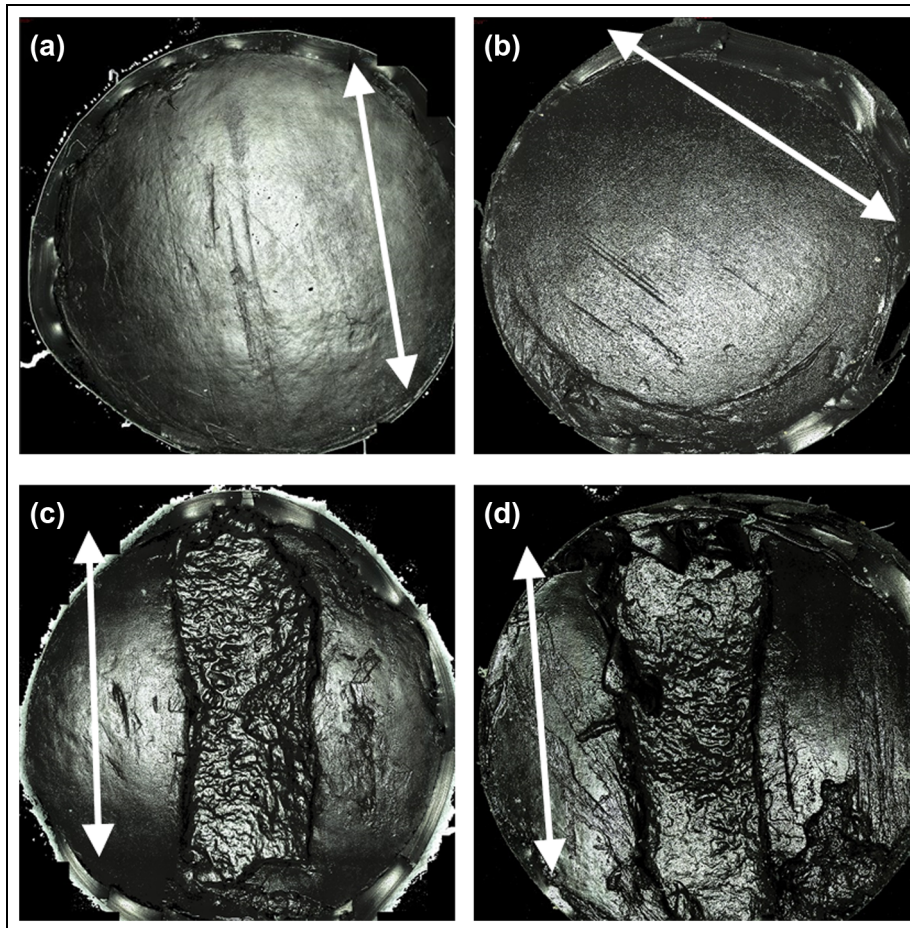
Figure 4. Example Alicona Infinite Focus scan images of the reciprocating 12 mm diameter pin surface with arrows indicating sliding direction: (a) cartilage defect group, (b) xenograft group, (c) Positive control group 1 (stainless steel pins flush) and (d) positive control group 2 (stainless steel pins 1 mm proud).

Positive control groups 1 and 2 sustained severe cartilage damage, wear and deformation, as shown in Figure 4. Damage, wear and deformation in the positive control groups generally consisted of large, steep flanked cartilage lesions stretching across the diameter of the pin surface, accompanied by multiple deep scratches on the surrounding cartilage surface. The mean volume of cartilage damage and wear in Positive control groups 1 and 2 was significantly greater ($p = 0.021$ and $p = 0.042$; independent t-test) than the negative controls at 15.3 and 37.1 mm^3 , respectively (Figure 5).

The cartilage defect group had the smallest mean volume of damage, wear and deformation at 0.99 mm^3 ; similarly, the volume of the xenograft group was also low at 2.4 mm^3 . No significant difference ($p > 0.05$) was present between the negative control group (0.098 mm^3) and both the cartilage defect ($p = 0.162$; independent t-test) and xenograft ($p = 0.188$; independent t-test) groups. Damage, wear and deformation in the cartilage defect and xenograft groups consisted of visible areas of increased surface roughness, scratches in the central region of the pin surface orientated parallel with the direction of translation and/or small,

shallow cartilage lesions with irregular boundaries (Figure 4).

of surface roughness, scratching or small shallow cartilage lesions (mean depth 0.2 mm); similar patterns were also noted for the cartilage defect group (Figure 4). There were no significant differences ($p > 0.05$) in the volume of damage and wear (volume extending below the cartilage surface) when compared to the negative control (0.1 mm³). Overall, the mean volume of

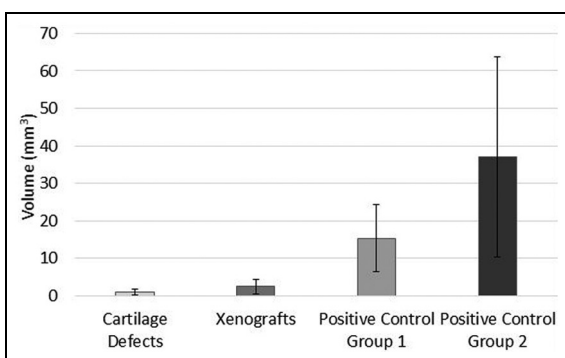
Figure 5. Mean volume (mm³; volume extending beneath cartilage surface) of articular cartilage surface damage, wear and deformation (mean \pm 95% confidence intervals; $n = 6$ per group) measured using the Alicona Infinite Focus.

Overall, there were no significant differences in dynamic friction ($p > 0.05$, paired t-test) between the negative controls and the paired experimental or positive control group tests (Figure 2); furthermore, increased levels of articular cartilage surface damage and wear were not associated with significant increases in the coefficient of dynamic friction. The positive control groups exhibited the highest levels of friction, with a small increase in the coefficient of friction observed between 60 and 180 min (Figure 3). The cartilage defect and xenograft groups demonstrated a lower mean coefficient of friction in comparison to the negative controls, with the greatest decrease in frictional coefficient (-0.019) recorded in the cartilage defect group at 180 min. The lower levels of friction recorded in the cartilage defect group were likely attributable to a reduction of contact area and increased fluid volume in the articulation, resulting in increased fluid load support of the applied load. These factors were also likely to have contributed to the low level of cartilage damage, wear and deformation (0.99 mm^3) measured in the cartilage defect group (Figure 5).

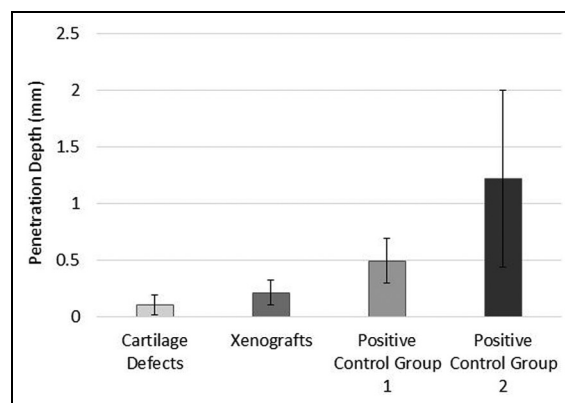
Figure 6. Mean penetration depth of articular cartilage surface damage, wear and deformation (mean \pm 95% confidence intervals; n = 6 per group) measured using the Alicona Infinite Focus.

The cartilage defect and xenograft groups had the smallest penetration depths of damage and wear at mean depths of 0.11 and 0.21 mm , respectively (Figure 6); the group means were not significantly different ($p = 0.986$; ANOVA). Positive control group 2 had the largest mean depth of damage, wear and deformation at 1.22 mm and this was significantly greater ($p < 0.05$; ANOVA) than the cartilage defect and xenograft groups (Figure 6). Positive control group 1 also had a greater mean depth (0.49 mm) of damage, wear and deformation than the cartilage defect and xenograft groups; however, these differences were not significant ($p > 0.05$; ANOVA).
