Combined Sacroplasty and Iliosacral Fixation Using Triangular Titanium Implants for the Treatment of Sacral Insufficiency Fractures with Concomitant Sacral Instability

Ryan Johnson ¹, Jason Seibly ²

1. Graduate Medical Education, Advocate Bromenn Medical Center 2. Neurosurgery, Central Illinois

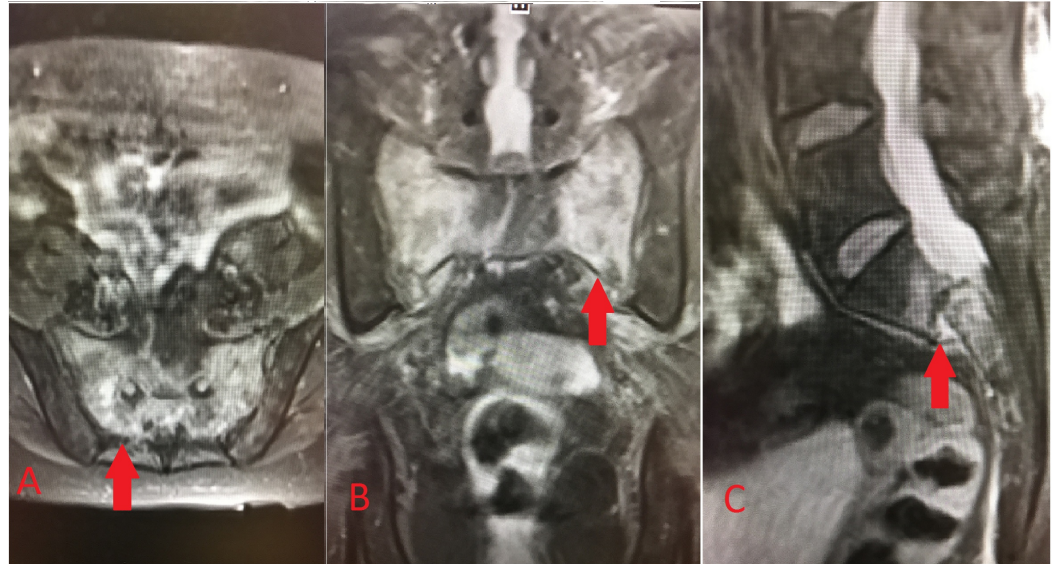
FIGURE 1: MRI of the sacrum and pelvis

A. Axial T2-weighted (T2W) short tau inversion recovery (STIR) sequence demonstrating hyperintensity (arrow) located within the bilateral sacral ala and the body of the sacrum; B. Coronal T2W STIR; C. Sagittal T2W STIR again demonstrating hyperintensity but also showing S1-S2 anterolisthesis (arrow)

In our patient, hyperintensities were noted diffusely in the bilateral sacral ala and the S1 and S2 regions on the MRI T2W STIR sequence, consistent with acute fracture and inflammation in the affected areas (Figure 1A-1C). Additionally, a CT scan of the pelvis demonstrated bilateral comminuted SIFs with S1-S2 anterolisthesis and bilateral L5 transverse process fractures (Figure 2A-2B). An MRI is not the most accurate test for bone fractures, which is where a CT scan plays a role. Our patient additionally underwent bone scintigraphy, which demonstrated increased uptake in the characteristic "Honda logo" shape (Figure 3). The authors felt that the patient's clinical evaluation, in conjunction with MRI/CT/bone scintigraphy imaging of the pelvis and sacrum, were satisfactory for the diagnosis of SIF and subsequent surgical planning.

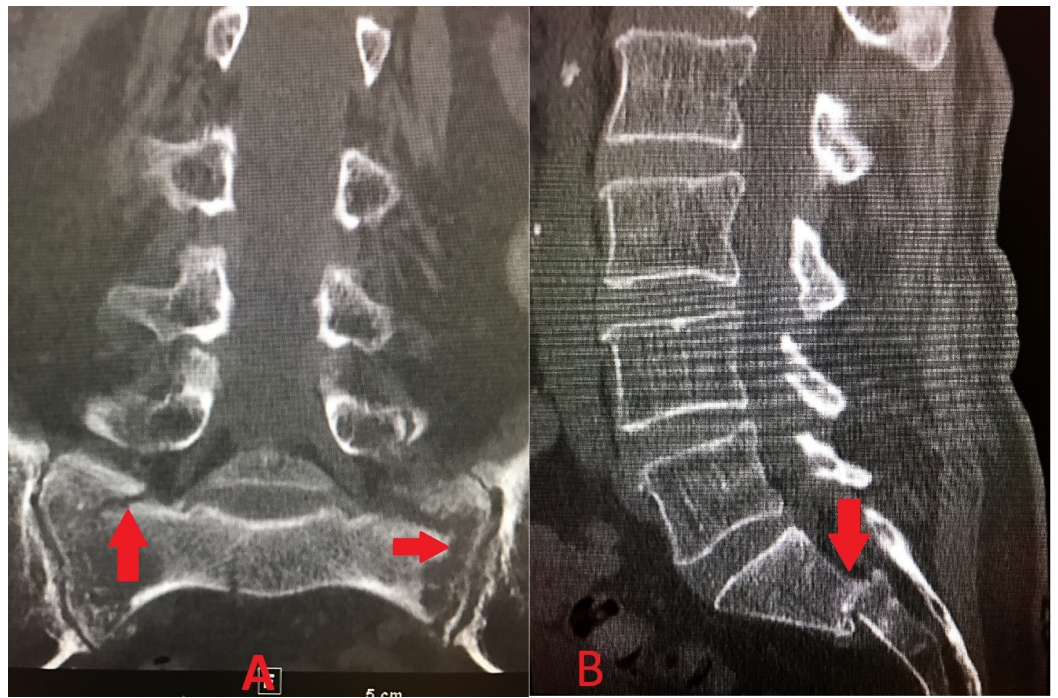
FIGURE 2: CT of the lumbar spine, sacrum, and pelvis

A. Coronal view showing comminuted SIFs (arrows) through the bilateral sacral ala; B. Sagittal view showing S1-S2 anterolisthesis (arrow)

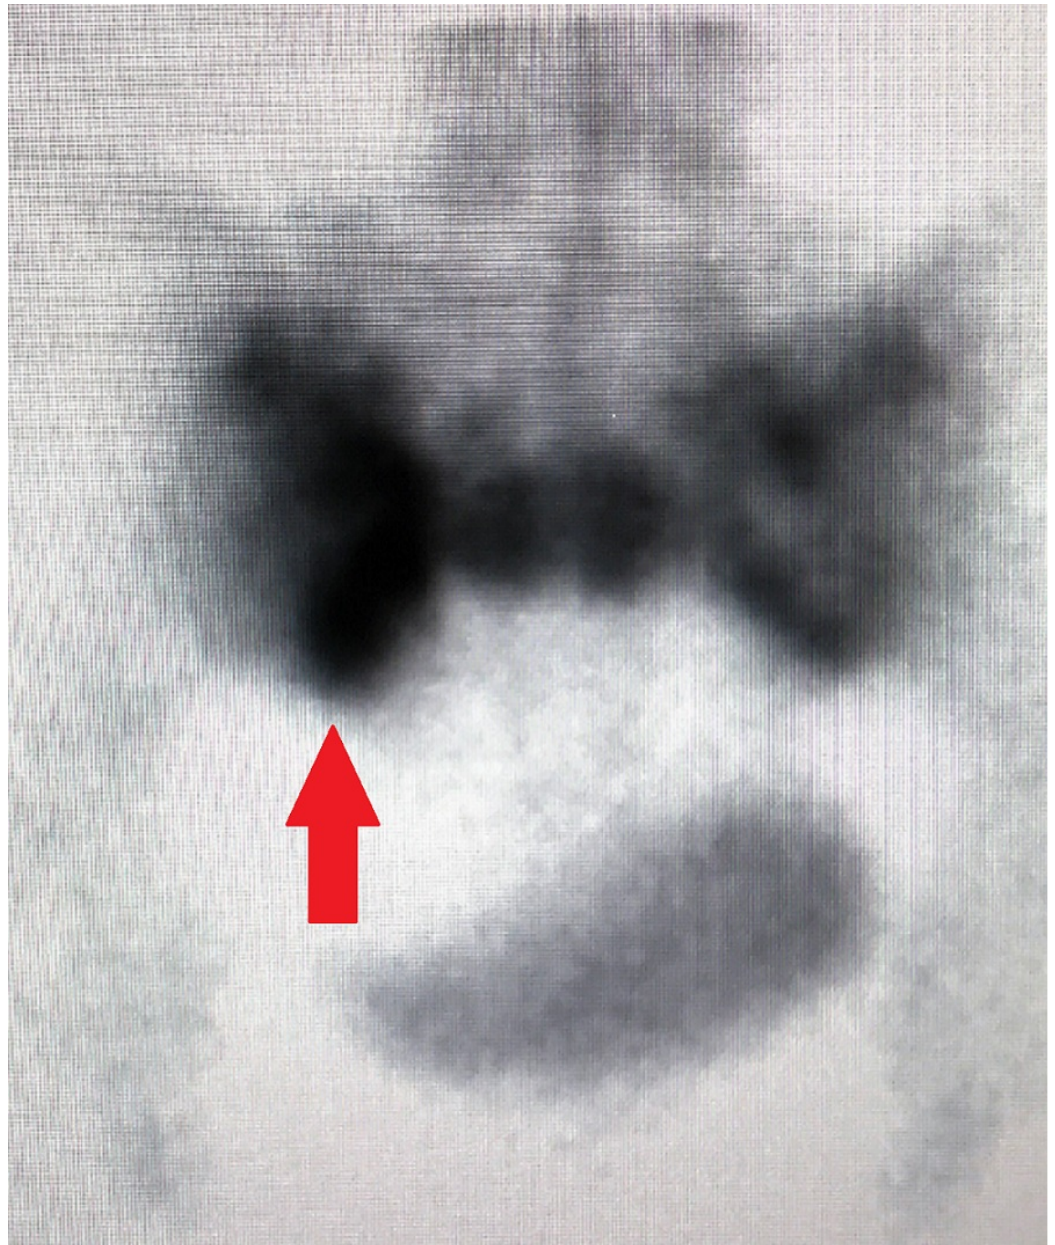
FIGURE 3: Technitium-99m labeled bone scintigraphy

Increased uptake of technitium-99m, demonstrated by the arrow, in the bilateral sacral ala and across the body of the sacrum in the characteristic "Honda logo" shape

The in-depth imaging characteristics of SIFs are beyond the scope of this case report. The author would like to refer readers to a review article published in the *American Journal of Neuroradiology* in 2010 by Lyders and colleagues [6]. The review article indicates the high frequency of associated fractures in patients with SIFs, specifically pelvic insufficiency fractures of the pubic rami and parasymphyseal region (88%) [6]. MRI and bone scintigraphy are the two most-sensitive imaging modalities for this condition, with sensitivities approaching 100% and 96%, respectively [6]. Each imaging modality has its limitations, which could result in a misdiagnosis. In patients with a history of cancer, the concern for metastatic disease results in biopsies to the region of increased uptake on bone scintigraphy. The classic appearance on bone scintigraphy is the uptake of the technetium in an "H" pattern, indicating bilateral vertical fractures and a transverse fracture. However, this "Honda sign" is only seen in 20%-40% of patients with SIFs [6].

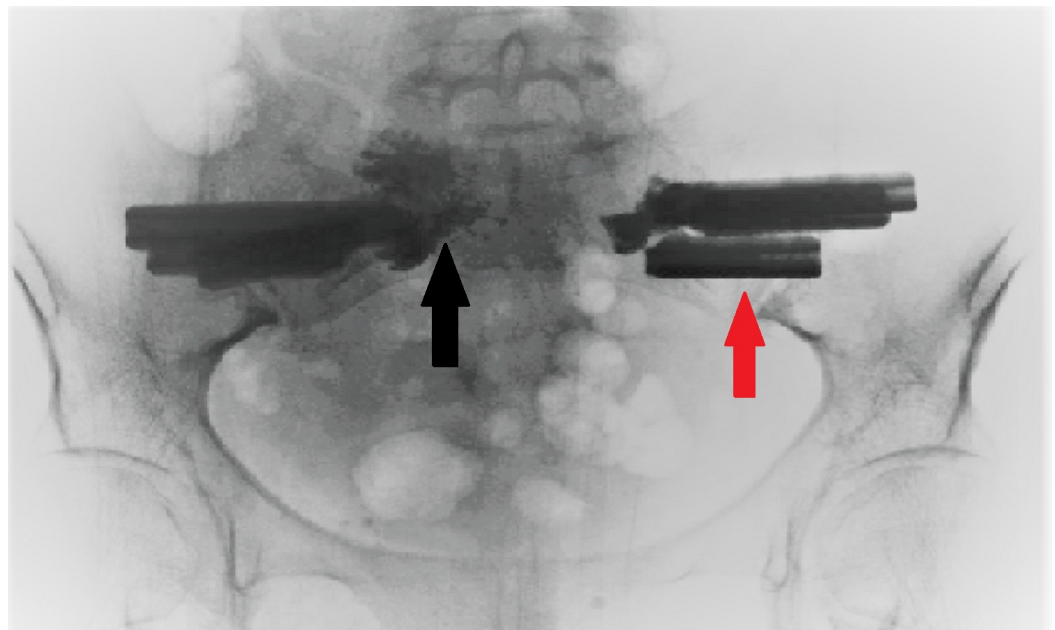
FIGURE 4: Intraoperative C-arm fluoroscopic radiograph of the pelvis and sacrum

The figure shows three triangular implants (red arrow) placed bilaterally through the ilium and sacral ala across the SI joint. Also seen is the polymethylmethacrylate (PMMA) cement (black arrow) inserted into the SI joint bilaterally.

The patient was positioned in the standard prone position on a Jackson operating table. She was prepped from hip to hip. A C-arm was used to mark the one-inch skin incision bilaterally, following the posterior sacral line on lateral fluoroscopy. After the skin had been incised, Steinmann pins were placed through the lateral ilium across the SI joint and into the sacral ala. After each pin had been placed, a three-dimensional image was obtained using the O-arm (Medtronic, Dublin, Ireland) to assess the pin position and make sure it crossed the alar fracture line. Next, the drill-guide was placed over the pin, resting on the lateral ilium. The implant length was then measured, and the implant trajectory was drilled over the pin. After the drilling, a triangular channel was created using the implant broach. The iFuse implant (Si-BONE, San Jose, CA) was then inserted and tapped into position. Three implants were placed on each side. Two implants were intentionally placed above the S1-S2 interspace, and the third inferior implant was placed below the transverse fracture line. After the implants were placed, a Kyphon Express needle (Medtronic, Dublin, Ireland) was placed through the central cannulation of each implant. Approximately 2 ml of PMMA was injected into the medial ala through each implant under live fluoroscopy. Several times during the cement delivery, a C-arm radiograph was obtained to make sure the cement did not undergo extravasation nor violate the S1 neuroforamen. This created a solid construct, fixating the sacrum securely to the ilium. The intraoperative C-arm fluoroscopic radiograph is shown in Figure 4.
