# VALVULAR HEART DISEASE

CASE REPORT: CLINICAL CASE

# Emergent Surgical Replacement of a Tendyne Prosthesis for Bioprosthetic Valve Thrombosis

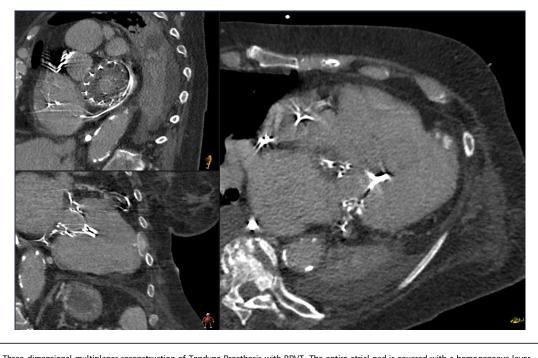
FIGURE 2 Cardio-Computed Tomography

Three-dimensional multiplanar reconstruction of Tendyne Prosthesis with BPVT. The entire atrial pad is covered with a homogeneous layer several millimeters thick, which is revealed intraoperatively to be neointima with underlying fluid components.

Echocardiographic examination revealed severe mitral valve stenosis resulting from extensive thrombotic deposits around the mitral valve prosthesis and severe tricuspid valve insufficiency (Video 1). Computed tomography (CT) confirmed thrombotic masses on the atrial part of the valve stent (Figure 2), while pneumonia was found as the most FIGURE 1 Aortic-Computed Tomography: Severely Calcified Aorta With Porcelain Character of the Arch and Only Small Window for Cross Clamping
