Are safe guards at trampoline parks safe enough?

A case report on a complete spinal cord injury after diving into a trampoline park foam pit

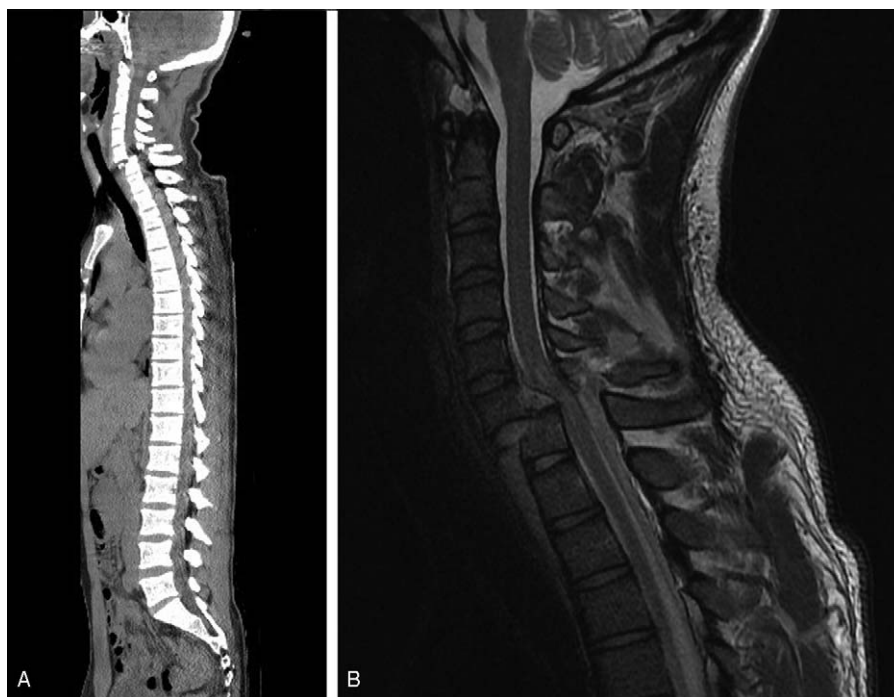
Figure 1. (A). Initial C-spine CT showing bilateral interfacetal dislocation on C6-7. (B) Initial C-spine MRI shows anterior translational injury at C6-7 with severe cord encroachment and complete discoligamentous complex disruption.

The patient was transferred to the emergency room of our hospital immediately. A C-spine CT revealed bilateral interfacetal dislocation on C6-7 (Fig. 1-A), and his C-spine MRI showed anterior translational injury at C6-7 with severe cord encroachment and complete discoligamentous complex disruption (Fig. 1-B).
