The effect of metal artifacts on the identification of vertical root fractures using different fields of view in cone-beam computed tomography

Conclusion: The specificity of CBCT decreased with the presence of a pin in the large-volume group, but not in the small-volume group. (*Imaging Sci Dent* 2015; 45: 147-51)

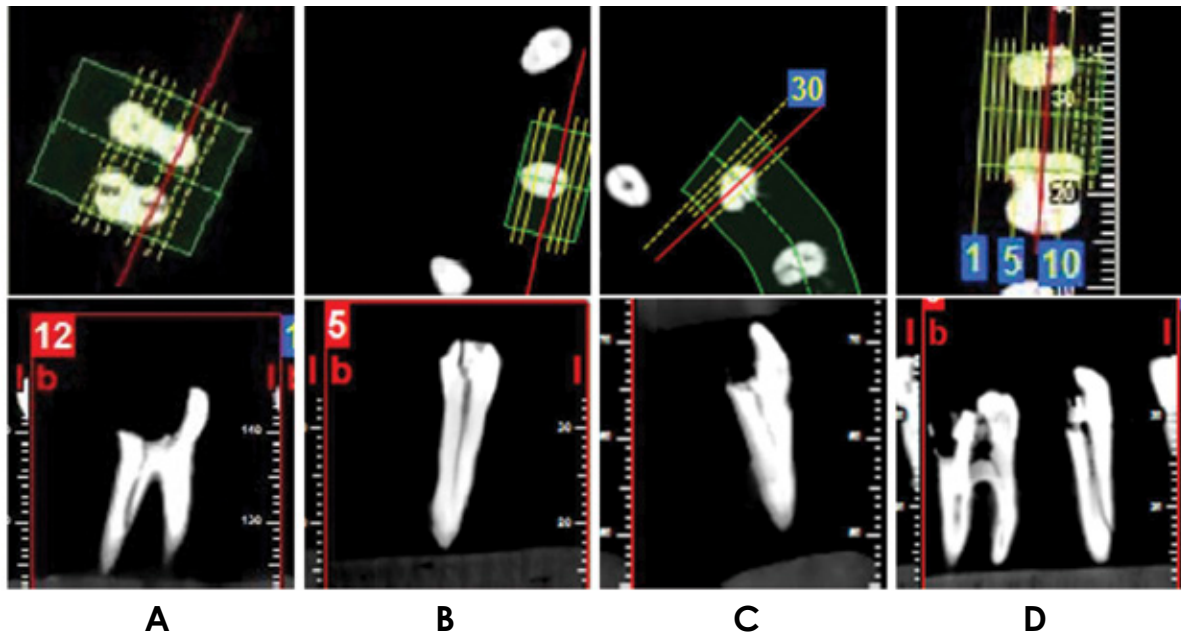
Fig. 1. Fracture lines in axial and cross-sectional cone-beam computed tomography images. A. Large volume without a pin. B. Small volume without a pin. C. Large volume with a pin. D. Small volume with a pin.

axial and cross-sectional views (Fig. 1) in a dim room using an 18.5-inch LG Flatron monitor (LG, Seoul, Korea), with a resolution of 0.3 × 0.3 pixel pitch. The images were randomly observed in limited numbers over consecutive days in order for the observers to identify tooth fractures. Specificity, sensitivity, positive predictive value (PPV), and negative predictive value (NPV), and the positive and negative likelihood ratios were calculated.

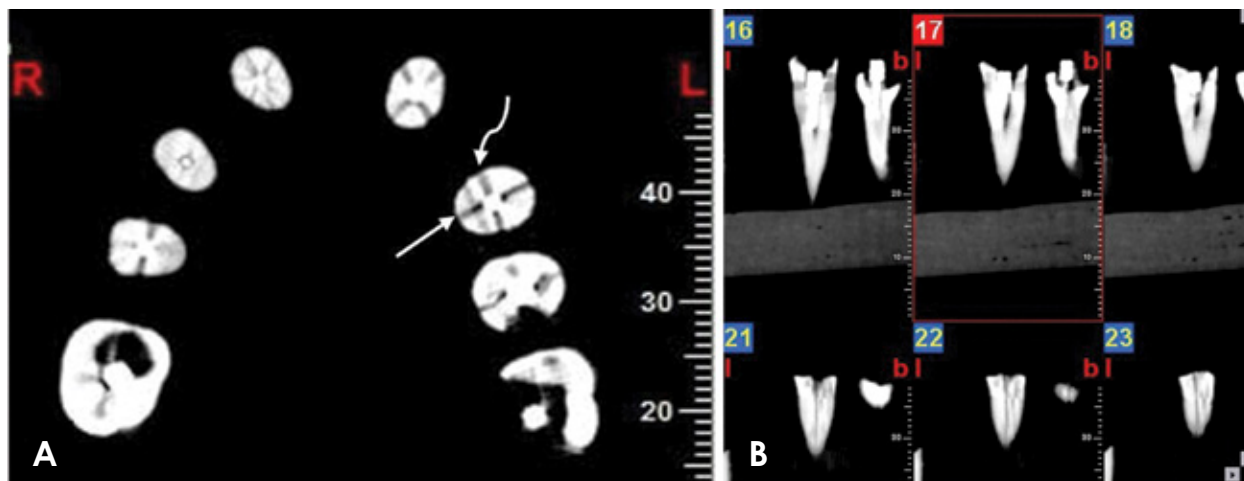
Fig. 2. Axial (A) and cross-sectional (B) small-volume cone-beam computed tomography images showing fractures in teeth with a pin. The fracture and the metal atrifact are shown with a straight arrow and a curved arrow, respectively.

This is a reasonable finding in light of the decreased imaging area, the lower amount of ray dispersion, the higher signal-to-noise ratio, and the higher resolution of the radiographs. Our findings correspond to those of Costa et al.,¹¹ who investigated horizontal fracture lines in small-volume CBCT. They are also in agreement with the findings of Iikubo et al.,¹³ who compared conventional periapical radiographs to CBCT images. The sensitivity of the large-volume CBCT images was 100% for the group with pins, but a lower value of specificity was reported in this group (89%). This finding is likely explicable through the beam-hardening phenomenon. Beam hardening occurs in connection with the increase of medium- energy X-rays, because lower-energy photons are absorbed by the structures being imaged instead of higher-energy photons. As mentioned above, this phenomenon results in artifacts that obscure the fracture lines in the region of interest. The artifacts that appear in the shape of dark areas or lines around endodontic materials are similar to the lines that reflect root fractures, resulting in false positives (Fig. 2).¹⁴

As seen in Figure 2A, the fracture lines and the lines

due to metal artifacts are not distinguished easily. A study carried out by Wang et al.¹⁵ with the aim of identifying tooth fracture lines using CBCT in comparison with conventional radiography and to determine the effect of root canal fillings found that CBCT was more accurate in identifying root fractures. The sensitivity of CBCT decreased in the presence of root canal fillings, but the specificity was not influenced by any of the factors they studied. In this study, specificity decreased with the presence of pins in the large-volume images, but not in the small-volume images. This effect might be due to the voxel size and issues involving contrast and spatial resolution.¹⁶ Large-FOV CBCT provides less contrast resolution and spatial resolution than small-FOV CBCT.⁶
