Effectiveness of 18F-fluoro-deoxyglucose Positron Emission Tomography/Computed Tomography and Magnetic Resonance Imaging to Detect Iliopsoas Tendonitis after Total Hip Arthroplasty: A Case Report

Makoto Kimura, MD, Nobuhiro Kaku, MD, PhD, Hiroaki Tagomori, MD, Hiroshi Tsumura, MD, PhD
Department of Orthopaedic Surgery, Faculty of Medicine, Oita University, Yufu City, Japan

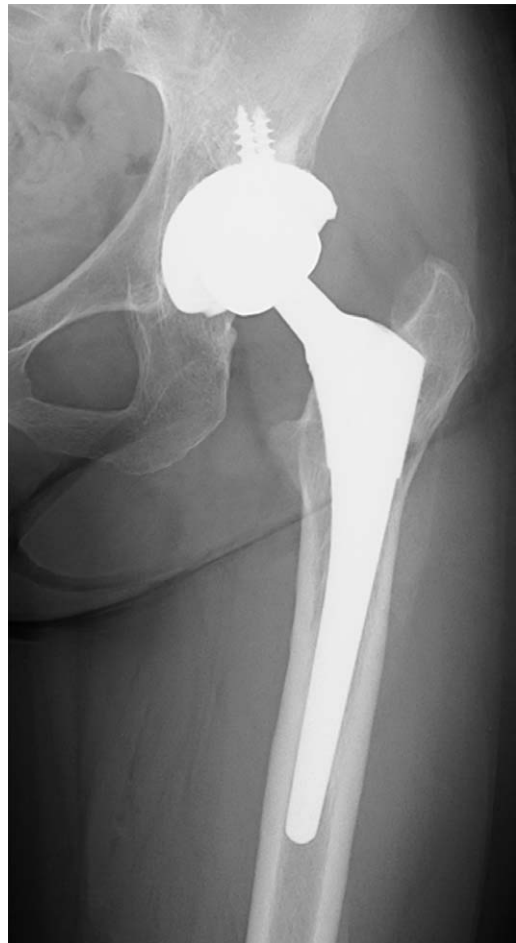
Fig. 1. An anteroposterior pelvic radiograph showing left primary total hip arthroplasty [M2a, a radial acetabular cup of size 50 mm and a Bi-Metric femoral stem metal ball head with a high-wall polyethylene liner [Biomet, Inc., Warsaw, IN, USA]].

The patient was a 61-year-old woman who worked in an agriculture. She was diagnosed with osteoarthritis associated with acetabular dysplasia at 53 years of age and underwent left femoral curved intertrochanteric varus osteotomy with a right THA at 56 years of age. Left THA was performed using metal on polyethylene at 57 years of age (Fig. 1). Thirty months after the left THA, she developed pain in the left groin when climbing and descending stairs. Conservative therapy, including rest and trunk muscle training, was performed for approximately 18 months; however, the pain did not improve. There was a distinct difference between left and right hip flexor muscle strength. Physical examination revealed no redness, swelling, or heat around the hip, and the patient did not complain of resting pain. Patrick's test was positive, and tenderness was noted in the Scarpa triangle. The patient also reported pain on dynamic hyperextension of the left hip. The results of blood tests revealed a white blood cell count of $4.06 \times 10^3/\mu\text{L}$ and C-reactive protein of 0.03 mg/dL. Active infection was not suspected. Culture of the articular fluid was negative. The metal ion concentrations were cobalt 0.5 $\mu\text{g/L}$ and chromium 0.5 $\mu\text{g/L}$. Radiographs showed no clear findings of fracture, osteolysis, or loosening around the joint replace-

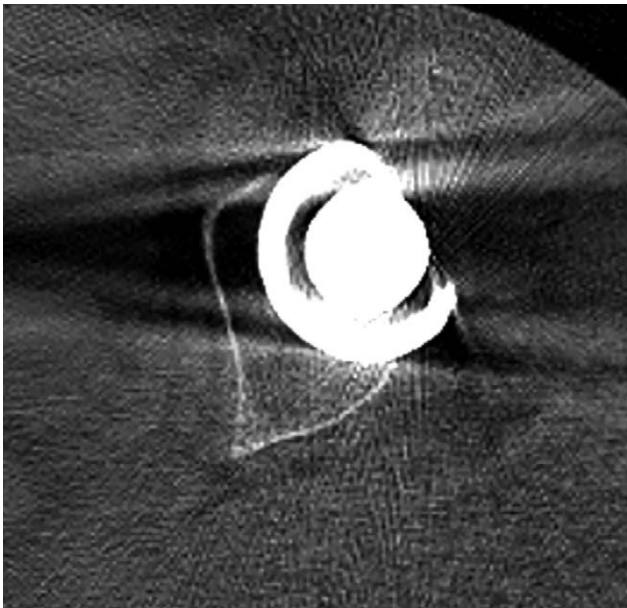
Fig. 2. Plain preoperative computed tomography (CT) image. The cup inclination was 37° and anteversion was 26° with stem anteversion of 18°. The front edge of the cup is seen protruding forward on reduction of the CT artifact.

ment. On plain CT after THA (Fig. 2), protrusion of the metal cup from the edge of the anterior acetabular wall was 10.3 mm. The peri-articular area was poorly assessed due to metal artifact. Imaging using 18F-FDG-PET/CT showed that the iliopsoas muscle was in contact with the protruding cup, and a consistent uptake along the muscle was visible (Fig. 3). The uptake was found inward from the muscle surface facing the anterior edge of the cup. The maximal standardized uptake value (SUVmax) was 5.582 in the early phase and 6.782 in the delayed phase. Uptake within the joint was also noted, suggesting a spillover of inflammation. Though plain MRI showed no evidence of pseudotumor or abnormal changes inside or outside the iliopsoas muscle, similar uptake was noted in the iliopsoas muscle on 18F-FDG-PET/MRI (Fig. 4). However, 18F-FDG-PET/MRI showed a clearer depiction of the muscle with uptake

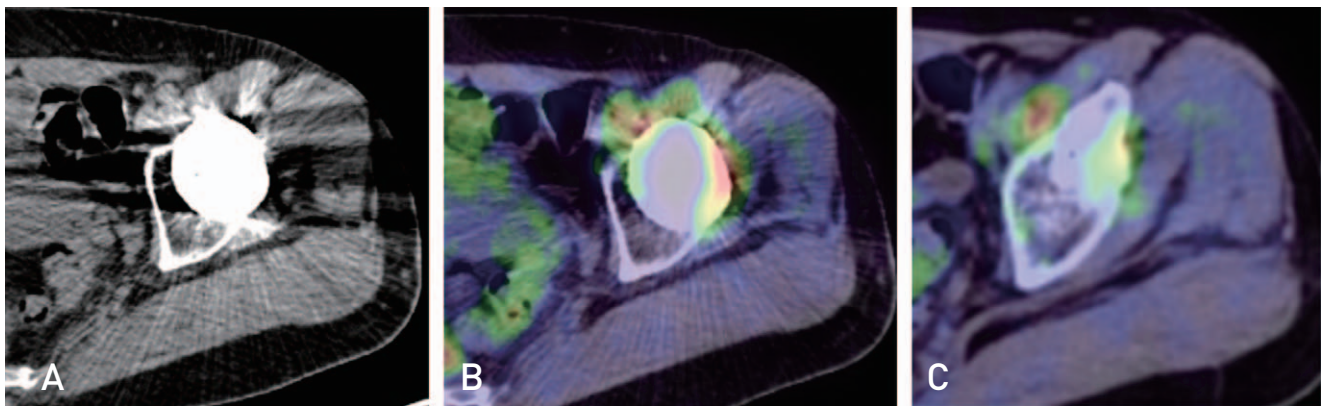
Fig. 3. Plain computed tomography (CT) and fluoro-deoxyglucose positron emission tomography (FDG-PET)/CT images at the same level. (A) Plain CT image with extensive artifact. The soft tissues near and around the prosthesis are difficult to assess. (B) Accumulation seen in the iliopsoas muscle. (C) The FDG-PET/CT image at a slightly higher position than B, and continuous uptake is observed within the iliopsoas muscle on the side of the cup.

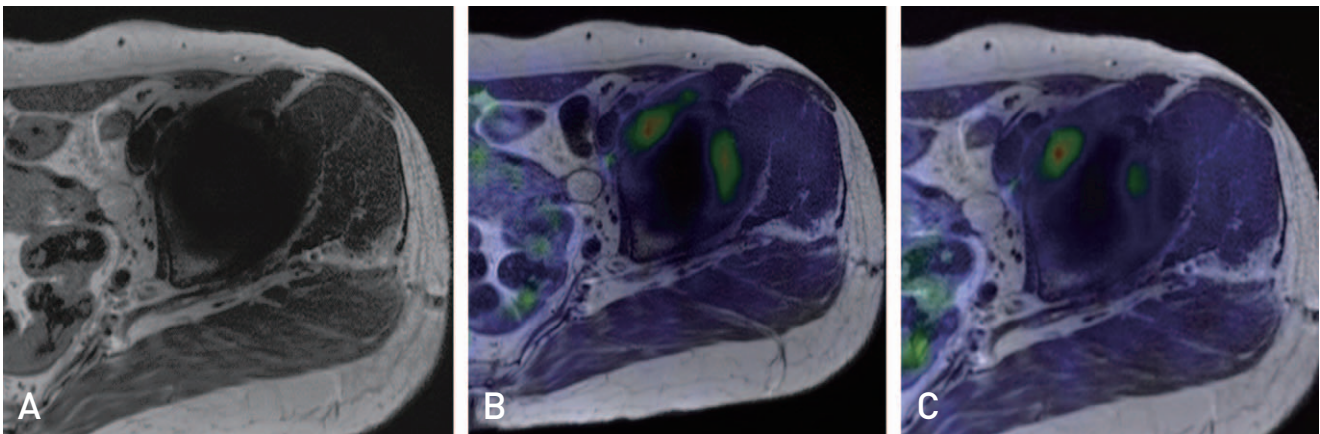
Fig. 4. Plain magnetic resonance imaging (MRI) and fluoro-deoxyglucose positron emission tomography (FDG-PET)/MRI images at the same level. (A) Plain MRI image with extensive artifact complicating assessment of the soft tissues near and around the prosthesis. (B) Accumulation localized at the psoas muscle. (C) The FDG-PET/MRI image at a slightly higher position than B, and continuous accumulation is observed within the iliopsoas muscle on the cup side.

compared to that of 18F-FDG-PET/CT. Based on the progress and image findings after primary THA, we preoperatively considered that the anterior edge of the cup protruding beyond the bone was the main cause of iliopsoas tendonitis. While both open and arthroscopic iliopsoas release were considered for iliopsoas impingement, we selected the isolated acetabular cup revision. This approach was the best option considering the high risk of hindering her ability to perform agricultural work due to hip flexion weakness after iliopsoas release.

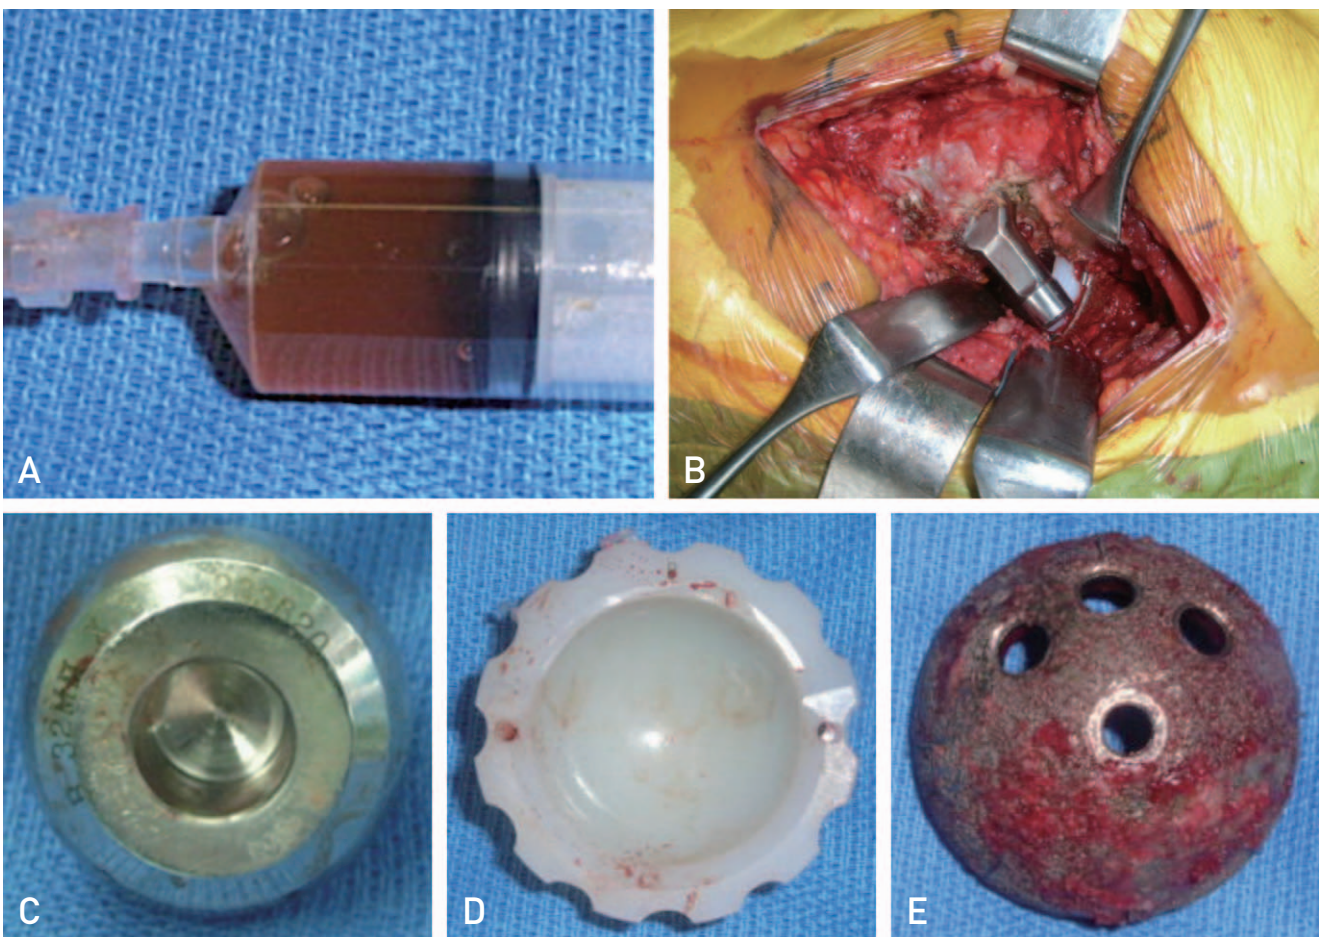
Fig. 5. Surgical findings. (A) Serosanguineous joint fluid with no purulence. (B) No metallosis or necrotic tissue can be seen within the joint. (C) There are no visible signs of metallic corrosion of the head and neck. (D) There is no evidence of excessive polyethylene wear. (E) There is satisfactory osseointegration of the prosthesis with the bone (bone ingrowth).

We used the posterior approach for revision. Intraoperative findings (Fig. 5A, B) showed an accumulation of slightly bloody joint fluid in the joint capsule. There was no grossly obvious hematoma or fluid retention in the iliopsoas muscle. No gross evidence of corrosion or wear was noted in the extracted implants (Fig. 5C-E). Revision with retention of the femoral stem was performed under the guidance of a CT-based navigation system (Brain Lab, Munich, Germany) using a smooth-edged cup with a 48-mm diameter (Continuum Acetabular System, Zimmer, Warsaw, IN, USA). The cup was replaced at a more medial position, and the absence of any anterior protrusion that could cause impingement was confirmed intraoperatively (Fig. 6). In the early postoperative period, the patient's pain and ability to perform daily activities improved markedly, including her ability to ascend and descend stairs. The Harris hip score, which was 56 points preoperatively, was 91 points at 6 months postoperatively. The patient was able to achieve the standard clinical outcome that is expected with primary THA.

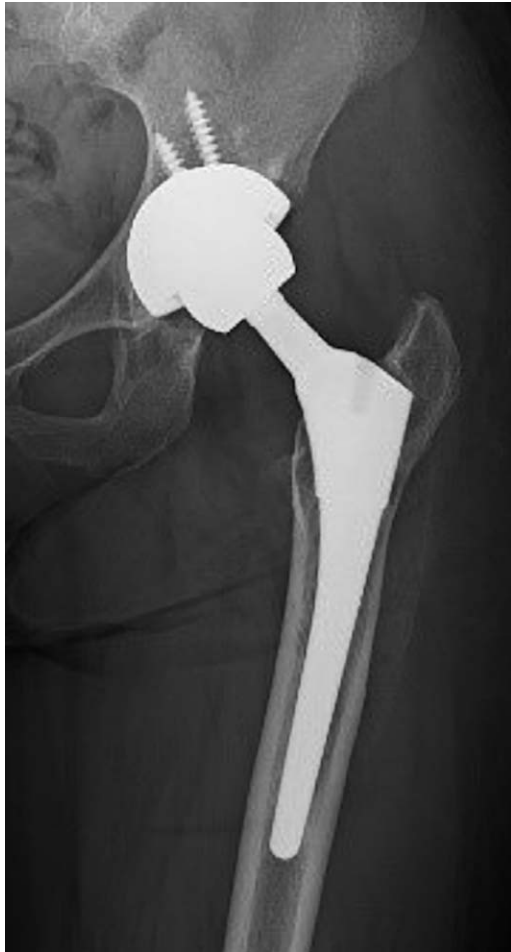
Fig. 6. An anteroposterior pelvic radiograph following left revision total hip arthroplasty. A small-sized cup (48 mm) was installed deep and internalized with an inclination of 39° and anteversion of 24° under the control of the navigation system. The offset polyethylene liner of 7 mm (Longevity offset liner; Zimmer, Warsaw, IN, USA) with a 6-mm longer ball head of 32-mm diameter was used during the revision surgery to obtain the accurate leg length correction and soft tissue tension for dislocation prevention.
