Article

Magnetoelastic Ribbons as Vibration Sensors for Real-Time Health Monitoring of Rotating Metal Beams

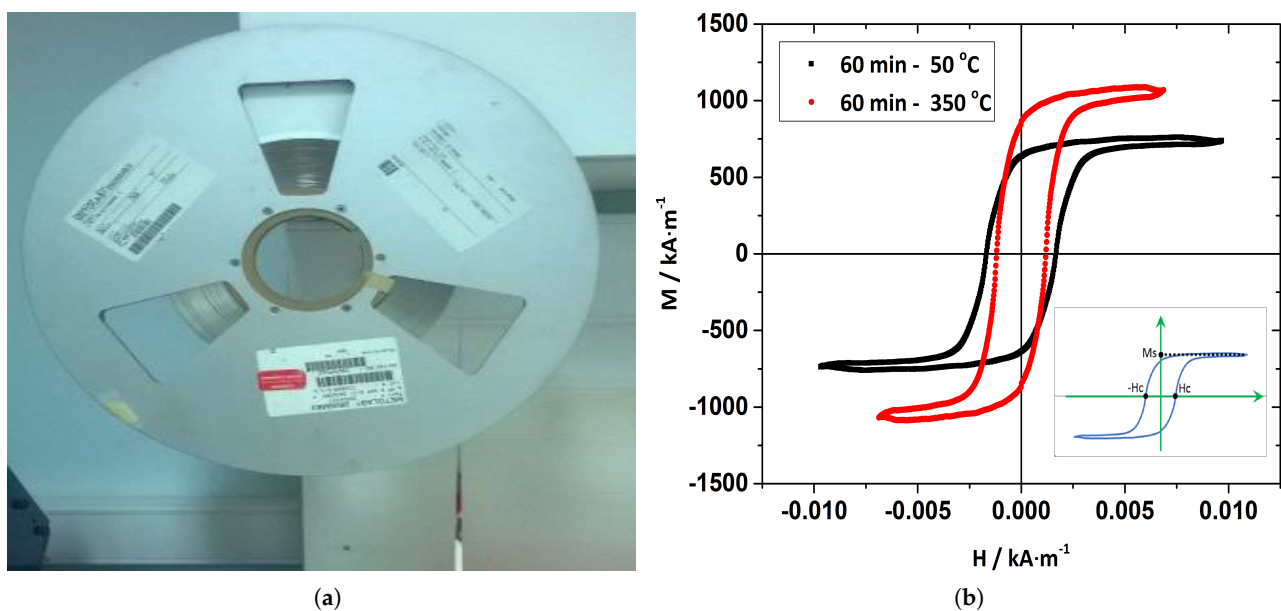
Figure 1. (a) Metglas 2826 MB ribbon spool. During the material production process, the spool length usually reaches hundreds of meters. (b) Hysteresis loop of the Metglas 2826 MB in two different temperatures.

Ribbons of magnetoelastic material known as Metglas 2826 MB are used in this work as vibration sensors in order to detect and transmit the vibration state of the rotating beams. This is a nickel–iron-based, soft, ferromagnetic alloy material that is usually produced in the form of a long thin ribbon (Figure 1a), by quenching methods, and is widely used in transformer applications due to the high permeability, linearity, and low eddy currents. Table 1 summarizes the physical and geometric properties of the ribbon as given by the manufacturer. According to this table, the properties of interest, in order to use these materials in sensing applications, are numbers 7, 8, and 9. The property number 7, which is the annealed saturation induction, is directly connected to the strength of the output signal of the sensor and depends, to a large extent, on the temperature at which the material is annealed. The Figure 1b graph presents the hysteresis loops (material magnetization M versus the applied magnetic field H) of the Metglas 2826 MB for two different annealing temperatures, within the time range of 60 min. It is clear that the saturation magnetization M_s (the maximum value of the magnetization) increases at higher temperatures and that the coercivity field H_c (the value where the loop crosses the horizontal axis) decreases. Thus, the material becomes a “softer ferromagnet”, improving sensing capacity.

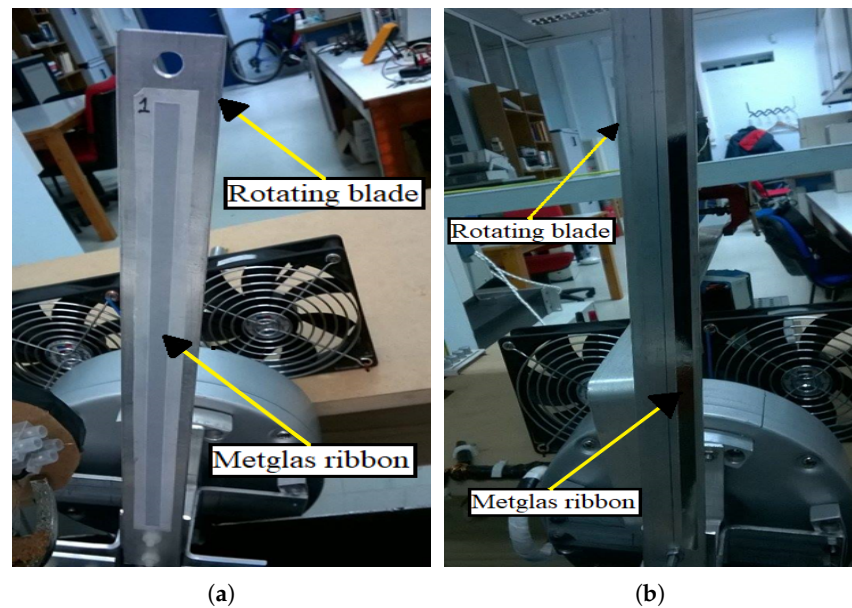
Figure 2. (a) A piece of a Metglas 2826MB ribbon attached to a rotating blade with double-sided tape. (b) The same rotating blade with the excess tape was stripped thoroughly using a strong plastic blade to prevent the beam from scratching.

Figure 2 shows a single piece of an annealed Metglas ribbon attached to a rectangular aluminum beam blade. The length of the ribbon is 25 cm and the length of the blade is 30 cm. In general, the proper ribbon size is determined by two factors: the size of the spinning mechanical part, and the type of detection coil used in the signal detection method, which also includes various signal amplification methods. However, the majority of the time, the decision is made through trial and error. In our case, a 25 cm ribbon and a 625-thread coil

were sufficient to record the vibration signal without any amplification. The aluminum blade is mounted on a single-phase electric motor with a fixed rotor and a rotating stator. Later, in the experimental section (Section 3), the motor setting and the rotating blades are described in more detail. The prepared ribbon is attached on one side of the blade using a 3M™VHB™ 4930 double-sided tape, of which physical properties are presented in Table 2, as given by the manufacturer. It should be noted at this point that, while it is difficult for the ribbon to detach due to its low mass and, thus, inertia, detachment can occur in practice. As a result, it is critical to select adhesives that are compatible with the surfaces on which they are used. In this case, the adhesive used interfaces well with metals where high dynamic stresses are involved, and it perfectly fits the experimental process of the work. Finally, the rotating blades used are made of 6063 aluminum alloy, and their dimensions were set using a CNC machinery in a workshop. Table 3 presents the physical properties and dimensions of the rotating blades.

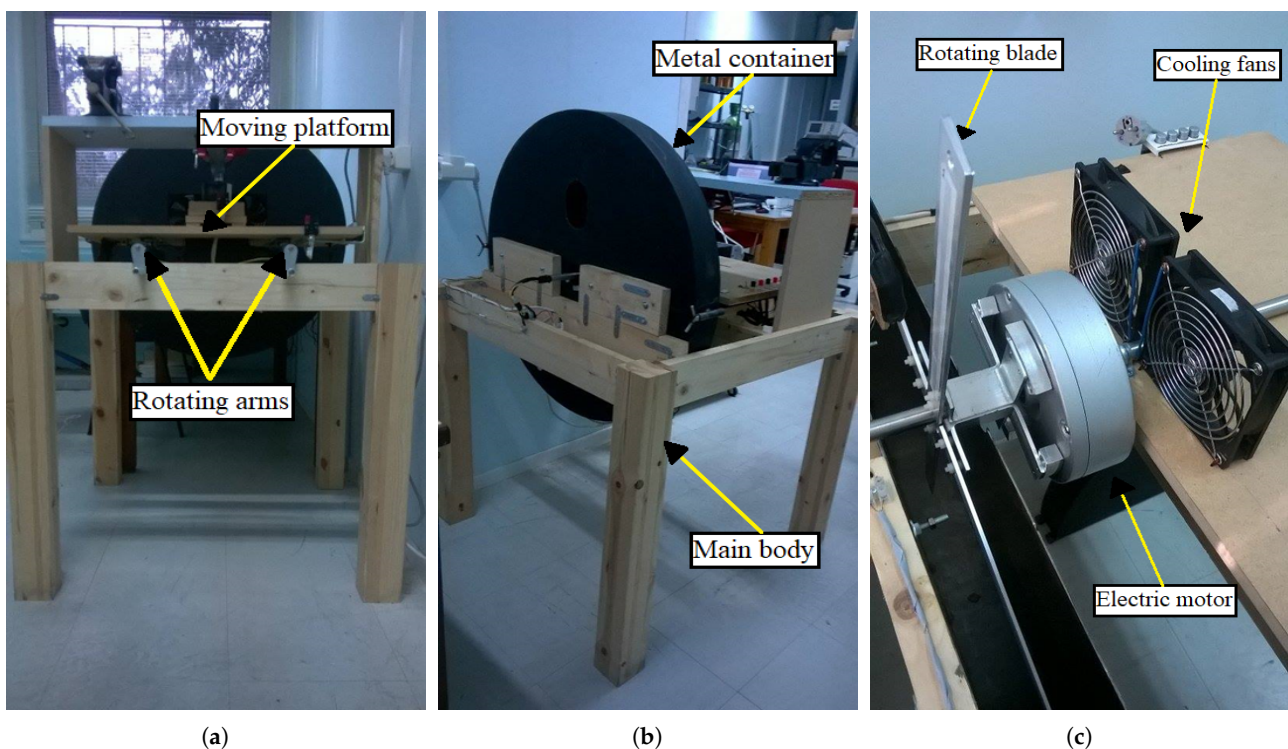
Figure 3. (a) Front view of the setup. The moving platform is shifted back and forth on metal rails using two rotating arms. (b) Rear view of the setup and the metal container inside of which the mounted, on the motor, blades are rotating, (c) View of the electric motor as it is fixed on the moving platform. The blades, mounted on the motor, are also visible inside the half-open metal container.

The experimental setup shown in Figure 3a,b was designed and built to test the hypothesis that magnetoelastic sensors can detect, in situ, the vibrations of a rotating blade, and transmit in a contactless fashion the vibration behavior of the blade. The setup is divided into three main parts, which are the main body, the moving platform, and the metal container. The main body is made of wood and is intended to hold the other two parts firmly during the experiment. The moving platform is also made of wood and is mounted on two metal rails which are attached to the upper side of the main body. The role of the platform is to move back and forth, using two rotating arms, in order to control the distance between the rotating blades and the detection coil. Later, in this section, it is explained how

the vibrational signal is detected from the rotating blades. In addition, the moving platform has all the electronic devices integrated on it in order to automate the experimental process. The last part is the metal container, located at the back of the experimental setup. The role of the metal container is twofold: firstly, to keep the experimenter safe from the rotating blades, and secondly, to act as a Faraday cage in order to reduce the electromagnetic noise inside it, as the detection method was performed using coils which are sensitive to electromagnetic noise.

Figure 3c shows the electric motor used, along with the mounted blades, on the moving platform. As was mentioned above, the electric motor is a single-phase electric motor with a fixed rotor and a rotating stator. Two stainless-steel tubes are attached at each side of the rotor to fix the motor on the moving platform, and they were also used to pass the motor cables through them to protect them from the rotary motion of the blades. The motor can be set to rotate at three different speeds of 60 rpm, 120 rpm, and 180 rpm. For the purpose of this work, only the highest speed of 180 rpm was used. The two cooling fans were placed in order to dissipate heat away from the motor, as an increase in temperature of up to 60 °C was observed during the experiments. A set of four blades was mounted on the electric motor using a specially shaped base (Figure 4), so that they can be easily inserted into the metal container.

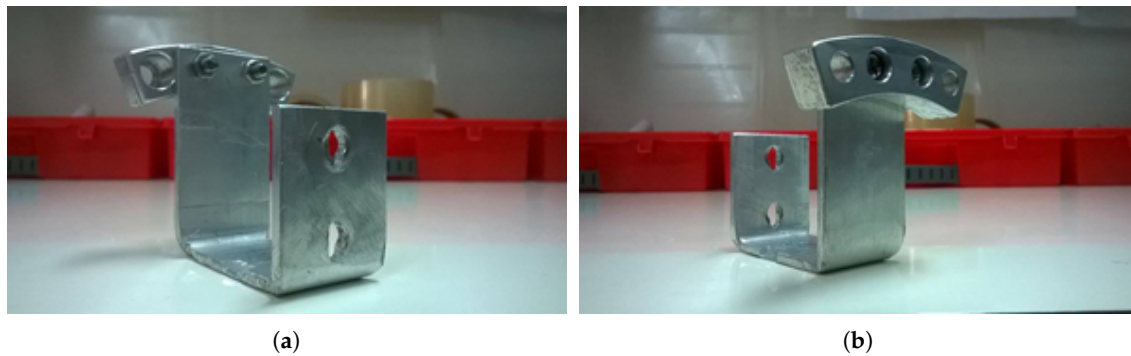
Figure 4. (a) Front and (b) rear view of the base used to mount the blades on the motor. The II shape of the base made it easy to close the metal container without the blades resting inside it as they rotated.

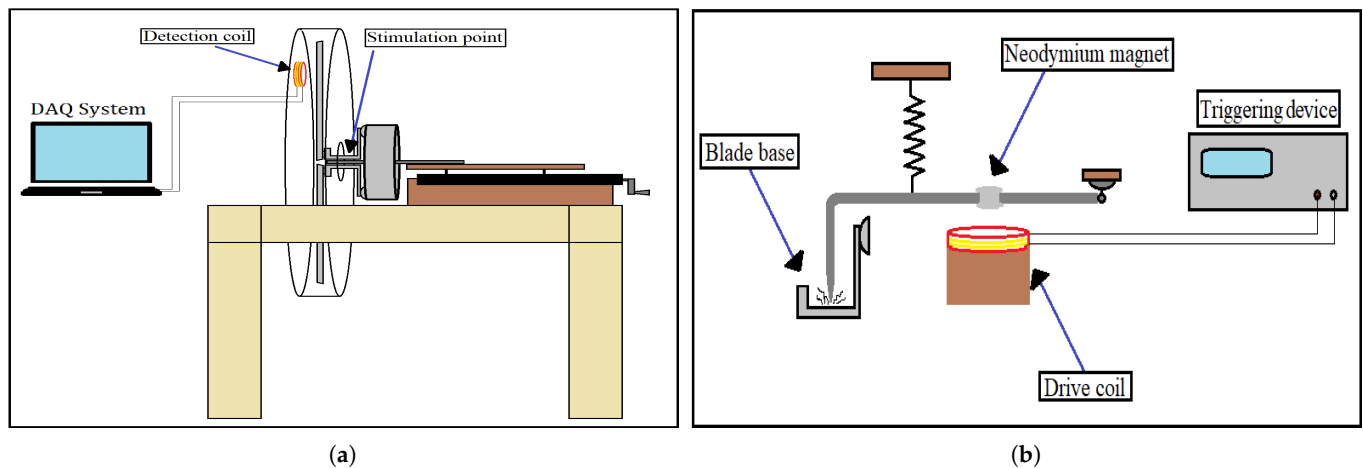
Figure 5. (a) Schematic of the experimental setup. A detection coil connected to a laptop was used to detect the vibrations of the rotating blades. (b) Schematic of the mechanical stimulation system. The edge point of the Γ -shaped rod excites the stimulation point shown in Figure 5a.

The experimental procedure was performed as follows: A detection coil (with physical and geometrical properties shown in Table 4) was mounted on the back and top of the metal container via a hole drilled for this purpose (Figure 5a). The coil terminals were connected with a special plug to the microphone socket of a laptop, and the measurements were carried out using Matlab software, where an algorithm was created to record and calculate the fast Fourier transform (FFT) spectrum of the signal of each blade separately. The measurements were recorded in situ, with the blades rotating, and the results were extracted within a few seconds. The basic principle of the detection method is the Faraday's

law of induction, and it works as follows: The attached Metglas ribbons on the rotating blades are forced to follow the mechanical oscillations of the blades, and, due to the magnetoelastic character, they change their magnetic state (magnetization) continuously. The change in the magnetic state of the ribbons produces an AC magnetic field which, in turn, induces an EMF voltage to a nearby coil through Faraday's law of induction.

During the first tests, an attempt was made to record the signal solely by the vibrations the blades are forced to make due to their rotation. However, it turned out that the recorded signal was very weak and comparable to the noise level, and any attempt to amplify it and record it failed due to the noise level. To overcome this situation, an automatic mechanical stimulation was designed, as shown in Figure 5b. A Γ -shaped aluminum rod is fixed on one end while the other end, which has the form of a sharp tip, is hanging with the use of a spring over the flat side of the base of the blades. A neodymium magnet fixed on the rod is attracted by a drive coil each time the coil is triggered and forces the tip of the rod to mechanically stimulate the base. This stimulation sets the mounted blade into free vibrations and, as discussed later, it mostly excites the bending, to the easy axis, oscillations of the blade. Finally, as Figure 6 shows, a second set of a neodymium magnet and a coil was used to synchronize the excitation process with the rotation of the blades. As the neodymium magnet is attached to the motor, it rotates with it, and each time it passes near the coil, it triggers an arbitrary waveform generator (TTi—TGA1241). The generator then sends a short pulse to the driving coil (Figure 5b), which attracts the aluminum rod and forces the tip to impact on the base, mechanically exciting both the base and the blades attached to it. The position of the magnet on the motor was set so that the blades are mechanically excited each time they pass directly opposite to the detection coil.

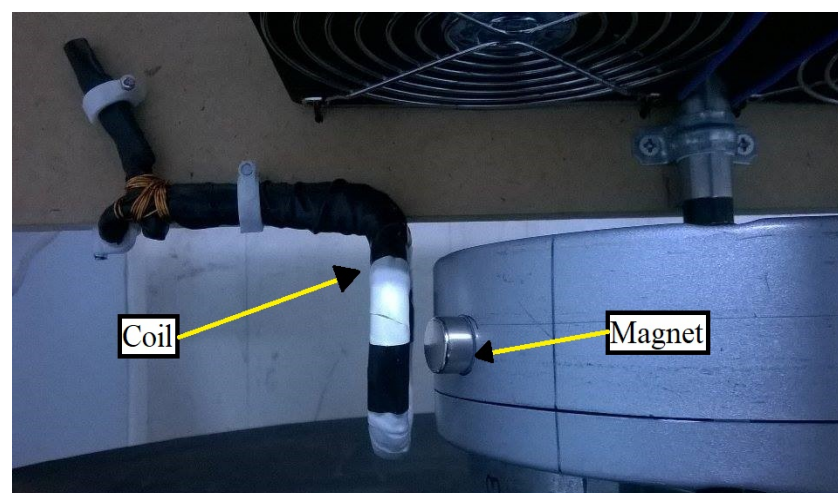
Figure 6. The second set of neodymium magnet and coil. The magnet is fixed to the motor and rotates along with it, passing next to the coil and inducing a voltage on it.

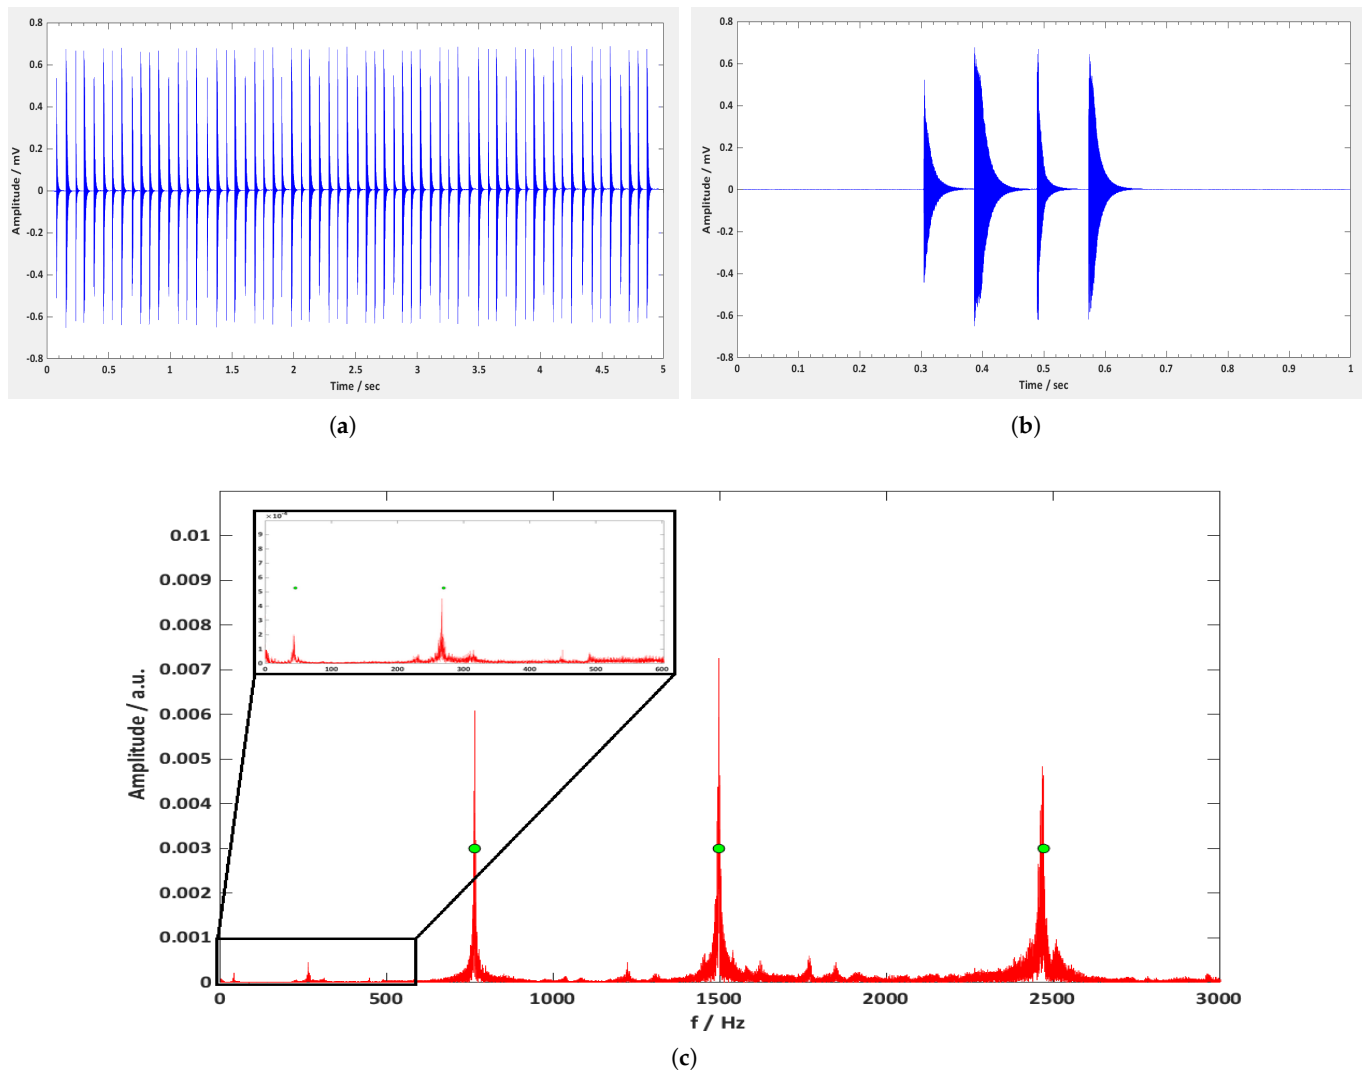
Figure 7. (a) Excitation signal of the undamaged rotating blades versus time. (b) Excitation signal for one rotation only. (c) FFT spectrum of the 1st undamaged rotating blade. The green circles indicate the frequency values of the first 5 bending modes of the undamaged blade as they were calculated by ANSYS modal analysis.

Figure 7a presents the measured data within the time range of 5 s, as they were recorded using the Matlab software program. It can be seen that during the first second there is a total number of 12 peaks in the graph, corresponding to three complete revolutions of the motor, as there are four blades mounted on the motor. This confirms the 180 rpm rotation speed of the motor. Figure 7b shows the same results but for one rotation only. Each peak corresponds to the oscillation signal of each blade, with the first peak being the signal of the blade number 1, the second peak being the signal of the blade number 2, etc. It can be seen that the first peak has the smallest amplitude, something that can also be confirmed in Figure 7a. This is due to the smaller length of the Metglas ribbon attached to blade 1, from which the detection signal is weaker, and this was done to make clear which peak corresponds to which blade, to make it easy to distribute the data per blade

using Matlab scripts. Figure 7c presents the FFT spectrum of the recorded signal from the first rotating blade (the blade with the smaller Metglas ribbon). It is clear that within the 3 kHz range of the graphs, there are a number of peaks with different amplitude and width. Below 500 Hz, there are two weak peaks with frequency values of 43.3 Hz and 267.3 Hz, respectively, while above 500 Hz, there are three very high peaks at frequencies of 765.4 Hz, 1498.1 Hz, and 2468.7 Hz, respectively. Since these data were collected from the mechanical oscillations of the first rotating blade, the corresponding FFT peaks should be associated with its natural vibration. To determine these modes, simulations were performed using ANSYS modal analysis.

the frequency values of them are displayed in green circles in Figure 7c. The percentage difference between the ANSYS and the experimental frequency values are shown in Table 5. According to these results, the dominant peaks in the FFT spectrum of Figure 7c correspond to the first five bending modes of the first rotating blade, which does not differ from the other blades, as they are all identical and without damages. In general, the frequency value of each peak is the vibration identity of the rotating blade and it is directly related to the physical and geometrical characteristics of the blade, such as the dimensions of the blade, the modulus of elasticity, the moment of inertia, etc. On the other hand, the amplitude of each peak shows the magnitude of the vibrations, and it is directly related to the energy of the mechanical excitation as well as the size of the sensor.

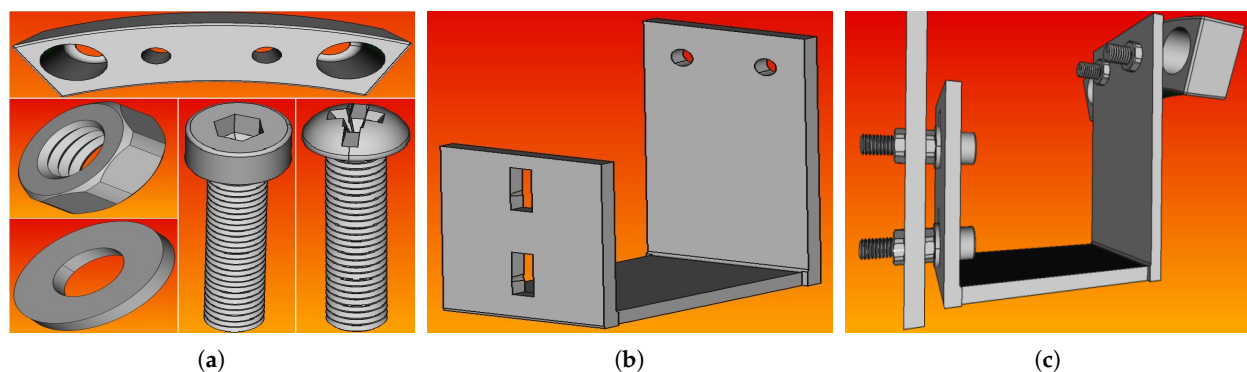
Figure 8. Designed parts of the rotating blade using FreeCAD software program: (a) bolts and (b) base, (c) assembled structure.

Figure 8 shows the parts and the assembled structure of the rotating blade, as designed in the FreeCAD software program. The designed model was then introduced into ANSYS modal analysis in order to calculate its free vibration modes. The material properties of each part were introduced using the Engineering Data section of ANSYS modal analysis, and the meshing properties on each part were chosen depending on the structure's complexity. The bolts were meshed with tetrahedral elements, while the rest of the parts were meshed with hexahedral elements. To combine the parts in one piece, bonded type connections were used. Figure 9b–f present the first five bending modes of the structure to the easy axis, and

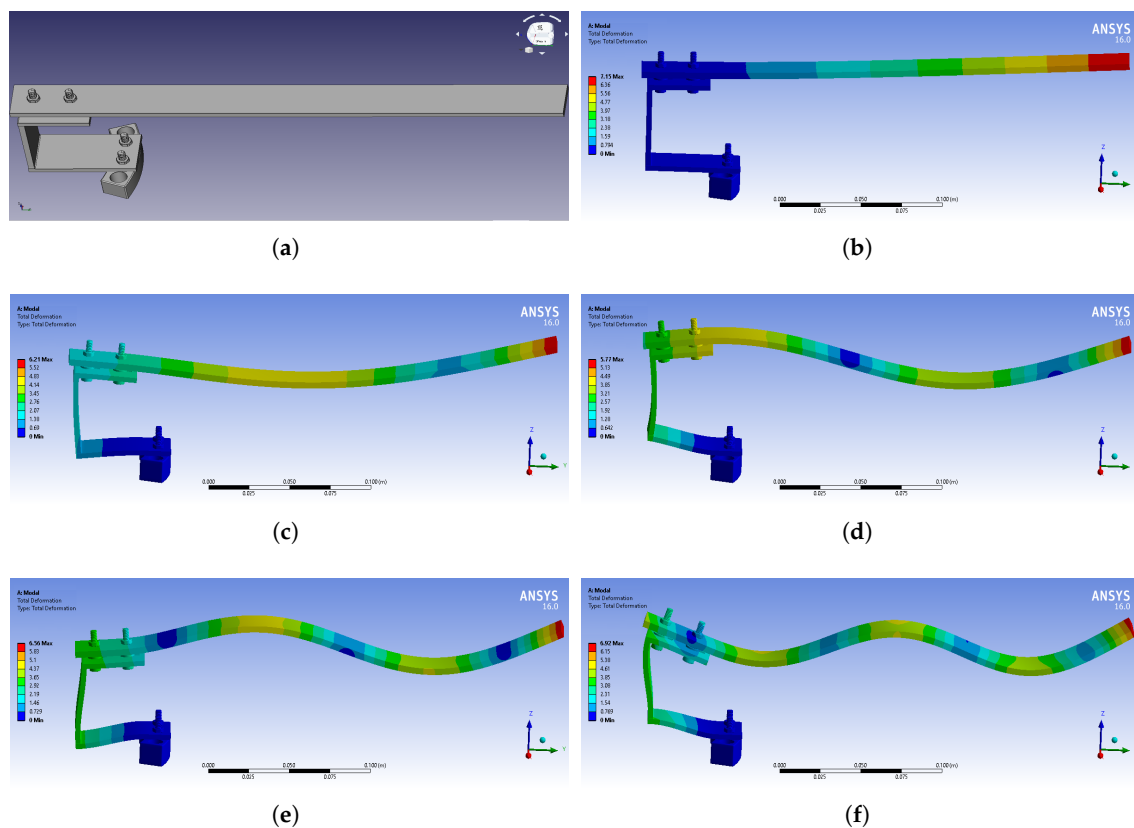
Figure 9. (a) View of the assembled rotating blade along with the first 5 bending modes of it on the easy axis, as they were calculated using ANSYS simulations: (b) 1st, (c) 2nd, (d) 3rd, (e) 4th, (f) 5th.

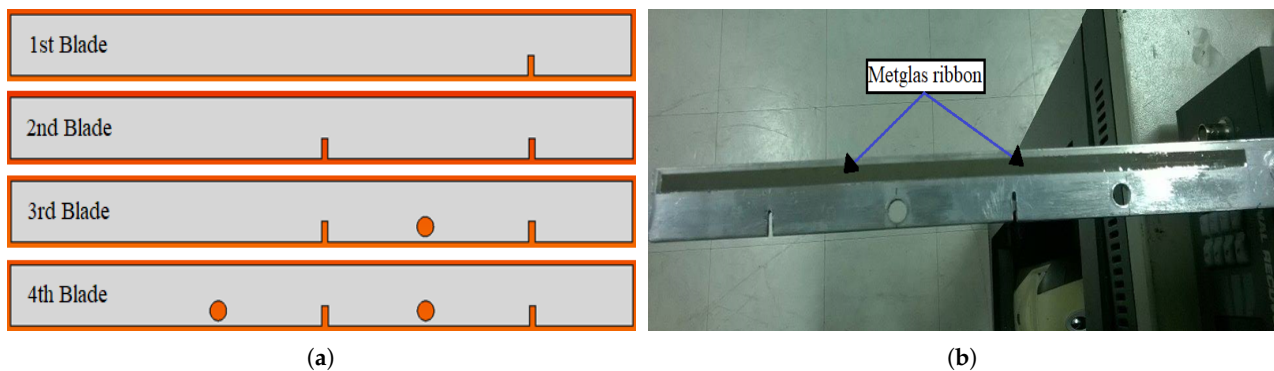
Figure 10. (a) Schematic illustration of the type of the damage introduced on each rotating blade. (b) The damaged 4th rotating blade along with the attached Metglas ribbon.

The second stage of measurements was performed by introducing various types of damages to the rotating blades. Figure 10a shows, schematically, the type of damages introduced on each blade. The first blade was damaged with a side cut of 1/3 the width of the blade and 2 mm wide, close to the free end of the blade. The second blade was damaged with the same type of cut but at two different locations, one at the middle and one at the free end of the blade. The third blade was damaged with an extra hole of 8 mm diameter between the two cuts, while the fourth blade was damaged with two extra holes of the same diameter on either side of the middle cut. The choice of the type and number of damages was made in such a way so as to have a gradual increase of damages to the rotating blades. Figure 10b presents the fourth rotating blade along with the introduced damages. As can be seen, the damage is restricted to one half side of the blade, while the Metglas ribbons to the other undamaged half. This was carried out on all rotating blades.

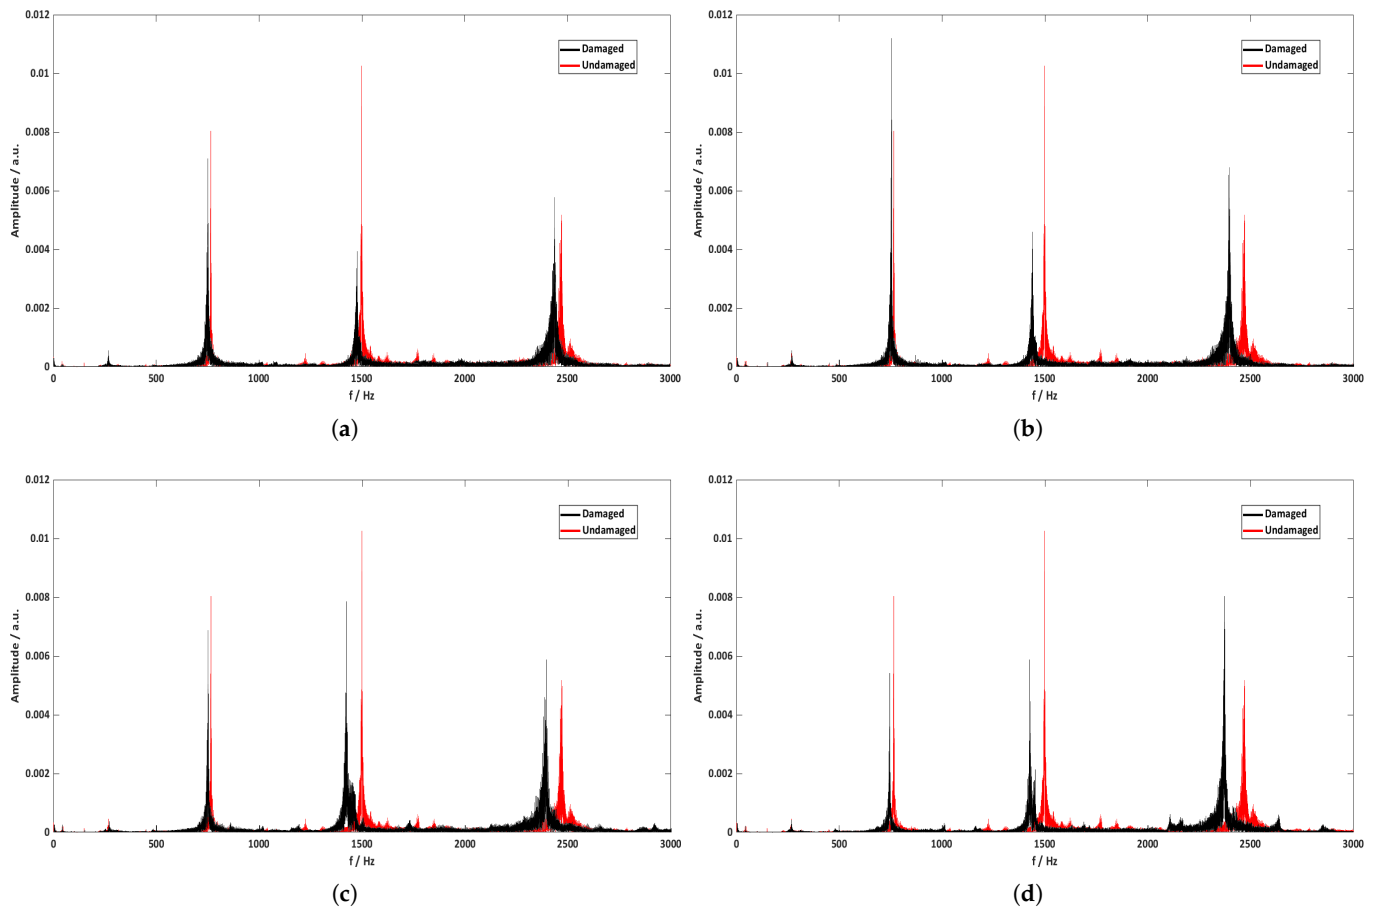
Figure 11. FFT spectrum results for each blade between the undamaged and the damaged state: (a) 1st, (b) 2nd, (c) 3rd, and (d) 4th.

Figure 11 shows the FFT graphs between the undamaged and damaged state of each rotating blade. These data were recorded in situ by the experimental method described in Section 3, and were collected and separated per blade through an algorithm in the Matlab software program. At first glance, it seems that the peaks of the bending modes are shifting to lower frequencies, and this can be confirmed in Table 6, where the frequency percentage differences between damaged and undamaged blades are presented. It is clear that as the magnitude of the damage is scaling from the first to the fourth blade, the percentage difference on each bending mode is increasing. This result is in line with the theory that the appearance of damages on beam-like structures strongly affects the stiffness of the beam, which is inversely proportional to the frequency. In addition, according to the results of Table 6, the bending mode that was changed the most is the fourth one for the fourth blade, with the percentage difference value being 7.2%. In general, the magnitude of change on each bending mode is directly related to the location where the damage occurs. Damages close to the nodes of the beam do not alter the frequency values of the corresponding mode as these are stationary points. On the other hand, damages located symmetrically between two nodes most alter the frequency values of the corresponding mode due to the highest amplitude of vibration at these points. Thus, it is very important to record data from different bending modes of each rotating blade in order to avoid false signals where

the size of the damage can be large and the corresponding change in frequency very small, and vice versa.
