Article

Advantages of the Application of the Temper Bead Welding Technique During Wet Welding

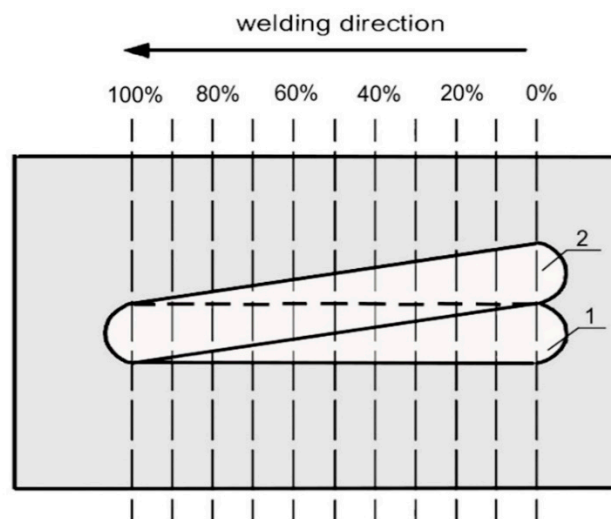
Figure 1. Scheme of the temper bead welding (TBW) technique specimen, 1—first (tempered) padding weld, 2—second (tempering) padding weld.

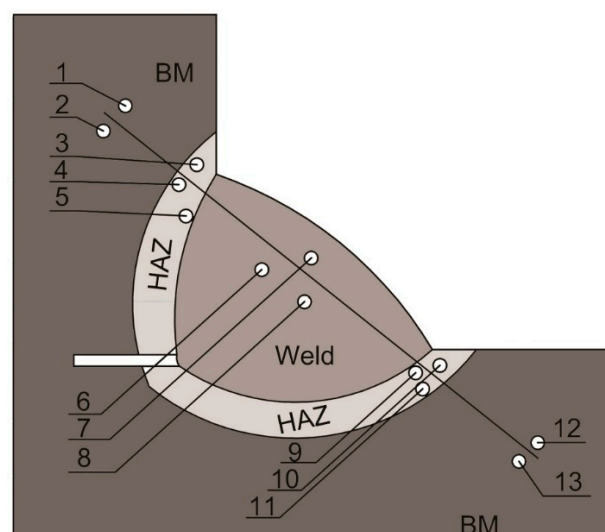
**Figure 2.** Hardness point distribution in the CTS specimens.

The hardness measurement scheme for CTS testing is presented in Figure 2. Figure 3 shows the regions of the TBW specimens in which the hardness was measured. The hardness measurements in the first padding weld of the normalization area of HAZ (HAZN) and the overheated area of the HAZ (HAZO) were located in the HAZ at the axis of the first bead.

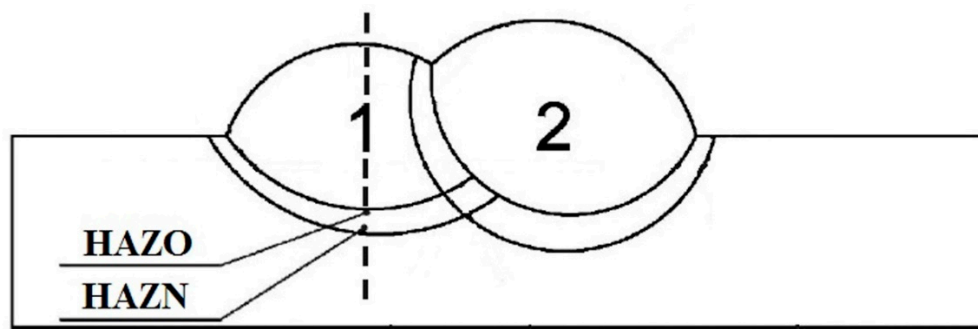
Figure 3. Hardness measurement areas of the heat affected zone (HAZ)—TBW specimens, overheated area of HAZ (HAZO) of the 1st padding weld in the weld axis, normalization area of HAZ (HAZN) of the 1st padding weld in the weld axis.

The hardness measurements were performed on cross-sections of each specimen with all ranges of pitch. The hardness was measured at points in two specific areas of the HAZ (overheated and normalized) of the first tempered weld (Figure 3). The results of the hardness measurements are presented in Figure 7. When the pitch between two beads increased, the hardness in the HAZO of the first padding weld decreased. The HAZO area in the specimens with low pitch values was characterized by the presence of the coarse-grained brittle structures created by the highest cooling rate in the welded joint (Figure 6b). These types of structures are one of the factors responsible for cold cracking. Thus, the HAZO area has a crucial influence on the formation of cracks.

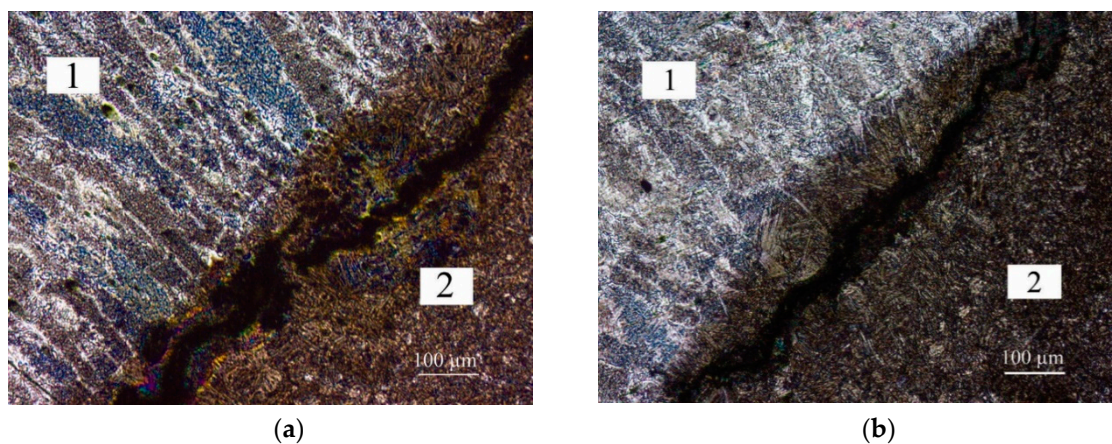
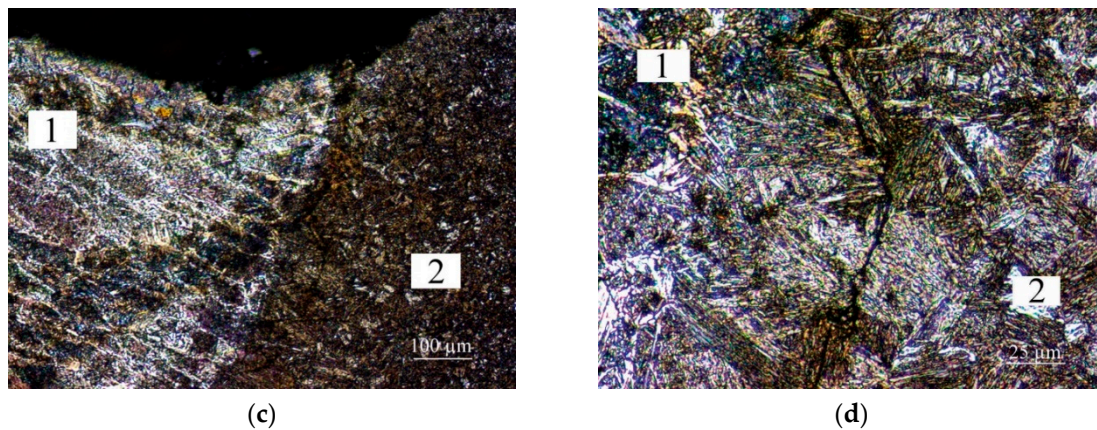
Figure 4. Results of CTS microscopic testing shows cracks in HAZ, 1—weld metal, 2—HAZ, (a) Specimen 1; (b) Specimen 2; (c) Specimen 3; (d) Specimen 6. Etch. Nital 4%.

After non-destructive testing, second welds from specimens 1, 2, 5 and 6 were rejected from further examinations due to significant imperfections. The remaining welds were capable of undergoing further examinations. In the HAZ of each specimen, acicular and martensitic structures were found, which are a result of rapid cooling during welding in the water. The short cooling time also caused high residual stresses and limited the extraction of diffusible hydrogen in the welding environment. The weld metal structure was built of dendrites. The results of the microscopic examination of CTS specimens are presented in Figure 4. During macroscopic testing, cracks in the HAZ of the two specimens (the first weld in specimen 4 and specimen 6) and in weld of one specimen (first weld in specimen 4) were observed. The cracks in the HAZ were initiated in the weld root and propagated along approximately 50% of the length of the fusion line. This area was characterized by an overheated, coarse grain, martensitic structure as is shown in Figure 4a,b. The cracks were observed in the welded joints that were made with the lowest value of heat input (ql). Microscopic examination of S460ML steel showed that cracks occurred in all joints welded in the water environment. These cracks were located in the HAZ, along the fusion line. It was estimated that the total length of these cracks were 30%–40% of the total length of the fusion line. Cracks in the weld also were revealed.

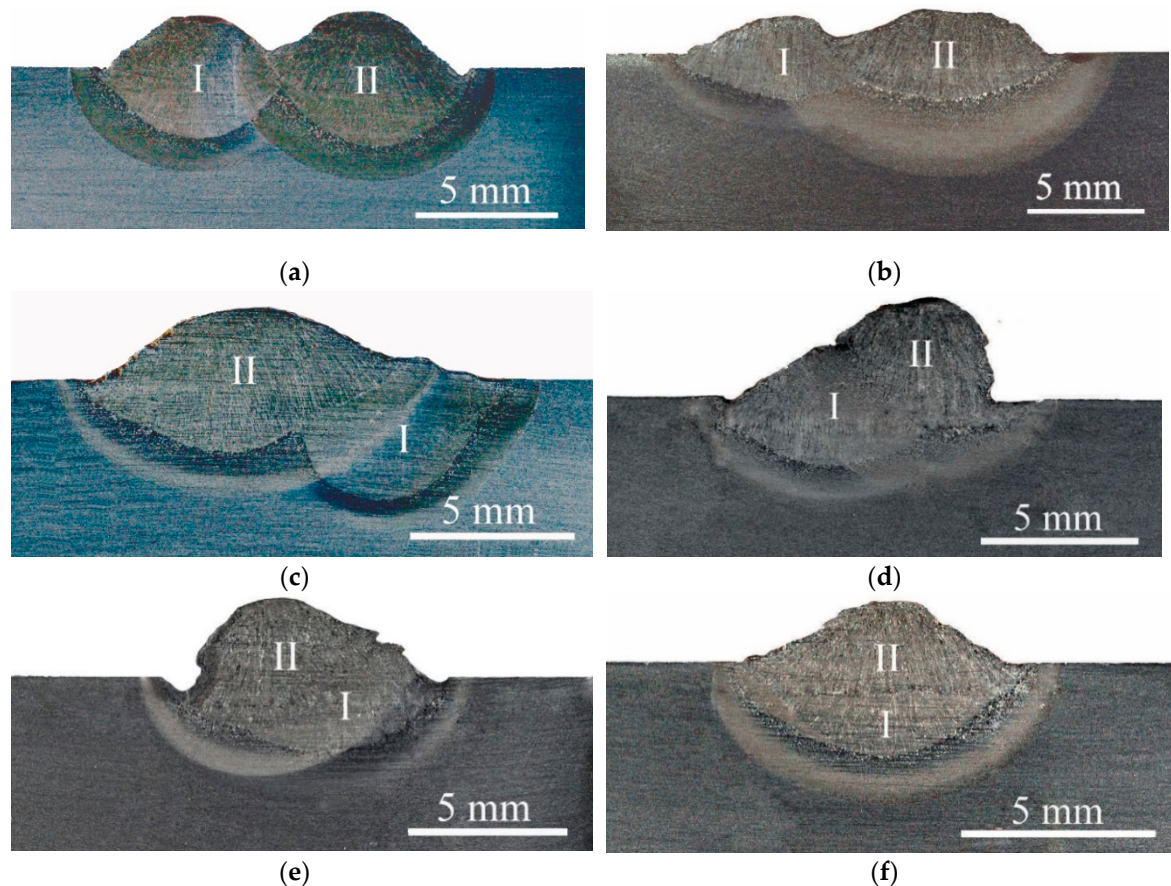
Figure 5. Results of the TBW macroscopic testing, I—first (tempered) bead, II—second (tempering) bead, (a) pitch 11%; (b) pitch 19%; (c) pitch 43%; (d) pitch 55%; (e) pitch 73%; (f) pitch 100%. Etch. Nital 4%.

In the first step of the examination, macroscopic tests were performed. The main aim of these examinations was to calculate the pitch between the two beads. After the macroscopic testing of specimens with a pitch of; 11%, 19%, 43%, 55%, 73%, and 100%, were selected for the next examinations. There were no cracks in these specimens. The results of the macroscopic testing are presented in Figure 5.

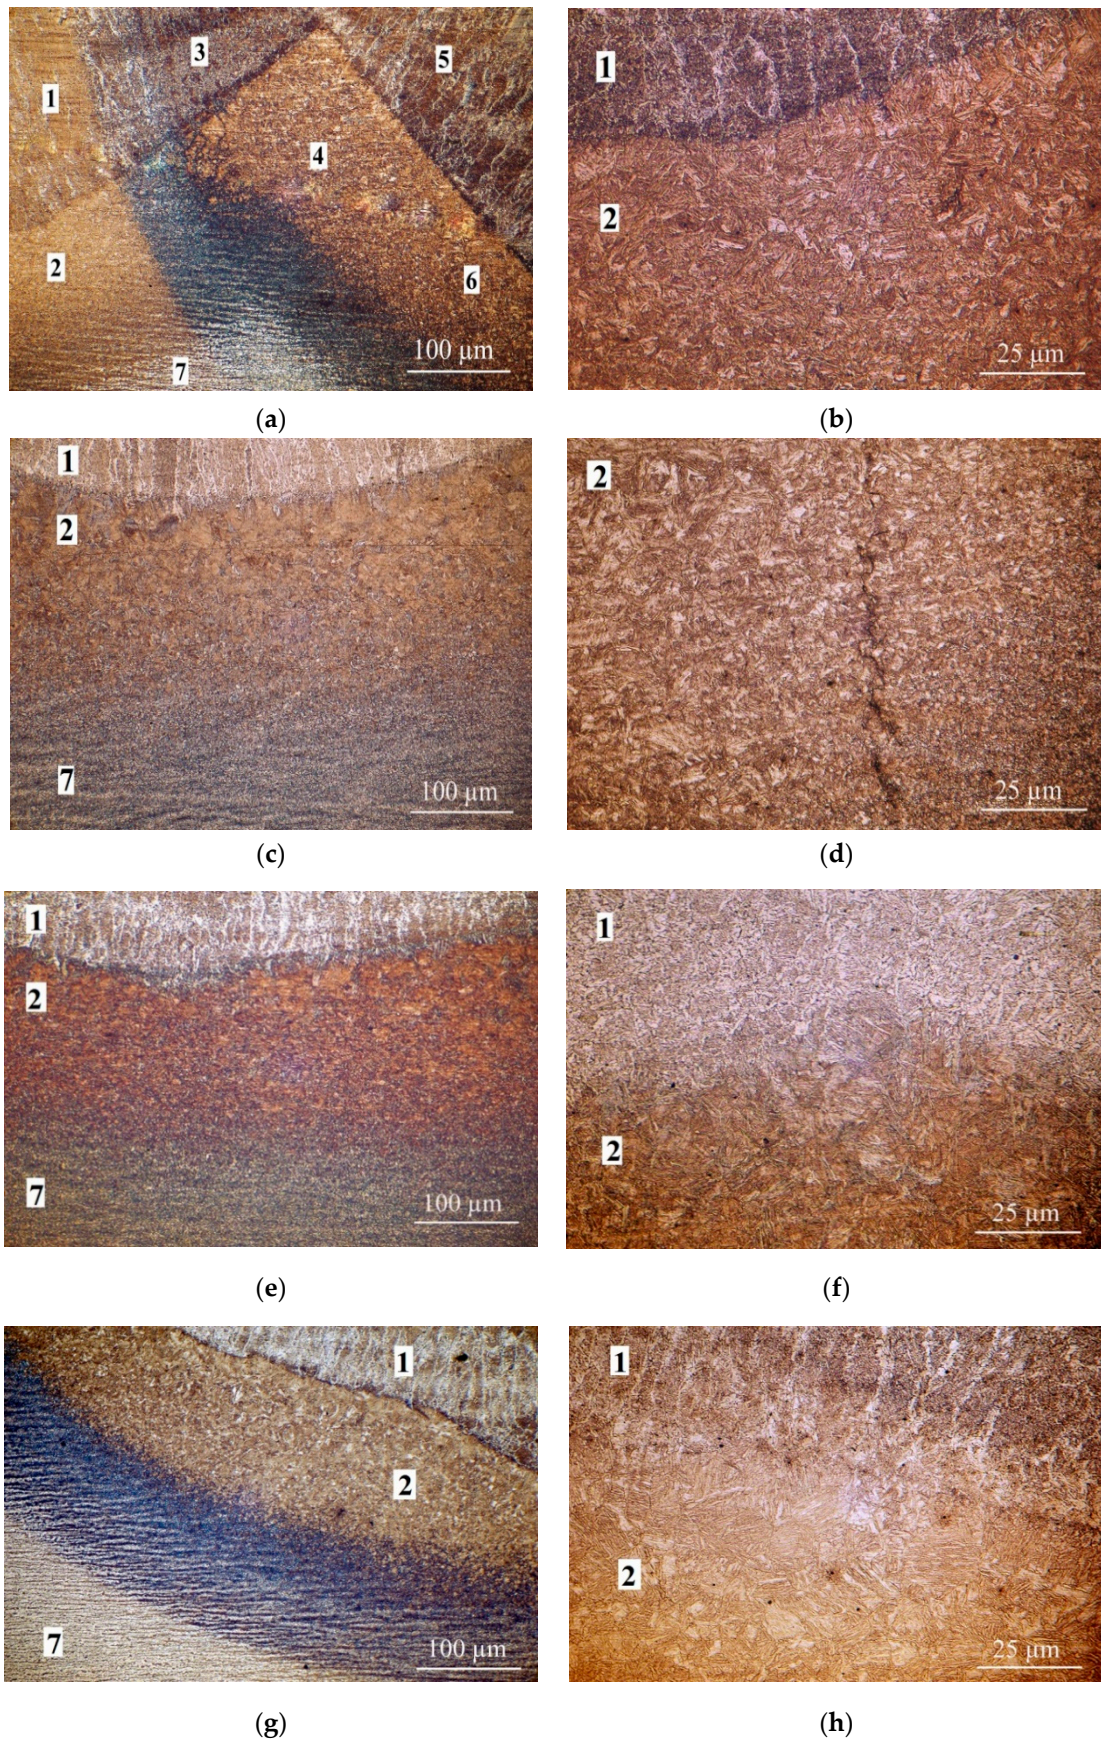
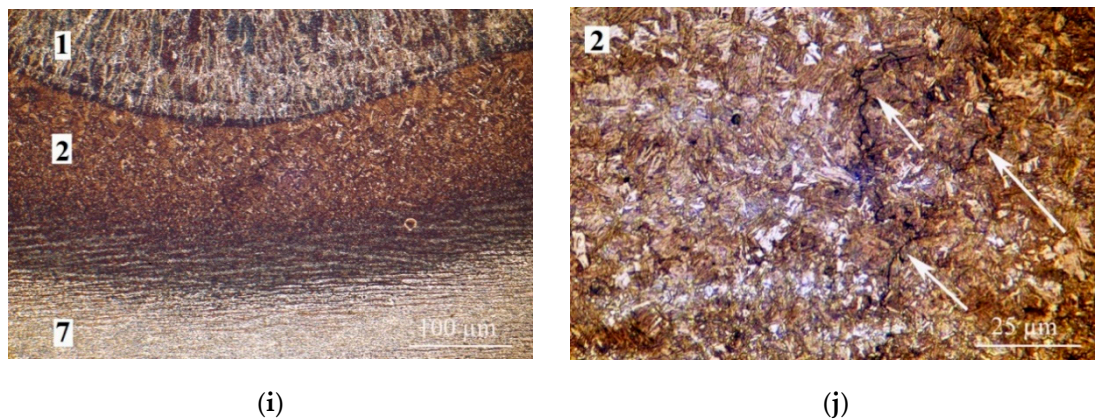
Figure 6. Results of TBW microscopic testing; 1—first bead, 2—HAZ under first bead, 3—area of the HAZ of the second bead overlapping the first bead, 4—HAZ of the second bead overlapping the HAZ of the first bead, 5—second bead, 6—HAZ under the second bead, 7—base metal. (a,b) pitch 11%; (c,d) pitch 43%; (e,f) pitch 55%; (g,h) pitch 73%; (i,j) pitch 100%. Etch. Nital 4%.

The results of the microscopic testing are presented in Figure 6. The welds in each of these specimens showed dendritic structures (Figure 6a, area 1). There was bright, fine-grained ferrite arranged in columns, from which grew acicular ferrite at the boundaries of the dendrites. Inside the dendrites there were fine ferrite grains. The structure of the HAZ was different. Near the fusion line, there were expanded quasiperlite grains with a structure following the Widmannstätten system (e.g., Figure 6b,c, area 2). The structure of this zone also indicated the presence of bainitic hardening structures and low-carbon martensite (Figure 6d). In the areas located the furthest distance from the fusion line, there were normalization structures with fine ferrite and pearlite. In all specimens, changes due to the tempering bead were observed. With the highest value of the pitch between two beads, there was a partial disappearance of the structure of the dendritic base bead and the formation of a ferritic fine-grained structure (e.g., Figure 6e,f, area 1). In the HAZ, the heat of the tempering beads refined and tempered the coarse-grained zone of the first bead (Figure 6g). When the pitch increased, the grain size decreased. TBW provided local heat treatment of the joints. The maximum hardness values for wet welding appeared in the coarse grained HAZ [37]. The grain size decreased during TBW (Figure 6h,i, compare with Figure 6a–d), which led to a reduction of hardness in the HAZ. The pitch increased and the number of cracks decreased. However, TBW could not repair the microcracks that occurred during the welding of the first bead and could even propagate these cracks (Figure 6j). Cold cracks can occur up to 48 h after welding is completed. TBW was used in the 120 s after first bead was laid, thus this technique reduced the probability of the occurrence of these cracks.

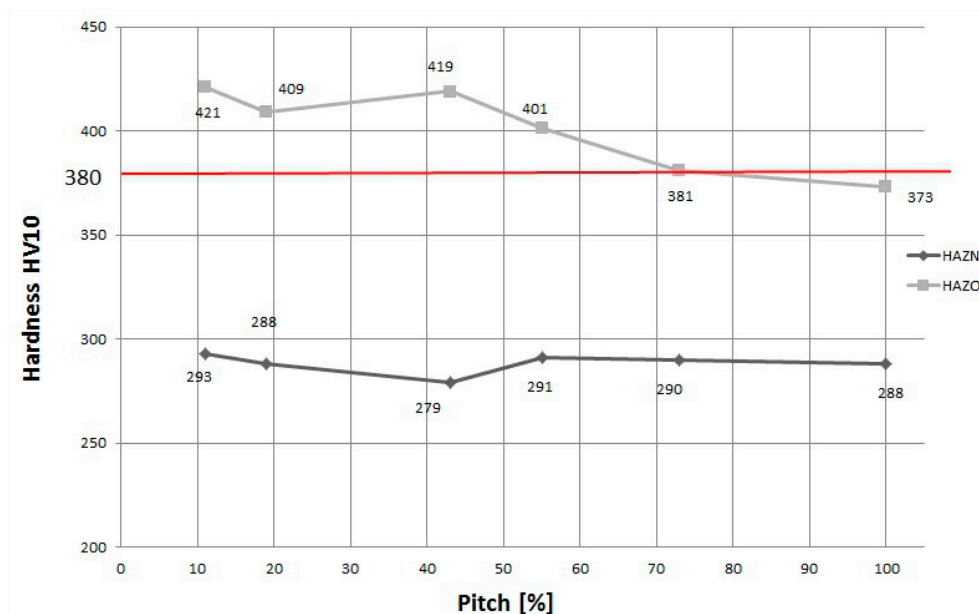
Figure 7. Hardness distribution for specimens with different overlap values in HAZO and HAZN areas of the first (tempered) weld.

In all CTS specimens the hardness was greater than 405 HV10. The HAZ of the tempered beads showed a significant reduction in hardness after using the TBW technique. For specimens with a pitch in the range of 75%–100% the hardness values were below 380 HV10 in the overheated area. In the HAZN, no significant changes in hardness were observed. The comparison in hardness decreased in
