Review

Review of Current Guided Wave Ultrasonic Testing (GWUT) Limitations and Future Directions

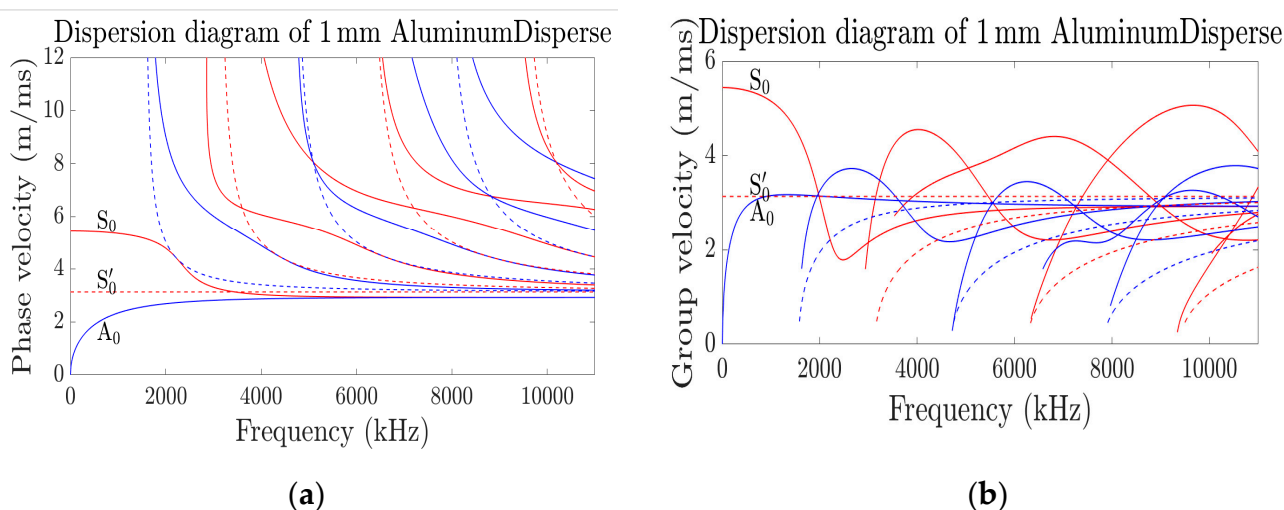
Figure 2. (a,b) Dispersive curve of 1 mm thickness of Al obtained using DC [77].

Similarly, in 2016 Armin Huber of the Lightweight Production Technology of the German Aerospace Center developed 'Dispersion Calculator' (DC) [75,77]. DC is more intuitive and interacting than the famous disperse software [76,77]. The calculator uses the stiffness matrix method formulated by S. I. Rokhlin and L. Wang [78–80] to compute the dispersion curve of longitudinal and shear waves in an anisotropic plate and multilayered transversely isotropic composites. Figure 2 is the guided wave phase velocity, and group velocity dispersive curves of 1 mm aluminum plate thickness generated using the DC. It could be deduced from the dispersive curve of phase velocity that S_0 mode is relatively nondispersive up to 200 kHz with C_p of about 5430 m/s when compared with other

modes. Therefore, it is suitable to monitor the health condition of the plate using S_0 mode as the generated excitation signal. However, excitability and sensitivity of the modes, especially with regards to thickness reduction due to corrosion was not accounted for. In [73], an optimized dispersion curve that relies on the excitability and sensitivity in addition to the group velocity of the mode was developed. This was named goodness dispersion curve, and it offers an informed mode suitable for damage detection but limited to material thickness reduction due to general corrosion. It was revealed that sensitivity of guided wave varies with wave frequency and at low frequency, the wave is insensitive to small thickness variation of the metal. Interestingly, the fundamental symmetric, S_0 , and asymmetric, A_0 , modes were recorded as insensitive.

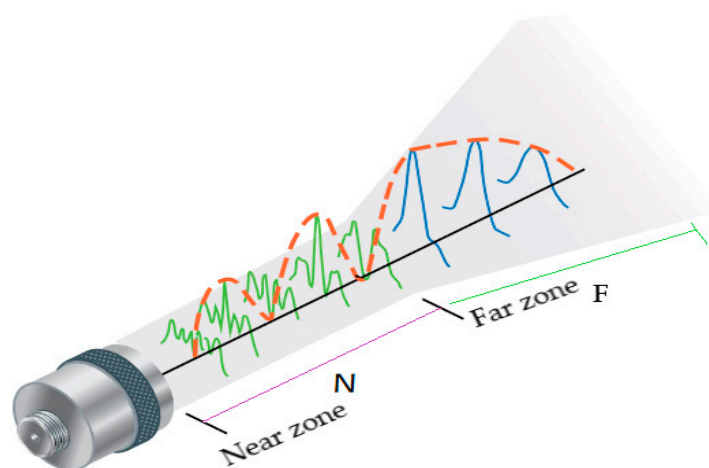
Figure 3. Transducer wave zones [84].

The transducer pressure wave is of two-zone formation [83]: the near zone and far zone, as shown in Figure 3. At the near zone, the wave pressure amplitude varies spuriously with many high and low echoes. However, beyond the near zone distance N , the wave gradually attenuates in the amplitude. The multiple echoes at the near zone make it challenging to detect structural damage between the near zone and transducer. This is a blind spot of the

transducer where damage detection through signal amplitude analysis is ineffective. Hence, damage detection is effective beyond the near zone distance and within the far zone. The near zone distance is defined as in Equation (12). D is the transducer diameter, f is the pressure wave frequency, λ is the wavelength, v is the velocity.

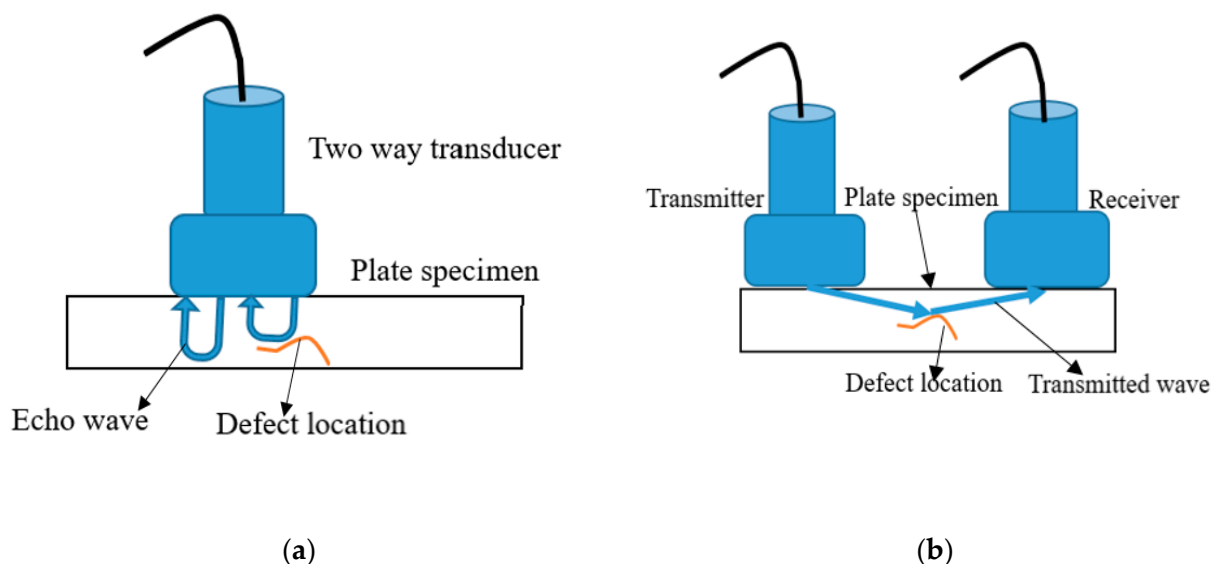
Figure 4. (a) Pulse—echo method with a transducer; (b) Pitch—catch method with two transducers (R) [86].

The configuration topology of the transducer is majorly either pulse-echo (P-E) or pitch-catch (P-C) depending on the geometry of the inspecting structure, targeted defect of interest and the needed data [34]. The typical examples of the methods are shown in Figure 4. In P-E, a single or two transducer(s) is used, and the reflected echo signal, time-of-flight (ToF) alongside the propagation velocity are used to determine defect, deterioration, discontinuity, or thickness of the material structure [70,85]. A minimum of two transducers is required in P-C and spaced sufficiently to generate defect interrogating wave and receive it after interrogation with the structural defect. This configuration is often applied to detect

or monitor defects that are not sufficient to cause reflection somewhat further transmission of the wave though attenuated. Unlike the P–E method, the P–C measurement is the amplitude of the damage signal or the received damage signal's shape. P–C is an excellent choice to make when the intention is to cover a long-range structure [86].

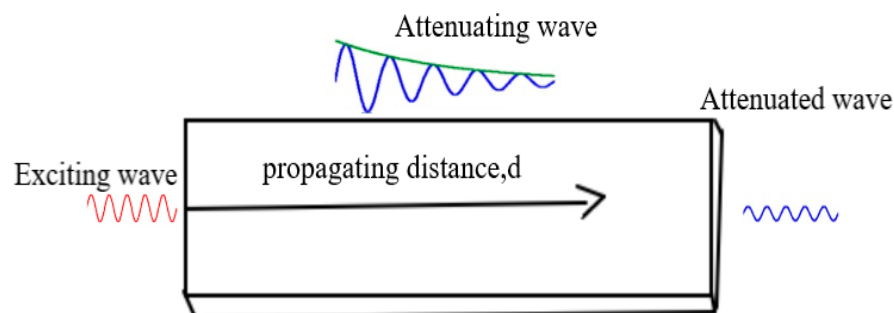
Figure 7. Signal attenuation in a medium.

Attenuation reduces signal level, either in amplitude or energy as it propagates through a medium [81]. Figure 7 is a typical demonstration of wave attenuation in a medium. The diminishing of the propagating signal amplitude often follows an exponential decay pattern expressed in Equation (13) while variation in the signal intensity is described in Equation (14).

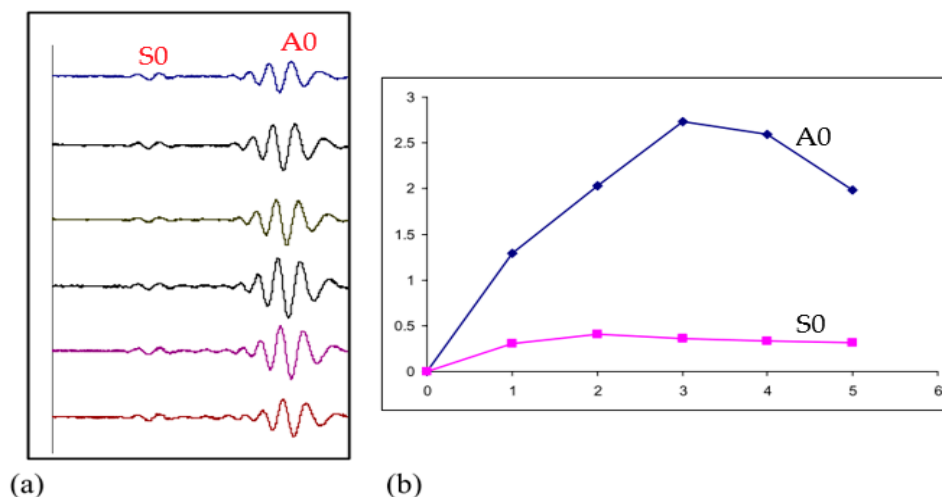
Figure 9. DI analysis on pitch-catch signals for corrosion detection. (a) Received signal at PWAS 4 when PWAS 0 sent at 120 kHz; (b) DI curves of both A_0 and S_0 wave packets at 120 kHz of path 0–4 [117].

High-frequency GWUT has been extensively used in monitoring corrosion activity in structures [63,114,115] although low-frequency monitoring was demonstrated in [116] using 64 PZT sensors. In [117], Victor Giurgiutiu et al. leveraged on piezoelectric wafer active sensor (PWAS's) cheap cost, and networked multiples of it for corrosion detection and localization in plates and pipelines. Fundamental lamb wave modes S_0 and A_0 at high frequency (120 KHz) were generated and used. It was revealed that A_0 is more sensitive than S_0 in detecting corrosion both in plate and pipe although S_0 travels faster but less sensitive to the metal thickness changes. This is depicted in Figure 9.

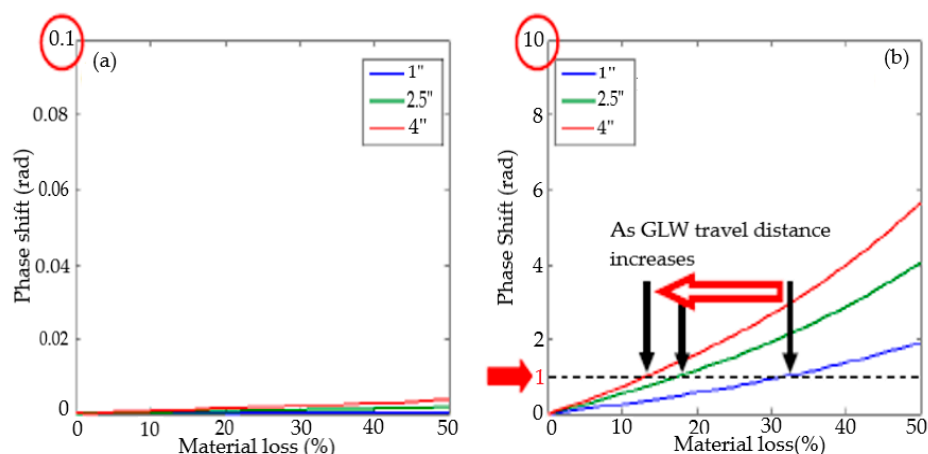
Figure 10. Phase shift estimation according to three-wave propagation distance (60 kHz excitation) (a) S_0 mode (b) A_0 mode of GLWAdpted with permission from [59]. Copyright 2012, ASME.

In [118], accelerated corrosion activity on a steel bar in concrete was successfully monitored using high frequency (200 KHz) lamb wave. The study revealed that corrosion in this nature could be detected using the FFT signal's amplitude response. In [59], corrosion activity was experimentally monitored and quantified using a damage index profile map and A_0 phase shift of the sensor signal. The A_0 group velocity was observed to vary accordingly with the material loss from 0–50% of the thickness. The obtained result suggested that the phase shift of the fundamental antisymmetrical lamb wave A_0 mode can be used to quantify early corrosion activity in structures, as shown in Figure 10.

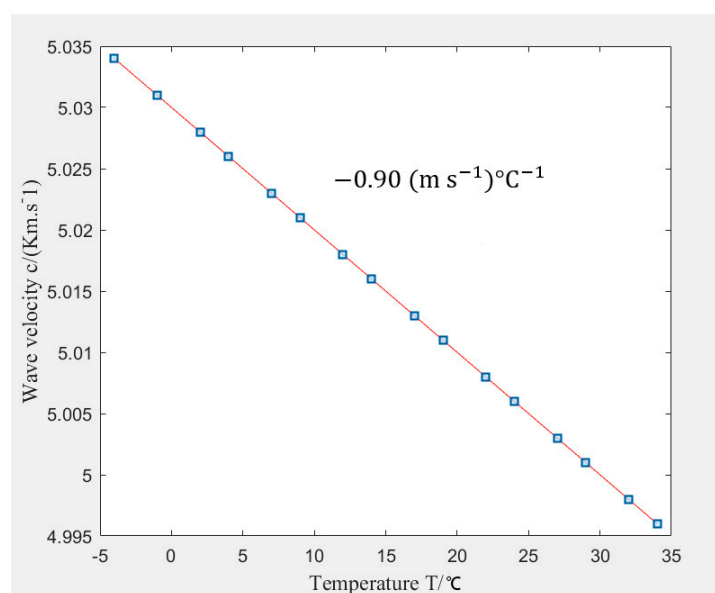
Figure 11. Temperature effect on Lamb wave velocity (R) [124].

Environmental factors vary uncontrollably and interact with installed asset structures. This interaction results in guided wave parameter variation, especially during thermal expansivity [122]. Since metallic structures are an excellent medium for propagating the inspecting wave and serve as host for the sensors, the effect of environmental variation on the metal could be transferred on the sensor directly or indirectly hence causing variation in the parametric features of the sensor signals. These variations mostly result in masking damage signals, thereby allowing failure to occur. Studies have been carried out to investigate the ambient temperature variation on the ultrasonic guided wave (host) and the transducers (actuator and sensor). In [123], Cawley made a comparison study of crack formation effect on the resonant frequency and impact of the beam's length on the resonant frequency. The result showed that the change caused by 2% depth cut of the crack was 40 times smaller than that caused by a 2% increase in the beam's length. The effect of temperature on UGW has been widely studied. In [124], Lui Zenghua et al. investigated the effect of temperature ($-4\text{ }^{\circ}\text{C}$ to $34\text{ }^{\circ}\text{C}$) on lamb wave, L (0,1) propagating on steel. The wave velocity was reported to vary inversely to increase in temperature, as shown in Figure 11. The retardation rate of the velocity was recorded to be 0.9 m/s for every degree of increase in temperature.

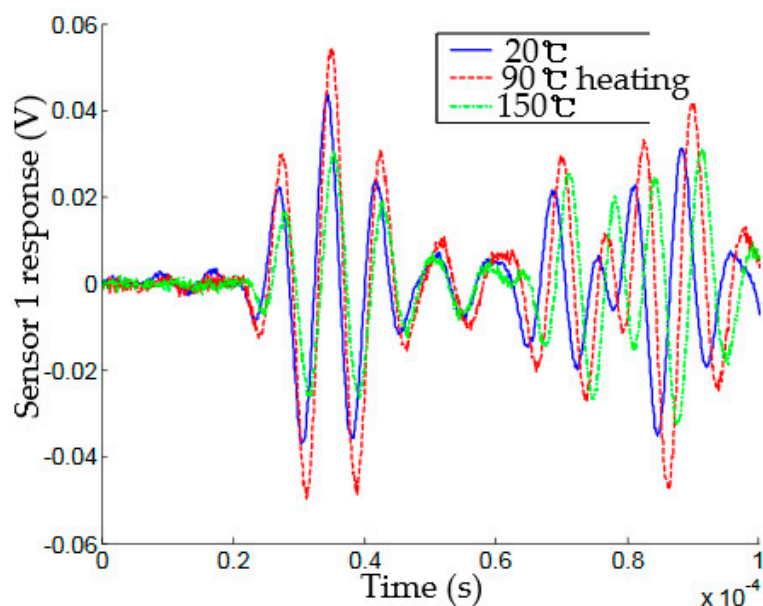
Figure 12. Temperature effect on PZT amplitude [126].

The study on anisotropic plate material carried out by Lanza et al. witnessed similar behaviour but on the wave signal amplitude [3]. It was observed that the wave amplitude increases at the temperature below $20\text{ }^{\circ}\text{C}$ and decreases at a temperature above $20\text{ }^{\circ}\text{C}$. This effect is suggested to be attributed to the competing roles of the PZT coefficients and the dielectric permittivity. When the parameters were isolated, the amplitude response to temperature variation was observed to be proportional. Similar proportionality response was observed when the high-temperature transducer array coupled in an empty pipeline was subjected to a temperature of $7\text{--}150\text{ }^{\circ}\text{C}$ [125]. In the pitch-catch study of varying temperature ($20\text{--}150\text{ }^{\circ}\text{C}$) effect on guided wave performed by Raghavan and Cesnik in [126], the response was observed to be nonmonotonic in the measured amplitude as shown in Figure 12. The amplitude response signal increased when the temperature is $20\text{--}90\text{ }^{\circ}\text{C}$ but decreased when it is $90\text{--}150\text{ }^{\circ}\text{C}$. This behaviour was subjected to further theoretical and experimental studies. Its behaviour was attributed to the assumption of perfect bonding and constant adhesive layer properties through the temperature range.

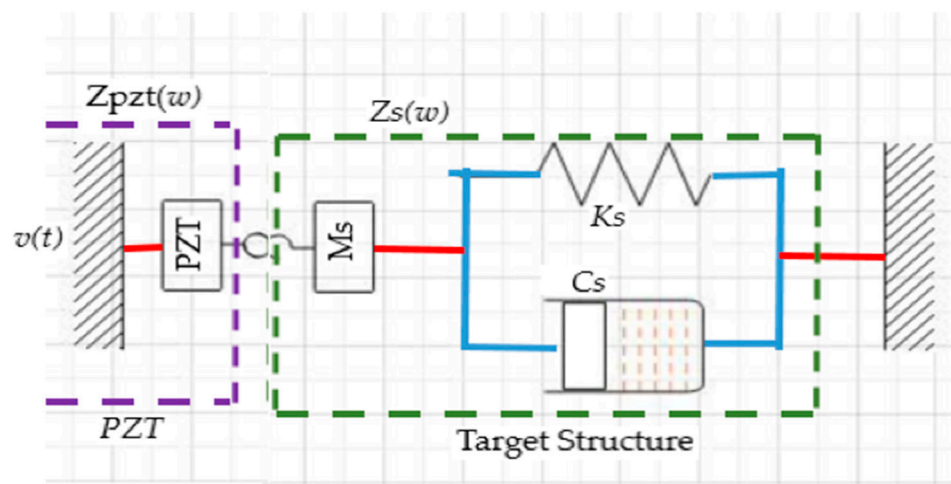
Figure 14. 1-D PZT–target structure interface [143].

It is an acknowledged fact that temperature variation brings about changes in the PZT constant properties, adhesive layer properties between the PZT and the target structure, mechanical properties of the target structure such as young modulus [4,140,141]. Principally, the PZT is bonded to the target structure using an adhesive agent. When an appropriate excitation voltage is applied on the PZT, it would exert acoustic pressure via adhesive layer to the target structure and cause its particles to vibrate in their mean positions. The interaction of the PZT sensor with the target structure in SHM has been modelled in different ways. The essence is to understand their behaviour when there is an existence of damage in the target structure. Among these models are the static and the dynamic finite element models that used the static properties of PZT and structural stiffness to determine the output characteristics of the PZT sensor. The impedance-based-model coupled electro-mechanical system has been more interesting and advantageous than the other two models [142,143]. However, these models are of one degree of freedom (1-DOF) because they considered only the interface between the PZT and the host structure. The physical model of the system is shown in Figure 14 and its simplified model equation for impedance coupling, $Z(\omega)$ the PZT and the target structure are given in Equation (21) while Equation's structural impedance is Equation (22). For brevity, the equation terms are defined in Table 6.
