Arthroplasty Today 1 (2015) 81-84

Original research

Uncemented fully hydroxyapatite-coated hip stem for intracapsular femoral neck fractures in osteoporotic elderly patients: a multicenter study

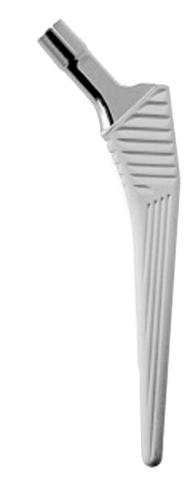
Figure 1. Photograph of an uncemented fully coated Korus stem (Gruppo Bioimpianti, Peschiera Borromeo, MI, Italy).

In our experience we have always used the collarless Korus stem. The use of a stem with a collar is recommended by certain authors [2,15] in the case of osteopenic bone. Use of a collared stem in such cases may afford additional stability and reduced subsidence. In our study group, however, we observed only one case of precocious mobilization caused by a subsidence of >3 mm. Precocious mobilization is explained, on the other hand, by the implanting of a stem undersized with respect to one calculated in pre-operative planning, as reported by Hamadouche et al. [17]. Another 4 cases of subsidence of >3 mm – non symptomatic and then stabilized – were found by X-ray testing at the 6 week and 3 month follow-ups. We may therefore conclude that the use of a collarless stem in any case guarantees very good primary stability even in the case of osteopenic bone.

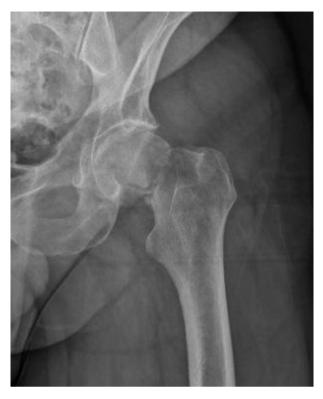
Figure 2. AP hip radiograph of a 79 year-old with an intracapsular left hip fracture.

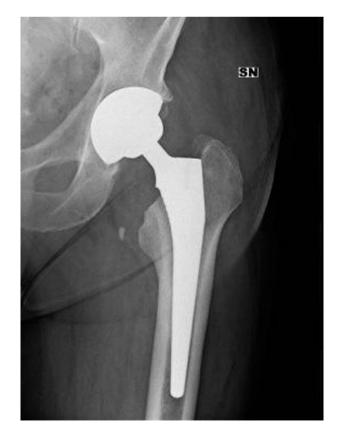
Figure 3. AP hip radiograph of the same patient 2 years after total uncemented total hip arthoplasty with a fully coated stem.
