C A S E R E P O R T

Intertrochanteric hip fracture in an arthrodesed hip treated by a LCP condylar plate

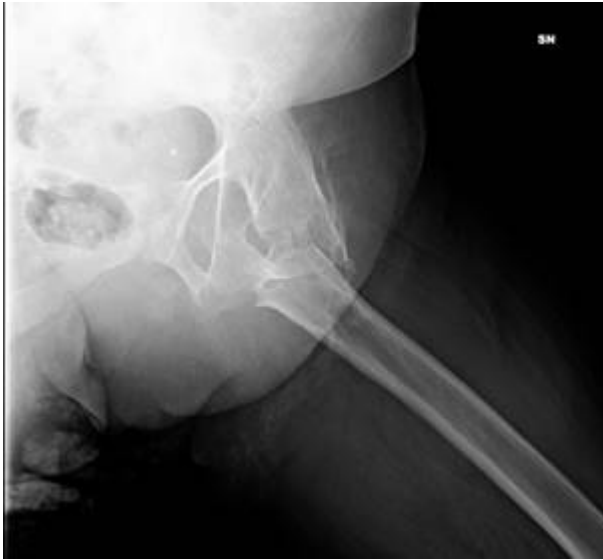
Figure 1. RX pre op in Emergency Room

X-rays showed an intertrochanteric fracture of the arthrodesed hip (Fig.1) and CT scan was performed to better investigate the location and the morphology of the fracture (Fig. 2-5). Based on the imaging, we planned to treat this fracture with a 4,5 LCP condylar plate of the contralateral side turned upside down.

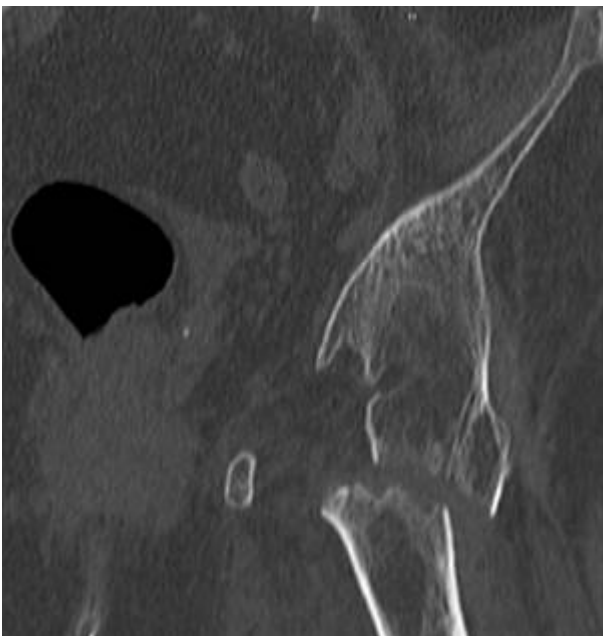
Figure 2. CT pre op in Emergency Room

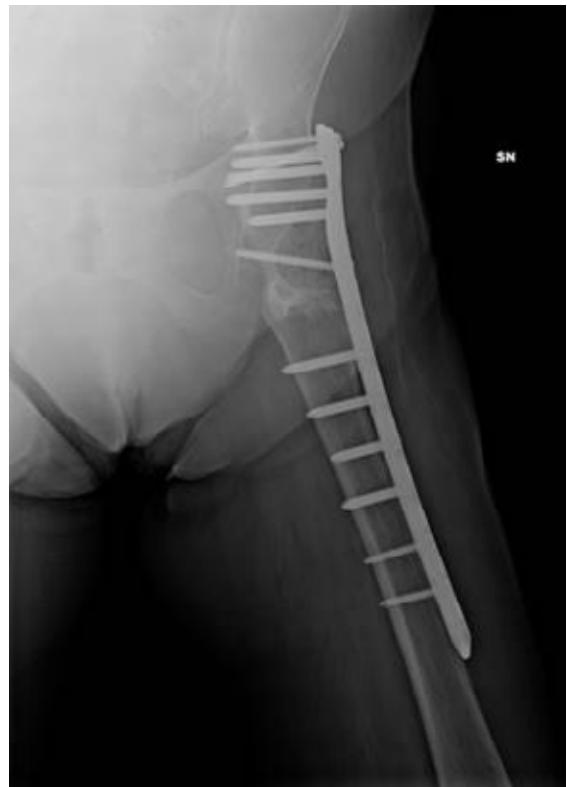
Figure 3. AP 6 months post op

At six months the fracture was completely healed, and the patient returned back to her preinjury level of function and autonomy.

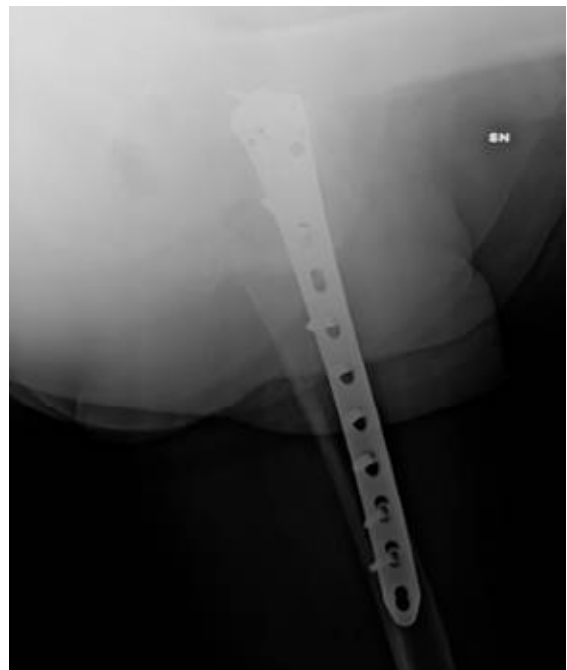
Figure 4. LL 6 months post op

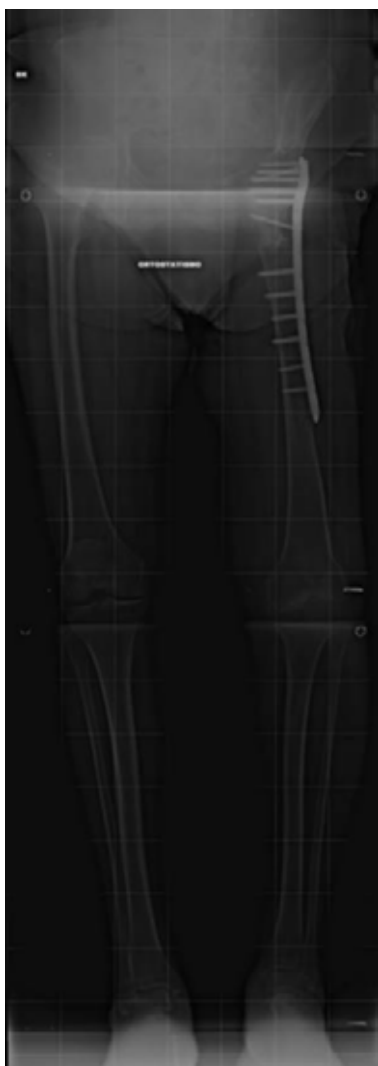
Figure 5. rx 18 months post op

X rays and clinical follow-up were carried out at 1 – 2 – 6 (Fig. 6, 7, 8) and 18 months (Fig. 9).
