# Weldability of Underwater Wet-Welded HSLA Steel: Effects of Electrode Hydrophobic Coatings

Jacek Tomków

Division of Welding Engineering, Faculty of Mechanical Engineering and Ship Technology, Gdańsk University of Technology, Gabriela Narutowicza 11/12, 80-233 Gdańsk, Poland; jacek.tomkow@pg.edu.pl

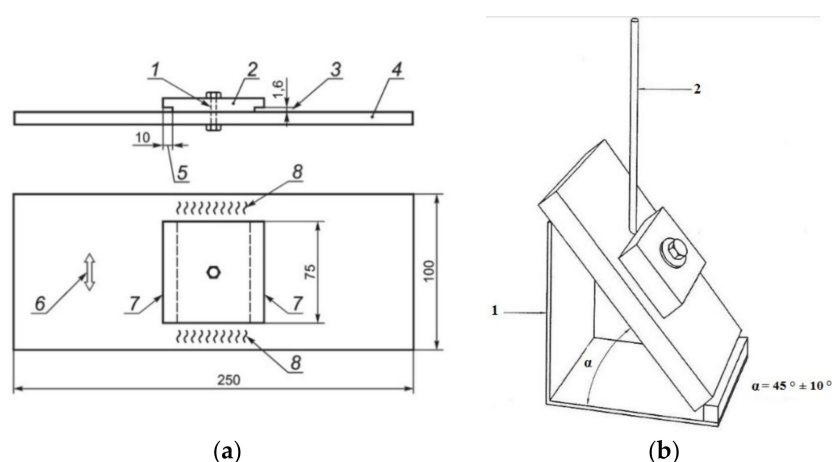
**Figure 1.** Control thermal severity (CTS) specimen: (a) scheme of CTS test; 1—hole 13 mm diameter, 2—top plate, 3—root notch gap, 4—bottom plate, 5—root notch depth, 6—rolling direction, 7—test welds, 8—anchor welds; (b) the location of the specimen during welding; 1—jig, 2—covered electrode.

For this research, the control thermal severity (CTS) test was selected, which resulted from the fact that fillet welds are the most commonly used in underwater-welded structures. Additionally, the CTS test assesses susceptibility to cold cracking in all regions of welded joints. A scheme of the CTS specimens is presented in Figure 1a. The specimen was housed in a special jig. The test welds were deposited symmetrically in the flat position (PA) in a single pass and in a single direction, across the full width of the block (Figure 1b).

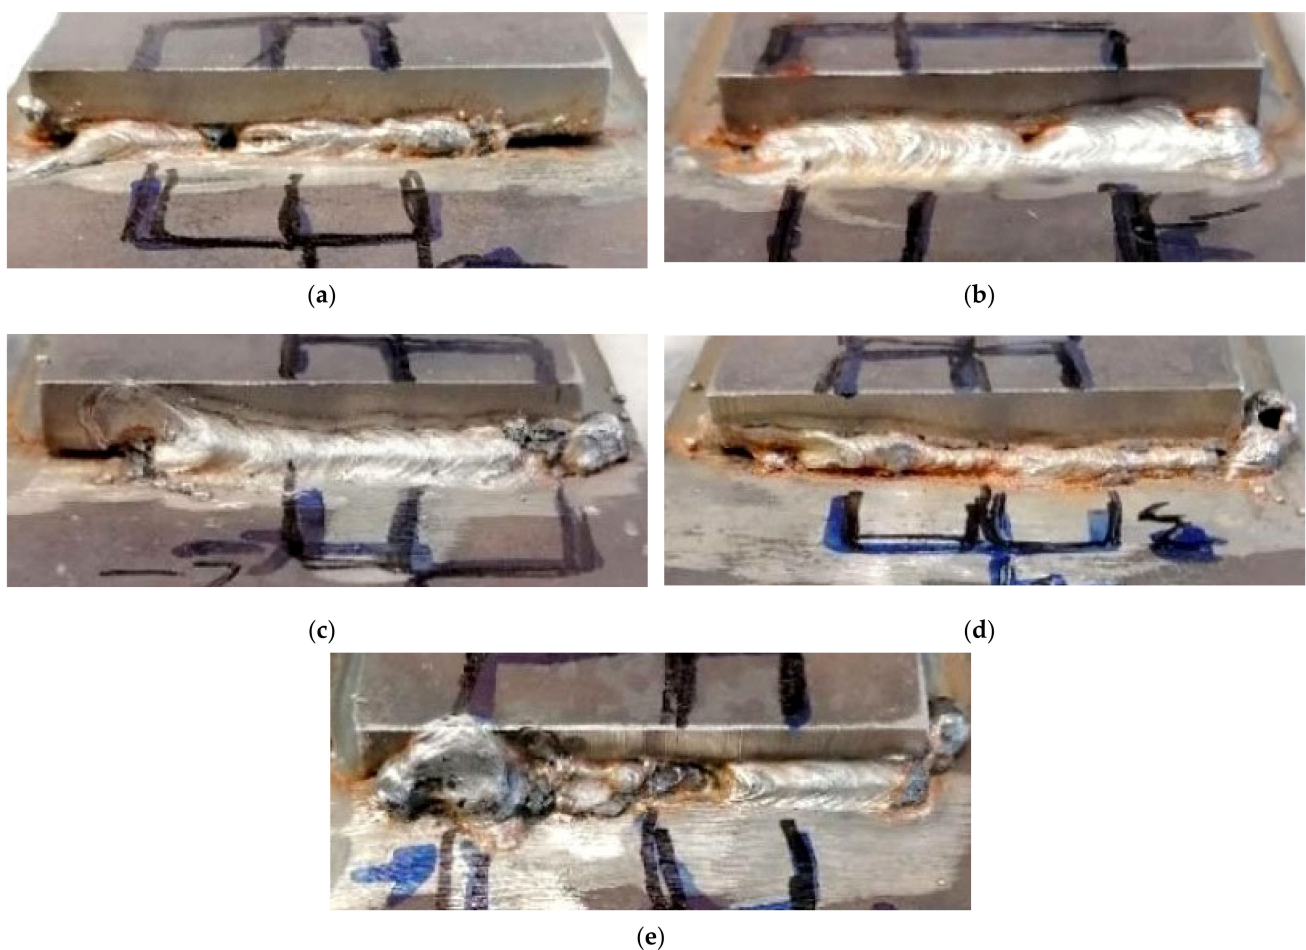
**Figure 2.** The exemplary results of the visual test (VT): (a) weld 1—specimen 1 (non-modified electrode), pores, weld length 60 mm; (b) weld 2—specimen 2 (underwater electrode), weld length 70 mm; (c) weld 1—specimen 3 (concrete impregnate), spatter, weld length 60 mm; (d) weld 2—specimen 4 (liquid foil), lack of fusion, undercuts, shape defects, weld length 70 mm; (e) weld 1—specimen 5 (paraffin wax), shape defects, pores, weld length 70 mm.

Exemplary photos of the VT are presented in Figure 2. The lines mark places identified for sample cutting in further investigations. The VT focused on the selection of cutting locations for further investigations, due to the fact that underwater wet welding in most cases is treated as a repair method. Our observations showed differences between specimens performed using electrodes with different surface coatings. Both test welds

in specimens 1 and 2 are characterized by their proper geometry. However, pores were observed in one weld in each specimen (Figure 2a,b). Welding of specimen 3 generated excessive spatter (Figure 2c), which was not observed for other specimens. The worst results were observed for the specimen welded using electrodes coated with liquid foil. The width of the weld was two-fold smaller than in other specimens. Additionally, a lack of fusion and undercuts was observed (Figure 2d). The biggest difference between two welds in the same specimen was observed for specimen 5. Weld 2 performed with higher heat input and was characterized by its proper geometry. Moreover, no imperfections were observed. The VT for weld 1 showed many imperfections, such as shape defects and pores, which started in the middle of the weld (Figure 2e). Guo et al. [49] proved that the heat input value is crucial to the quality of offshore welded steel joints. Additionally, in the author's previous investigations [25], it has been shown that higher heat input values lead to improvement of the quality of S460N steel wet-welded joints.

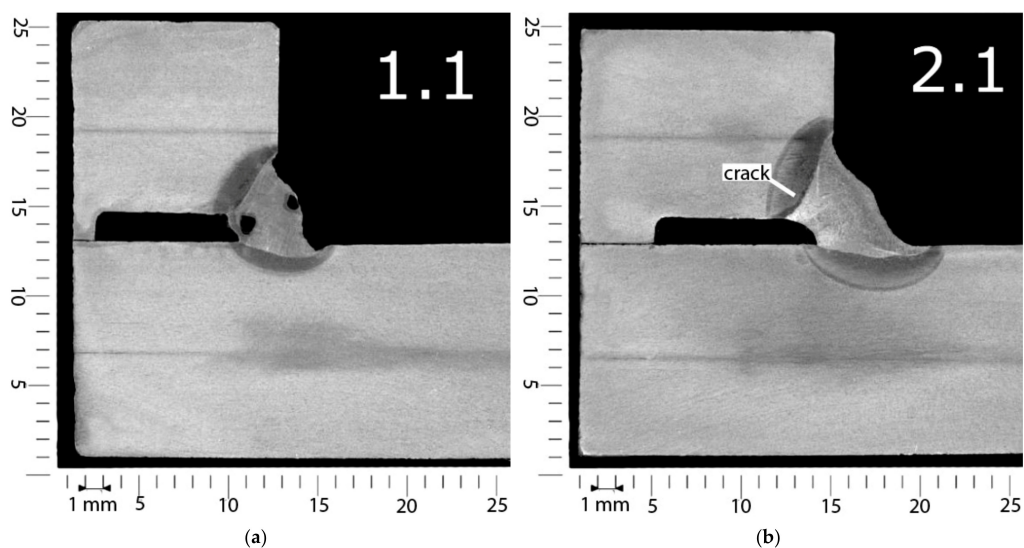
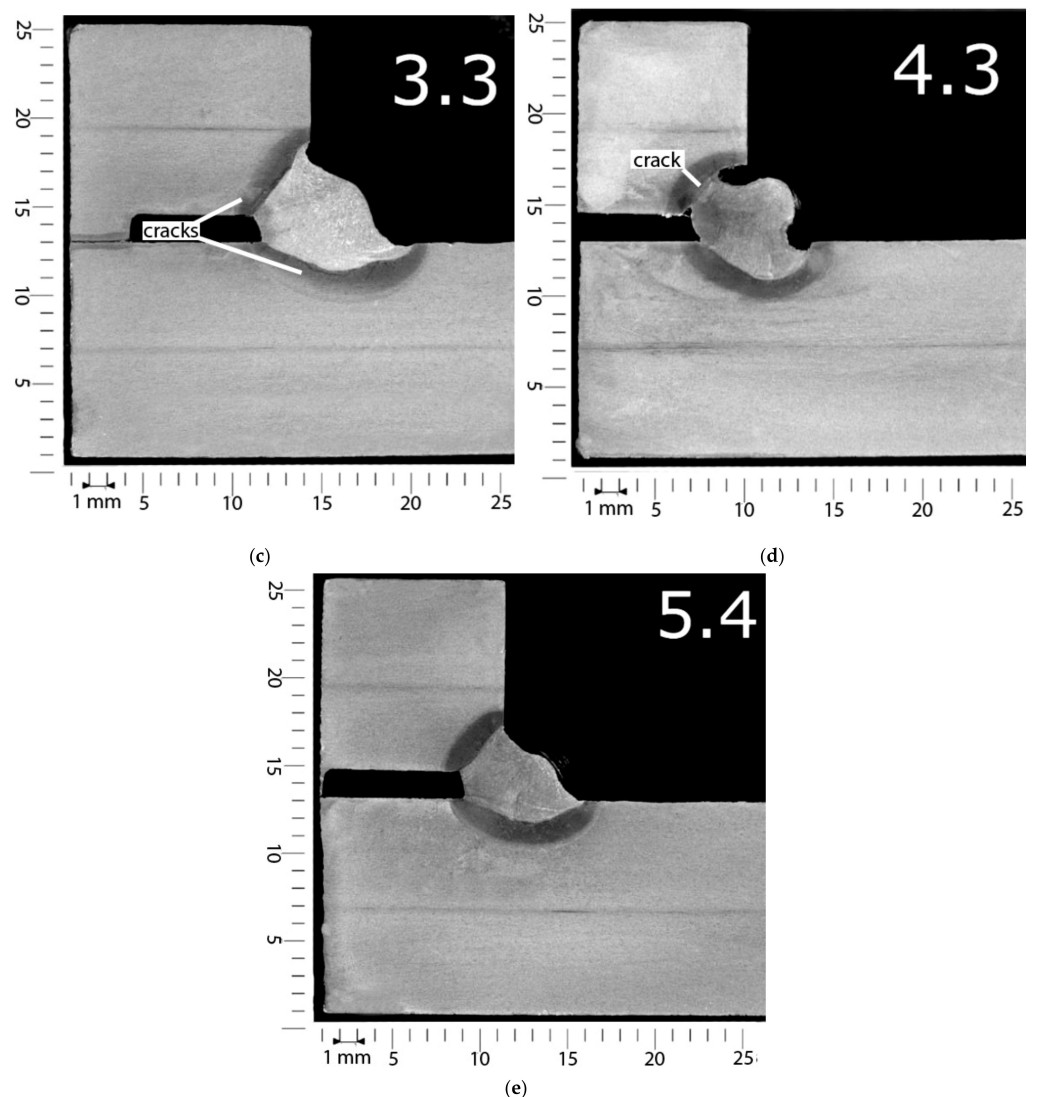
**Figure 3.** Exemplary results of macroscopic testing: (a) weld 1—specimen 1 (non-modified electrode), pores and undercuts; (b) weld 1—specimen 2 (underwater electrode), cracks in the heat-affected zone (HAZ); (c) weld 2—specimen 3 (concrete impregnate), cracks in the HAZ and undercuts; (d) weld 2—specimen 4 (liquid foil), cracks in the HAZ and deep undercuts; (e) weld 2—specimen 5 (paraffin wax), no imperfections.

Exemplary macroscopic photos are presented in Figure 3. The macroscopic observations also showed differences in specimens welded with different electrodes. Specimen 1, welded using non-modified electrodes, is characterized by the existence of porosity in the weld, which proved the results of VT (Figure 3a). Additionally, undercuts were observed. However, no cracks occurred. These cracks were observed in weld 1 (Figure 3b), which

was performed using underwater electrodes (specimen 2). These cracks were located in the HAZ, parallel to the fusion line. This location is characteristic of cold cracks occurring in wet welding conditions, as stated for the investigated S460N steel in previous investigations [39]. Cracks were observed in joints welded (specimen 3) using electrodes coated with concrete impregnate (Figure 3c). These cracks were longer and wider than in specimen 2. Additionally, small undercuts occurred in two welds of this specimen. The biggest imperfections were observed in specimen 4, performed with the use of liquid-foil-coated electrodes. The quality of both welds was poor, with cracks and deep undercuts observed in each cross-section (Figure 3d). The macroscopic observations of specimen 5 showed no imperfections in three out of four observed cross-sections (Figure 3e). The last cross-section was cut from locations characterized by many imperfections (Figure 2e), so the macroscopic test confirmed the poor quality of the joint in this location.

Macroscopic tests showed the presence of many imperfections in all welded joints, which is typical for underwater conditions [5,7,9]. The most often observed were undercuts and cracks. Garg et al. [50] stated that increasing the cooling rate results in an increasing number of undercuts in electric welded joints. The high cooling rate in wet welding conditions leads to the presence of undercuts in all specimens. The macroscopic tests of CTS specimens showed differences in comparison to the pad weld observations performed in previous investigations [39]. No cracks were observed for pad welds. The presence of cold cracks in joints with filled welds resulted from the different thermal conditions. These differences are connected to the different shapes of the specimens and the presence of notches in CTS samples [42].

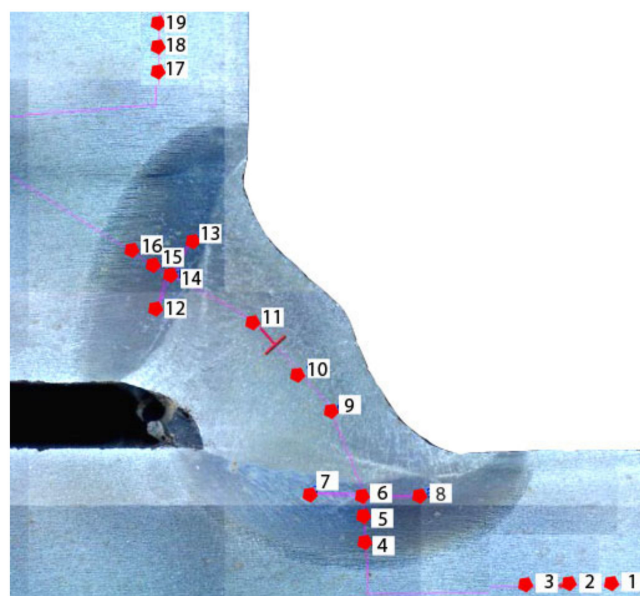
**Figure 4.** The distribution of measurement points.

Hardness measurements were performed in one cross-section from the test weld at 19 points: 3 in the weld metal, 6 in the BM, and 10 in the HAZ (5 in each side of the joint). A schematic of the distribution of the measurement points is presented in Figure 4.

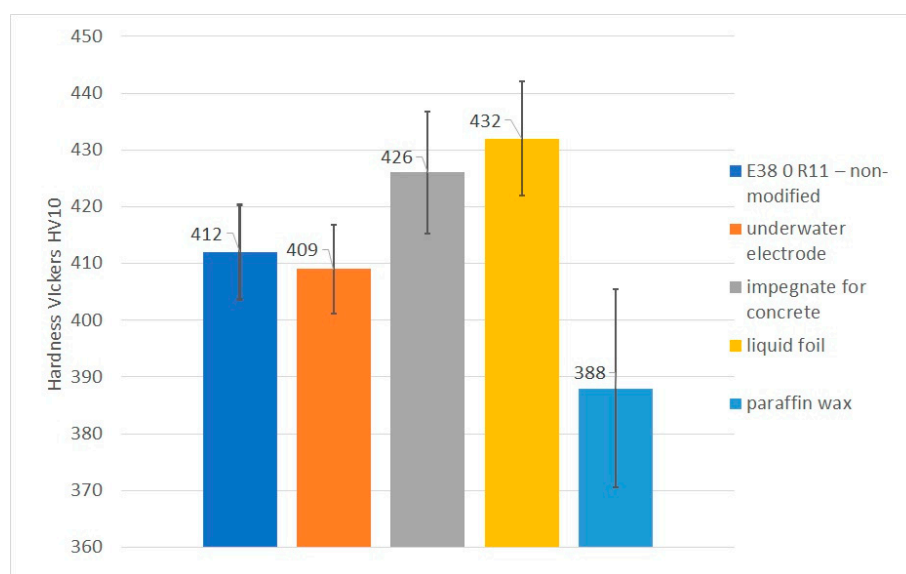
**Figure 5.** The average HV10 hardness values in the HAZ.

Hardness measurements showed that the HAZ hardness values in specimen 1 (non-modified electrode) and specimen 2 (underwater electrode) were similar, with both being in the range of 400–430 HV10. Previous investigations performed for pad welds [39] showed that the average hardness for non-modified electrodes was 479 HV10 and for underwater electrodes was 472 HV10. This resulted from the greater dilution in pad welds than in welded joints with fillet welds, as stated in the literature by Sun et al. [52]. The same differences between pad welds and CTS specimens were observed for other specimens welded using different electrodes. Additionally, it was observed that usage of concrete impregnate and liquid foil resulted in increased hardness. The hardness of specimen 3 increased to 448 HV 10, while that of specimen 4 increased to 454 HV 10. The measurements of specimen 5, which was welded with electrodes, confirmed the results of previous experiments [39]. The hardness in the HAZ of the joint welded using an electrode with paraffin was significantly lower. Moreover, some measurements were lower than 380 HV10, which is minimum value required for joints welded in air. It had been proven previously [25] that higher-quality S460N steel joints are characterized by lower HAZ hardness. The same effect was observed in the presented investigations. Previous investigations [39] showed that high HAZ hardness could be observed in structures characterized by the presence of a greater number of cold cracks. This suggests that the different hydrophobic coatings investigated in this paper may result in differing susceptibility of HSLA steels to cold cracks. The Vickers HV10 hardness measurement results are listed in Table 5. Values higher than 380 HV10 are shown in bold. It was proven that paraffin wax as a coating on covered electrodes provides significantly decreases the hardness in the HAZ. The average hardness was higher than 380 HV10, however that value is recommended for air welding, in which the cooling rate is much lower than in wet welding. A graphical comparison of average HAZ hardness values is presented in Figure 5.

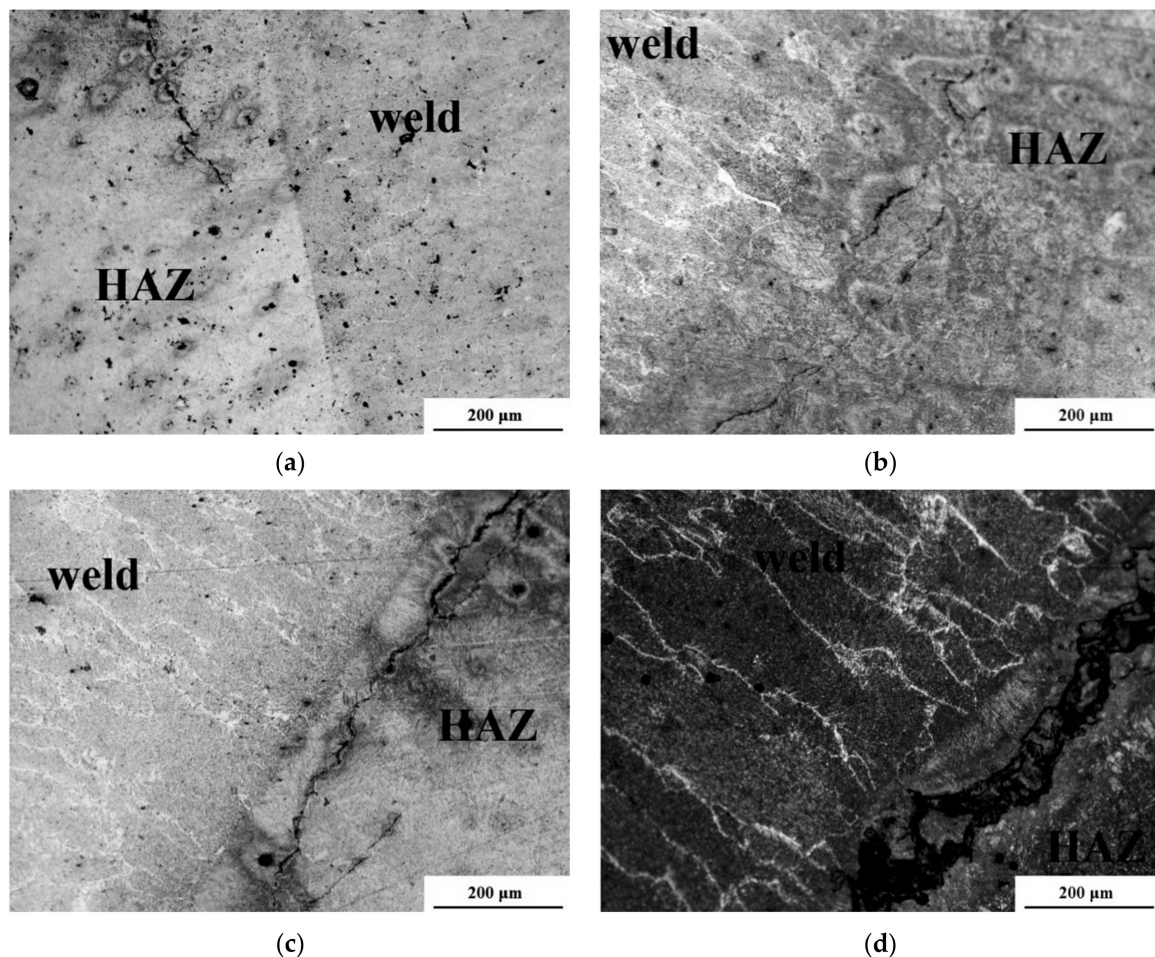
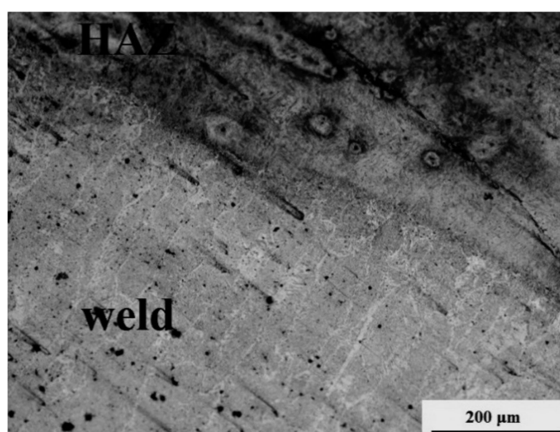
**Figure 6.** Optical micrographs of: (a) specimen 1 (non-modified electrode); (b) specimen 2 (underwater electrode); (c) scheme 3 (concrete impregnate); (d) specimen 4 (liquid foil); (e) specimen 5 (paraffin wax).

The microstructures are shown in Figure 6. The main aim of the microscopic test was to evaluate the specimens for the occurrence of cold cracks. It had been proven in previous investigations [39] that the use of electrodes coated with concrete impregnate and liquid foil generated 85–95 mL/100 g diffusible hydrogen in deposited metal. In comparison, the non-modified electrode generated 75 and the underwater electrode 65 mL/100 g diffusible hydrogen. However, the use of paraffin wax decreased the hydrogenation below 50 mL/100 g diffusible hydrogen. These results and the hardness measurements presented in Section 3.3 suggest differences in specimens welded with different filler materials. From each specimen, four cross-sections were observed in the HAZ and in the weld metal. Each joint was characterized by typical microstructures for the underwater-welded HSLA joints [5,9,25]. The weld metal presented a dendritic structure. The HAZ consists of brittle structures such as martensite and bainite. There were no significant microstructural differences in specimens 1–4. In specimen 5, the dimension of coarse-grained martensite area in HAZ was the lowest. Microscopic observations of specimen 1, which was welded with non-modified electrodes, showed long cracks in the HAZ running parallel to the fusion line along 30–40% of its length. (Figure 6a). Additionally, short cracks were found in the weld metal. Lower numbers of cracks were observed in the HAZ of the specimen welded using underwater electrodes (Figure 6b). These cracks ran through 15–20% of the fusion line length. Both specimens were characterized by similar hardness in the HAZ. The differences in the number of cracks resulted from different hydrogen amounts in the deposited metal [38]. No cracks were found in the weld metal. Microscopic tests showed that concrete impregnate as an electrode coating leads to increased numbers of cracks, both in the HAZ and the weld metal (Figure 6c). HAZ cracks ran parallel and vertical

to the fusion line. They started in the weld root and propagated along 70–80% of the fusion line length. The worst results were found during observations of test welds in specimen 4 (Figure 6d). Cracks in the HAZ were wide and long (90–100% of the fusion line length). However, the number of cracks in the weld was smaller than in specimen 3. It can be stated that liquid foil and concrete impregnate cannot be used as protective coatings during wet welding of HSLA steels. Microscopic testing of the specimen welded using electrodes coated with paraffin wax showed much different results than for other hydrophobic substances. No cracks were found in the weld metal. In the HAZ, only one short crack running parallel to the fusion line was found (Figure 6e). Microscopic observations proved that cold cracks occurred in wet-welded joints. A number of cold cracks resulted from the presence of brittle structures in the HAZ, characterized by high hardness, with the highest amount of diffusible hydrogen in the deposited metal [39]. It was also proven that HSLA steels are materials in which the high cooling rate leads to creation of the brittle martensitic microstructure [53].
