Original Article

Biomechanical evaluation of the impact of collared cementless total hip arthroplasty stems on implant subsidence: a cadaveric study in German Shepherd

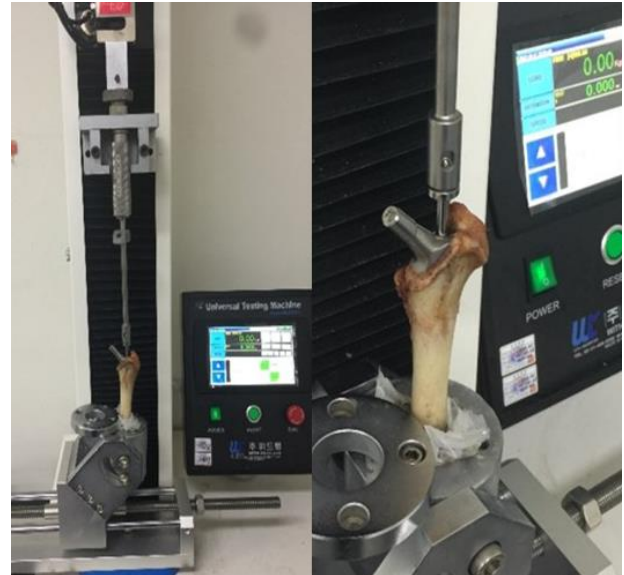
Fig. 1: Images of the yield and failure loading testing of a collarless BFX stem during 5-mm subsidence. After the distal femur was potted in the load frame with polymethyl-methacrylate following osteotomy, the load was applied to the femoral stem parallel to the longitudinal axis of the femur

The specimen constructs were mounted to the loading frame of the testing machine (WL2100C, Withlab Co., Ltd., Kyunggi do, Korea) with the long axis of the femur placed parallel to the long axis of the testing machine. To secure the femur, the distal femur was potted in the loading frame with PMMA. An impactor handle and head were used to transfer the load to the femoral stem parallel to the longitudinal axis of the femur. Compressive loading stopped on each femur when the stem subsided 5 mm (Fig. 1) based on the load-displacement curve. The load applied was recorded for all specimens. During the 5-mm stem subsidence, the specimens were loaded to subside in a single axial load at a rate of 500 N/s (Buks *et al.*, 2016). Load and stem displacement data acquired during the tests were used to generate load-displacement curves for obtaining yield/failure data for each specimen construct using the WL2100C testing software (Withlab Co., Ltd., Kyunggi do, Korea). The curves and data were used to quantify the following structural construct properties: stiffness (the slope of the linear region of the load-displacement curve), yield (the initiation of curve nonlinearity), and failure (the point of maximum load before the construct no longer sustained load). Yield and failure energies were calculated as the areas under the load-displacement curves to the respective points.
