Repair Bond Strength of Composite to Zirconia Ceramic Using Two Types of Zirconia Primers

Article type:
Original Article

Objectives: This study aimed to assess the effect of application of two types of zirconia primers on repair bond strength of composite to zirconia ceramic.

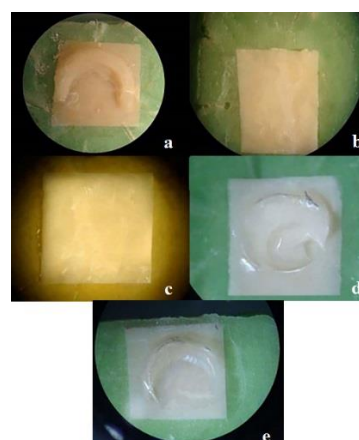
**Fig. 1.** Modes of failure under a stereomicroscope at x20 magnification: (a) mixed failure in ZPP; (b) adhesive failure in MB; (c) adhesive failure in PBR; (d) cohesive failure in ZPP+PBR; (e) mixed failure in MBP+PBR

Figure 1 shows different modes of failure in different groups under a stereomicroscope at x20 magnification. SEM micrographs revealed mixed failure in both samples of ZPP group (Figure 2). Both samples randomly selected from MBP group showed adhesive failure (Figure 3).

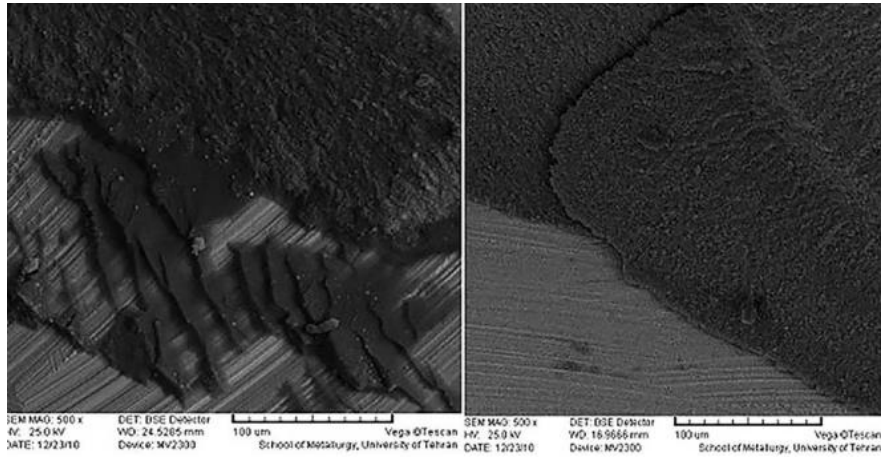
Fig. 2. Mixed failure in both samples randomly selected from ZPP group

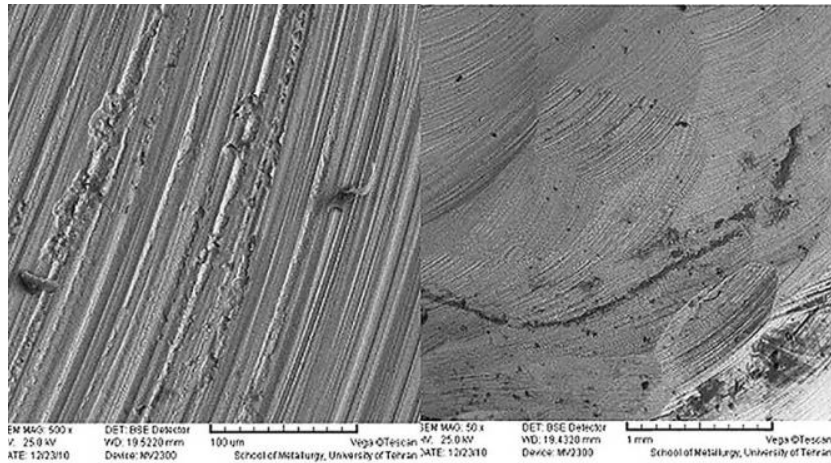
Fig. 3. Adhesive failure in both samples randomly selected from MBP group

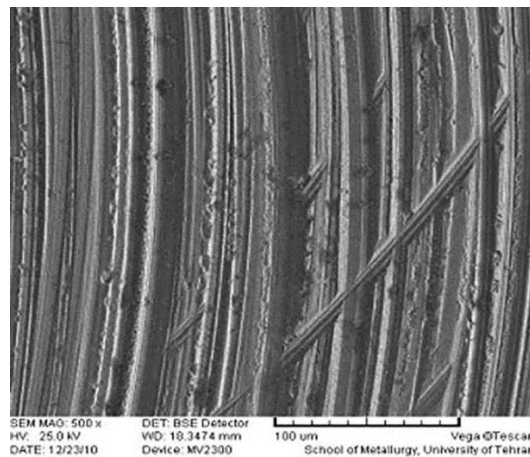
Fig. 4. Adhesive failure in both samples randomly selected from PBR group

Both samples randomly selected from PBR group also showed adhesive failure (Figure 4). Of the two samples selected from ZPP+PBR group, one sample showed mixed (Figure 5a) and the other showed cohesive failure (Figure 5b). Mixed failure was noted in both samples randomly selected from MBP+PBR group (Figure 6).

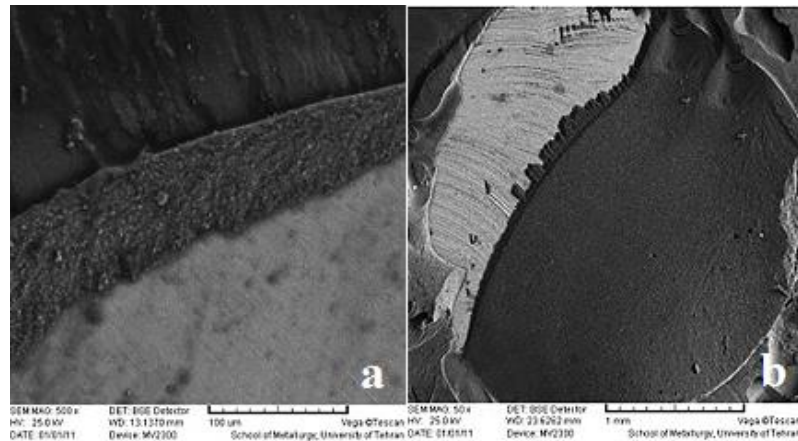
Fig. 5. Mixed failure (a) and cohesive failure (b) in samples randomly selected from ZPP+PBR group

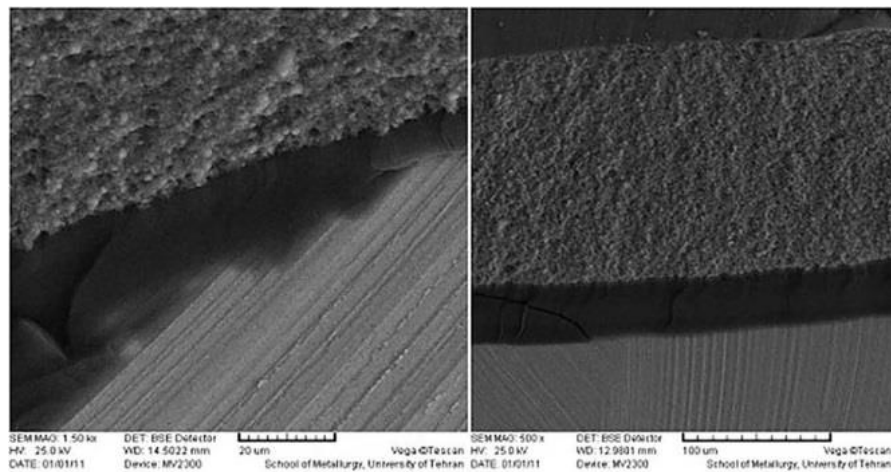
Fig. 6. Mixed failure in both samples randomly selected from MBP+PBR group
