# Stress Analysis on Mesiolingual Cavity of Endodontically Treated Molar Restored Using Bidirectional Fiber-Reinforced Composite (Wallpapering Technique)

**Purpose:** This research is to determine the stress distribution of a fiber-reinforced composite made of polyethylene and e-glass on the mesiolingual cavity of ETT.

**Materials and Methods:** A three-dimensional model of the mandibular molar was prepared for cavity preparation and the formation of restorations using SolidWorks 2021. The models were analyzed with Abaqus 2020 to determine stress concentrations after given vertical and oblique loading.

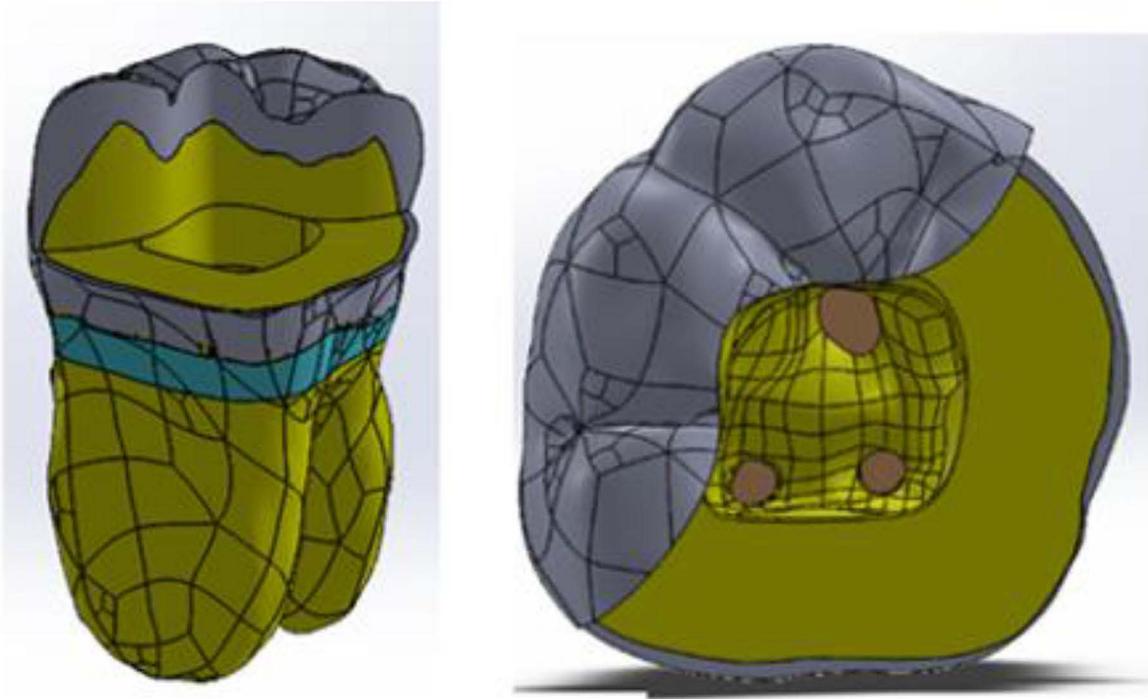
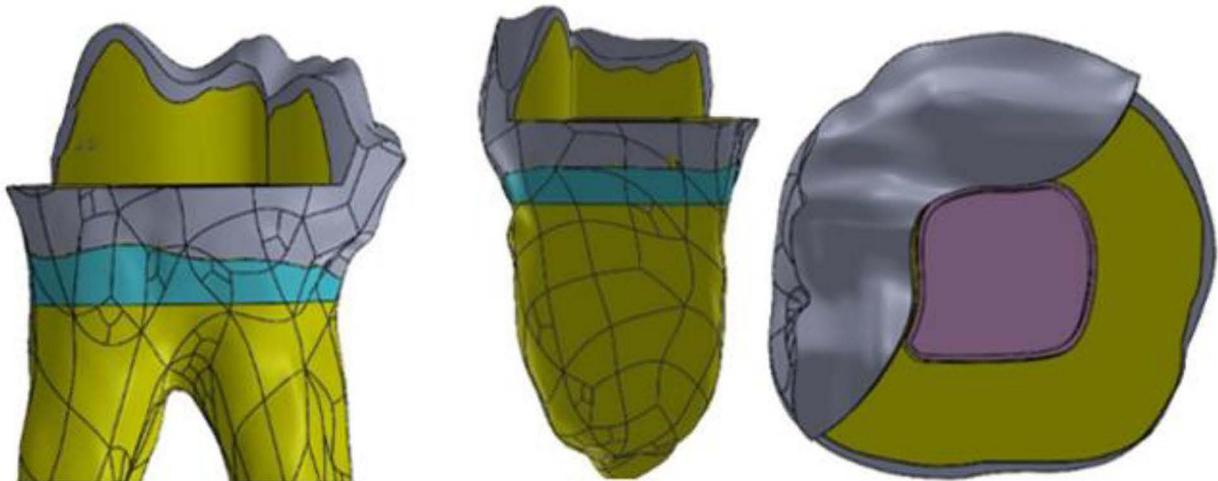
**Figure 1** (A) Non cuspal coverage and (B) cuspal coverage cavity design.

Finite element analysis is conducted by using Abaqus 2020 to obtain the data. The research material was a three-dimensional (3D) solid model of the mandibular right first molar. A 3D Model was obtained by following several procedures. First, the tooth was scanned using the Micro-CT (computerized tomography) scanner. Then, the results were processed using software to create a proper 3D model. The processes include point cloud data reduction and imperfection cleaning to prevent misinterpretation. After the modifications were completed, the 3D solid model was generated from the point cloud data and imported into 3D Modeling Software for further preparation. The components of the 3D solid model of a molar tooth have been prepared for root canal treatment, consisting of enamel, dentin enamel junction (DEJ), dentin, cemento-enamel junction, cementum, gutta-percha, periodontal membrane, alveolar bone, and smart dentin replacement (SDR) flowable composite. The cavity was modified using SolidWorks 2021, and the criteria for cavity design on the lower molar were prepared without mesial and lingual walls listed in [Table 1](#). The subject of research was divided into non-cuspal coverage ([Figure 1A](#)) and cuspal coverage ([Figure 1B](#)). The restoration was built using the

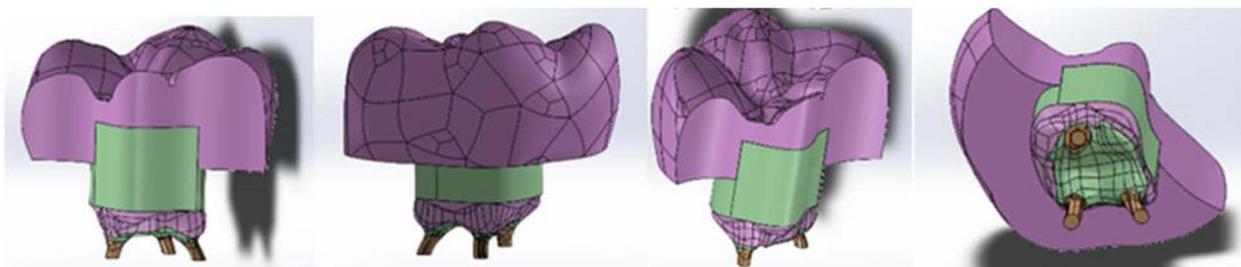
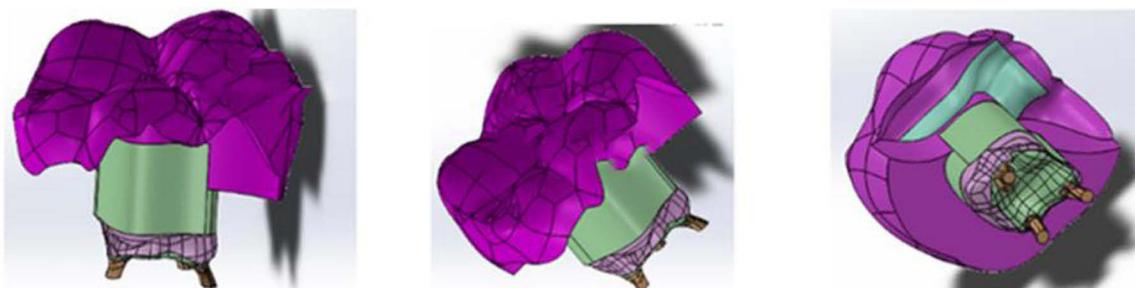
**Figure 2** Components of 3D direct restoration reinforced fiber composite (A) non-cuspal coverage and (B) cuspal coverage.

wallpapering technique, and the materials used are listed in [Table 2](#). The fiber-reinforced composite restoration that has been applied can be seen in [Figure 2](#). The types of fiber materials used are polyethylene fiber and e-glass fiber.

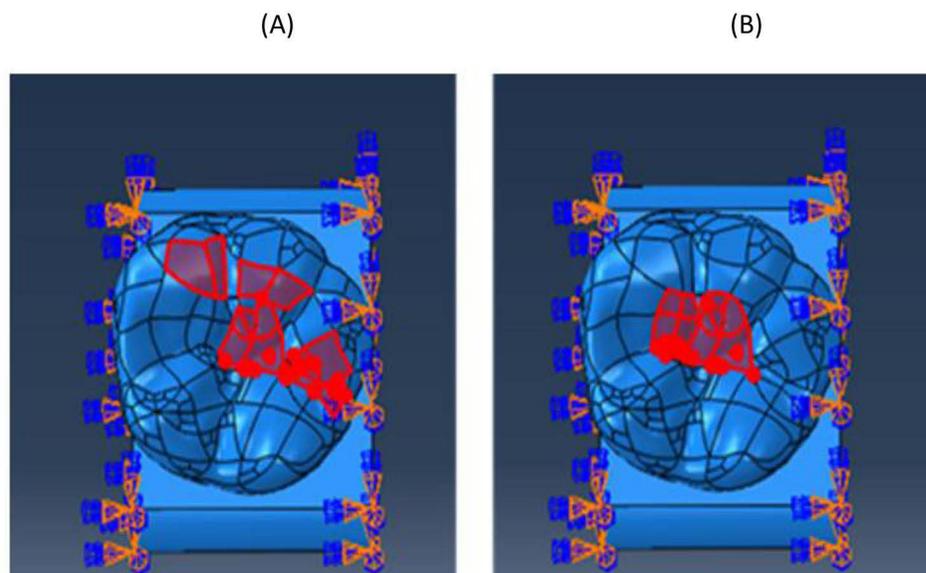
**Figure 3** The loading zone (A) vertical force and (B) oblique force are represented by the red region.

The tooth model was assumed to be homogeneous, linear elastic, and isotropic, while the fiber component was considered orthotropic. The surface-based cohesive interaction was given to the interaction between the tooth and the restoration. The interaction of layers that are not perfectly adhered was given material properties consisting of shear bond strength and tensile bond strength using a self-etch adhesive system. The modulus elasticity of the hybrid layer model was 11,765 MPa and thickness was 5  $\mu\text{m}$ .<sup>25</sup> Two loading conditions applied to the occlusal surface were 720 Newton (N) of vertical force and 200 N of oblique force at a 45° angle (Figure 3).

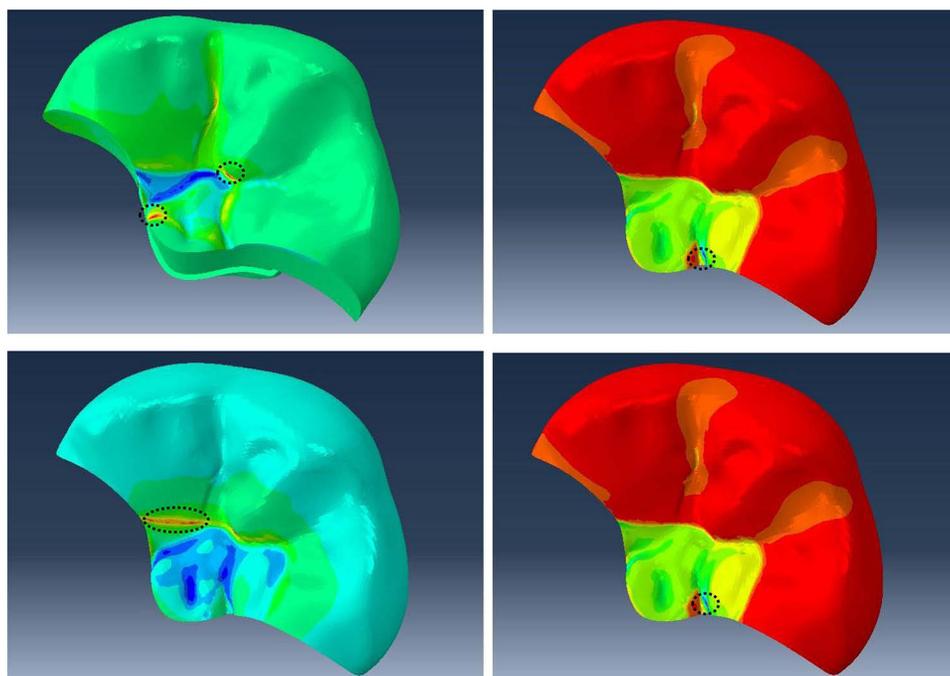
**Figure 4** The black dashed circles is the location of high-stress concentration on a fiber-reinforced composite of polyethylene non-cuspal coverage (PNCC). The red area is the maximum principal stress on the surface of the restoration when a vertical force (above) and an oblique force (below). The blue area is the minimum principal stress on the surface of the restoration when a vertical (above) and an oblique force (below).

Figure 4 shows the location of high stress on a fiber-reinforced composite of polyethylene non-cuspal coverage (PNCC). The maximum principal stress and minimum principal stress occur on the fissure when vertical loading (upper) and oblique loading (below) are applied. Sharp angles and narrow curvatures within fissure systems have the potential to produce stress concentration and crack initiation. Figure 6 illustrates this as well. On a fiber-reinforced composite with polyethylene cuspal coverage (PCC), the high-stress concentration was located on the fissure; nonetheless, failure has not occurred because the maximum and minimum principal stress do not exceed the material strength (Table 7).

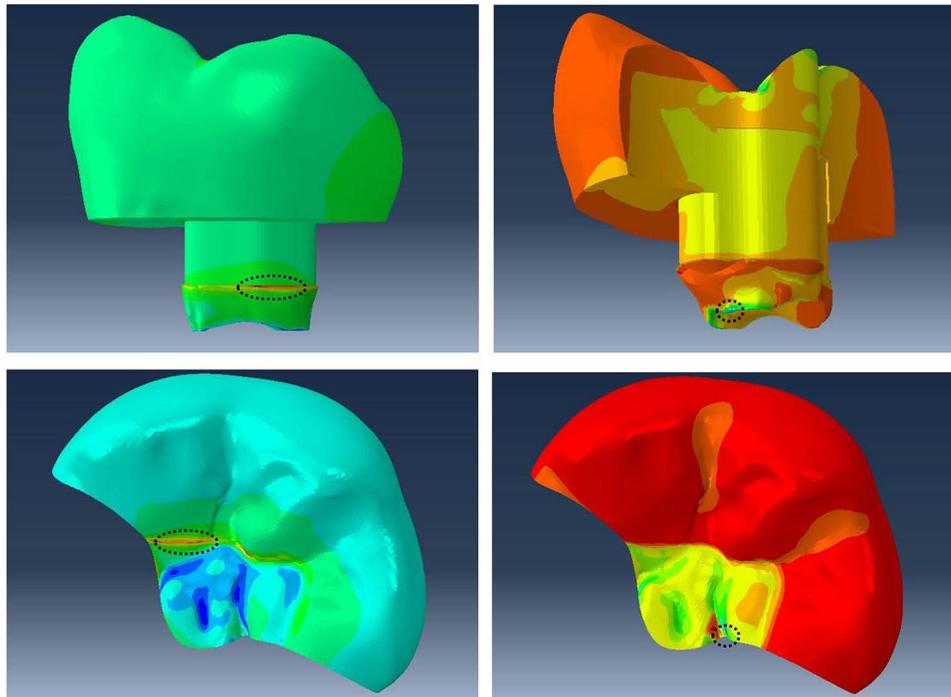
**Figure 5** The black dashed circles is the location of high-stress concentration on a fiber-reinforced composite of e-glass fiber non-cuspal coverage (ENCC). The red area is the maximum principal stress on the surface of the restoration when a vertical force (above) and an oblique force (below). The blue area is the minimum principal stress on the surface of the restoration when a vertical (above) and an oblique force (below).

Figure 5 shows the location of high-stress concentration on a fiber-reinforced composite of e-glass fiber non-cuspal coverage (ENCC). The stress location occurs on the circumferential fiber, base fiber, and fissure. A failure occurred on the circumferential fiber due to the maximum principal stress exceeding the tensile strength of the fiber component (Table 6) when vertical force was applied. A failure also occurred on base fiber due to the maximum and minimum principal stress exceeding the material strength when vertical force was applied, and when oblique forces were applied, failure occurred due to the maximum principal stress exceeding the tensile strength of e-glass fiber (Table 6).

The failure occurred on the base and circumferential structure of e-glass fiber reinforced composite (Figures 5 and 7) when vertical force was due to tensile and compressive stress, while oblique force was applied due to tensile forces. In circumferential fiber failure occurs when vertical force due to tensile force results in stress concentration that exceeds the strength of the material. Restoration materials should have a modulus of elasticity similar to dentin (17.8 GPa) to create a homogeneous stress distribution and reduce the incidence of root fracture.<sup>7,12,40,41</sup> The results showed the stress concentration on polyethylene fiber-reinforced composite restorations did not exceed the strength of the materials. E-glass fiber has an elastic modulus of 8.87 GPa. Composite and polyethylene fiber has elastic modulus close to dentin 20.4 GPa and 23.6 GPa. Yamanel et al investigated the materials that had a high modulus of elasticity which tended to concentrate more stress within the restoration, whereas materials that had a low modulus of elasticity tended to transfer more stress to the tooth structure affected a greater risk of fracture.<sup>42-44</sup> Materials had a lower modulus of elasticity experienced greater strain when a force was applied.<sup>33</sup>

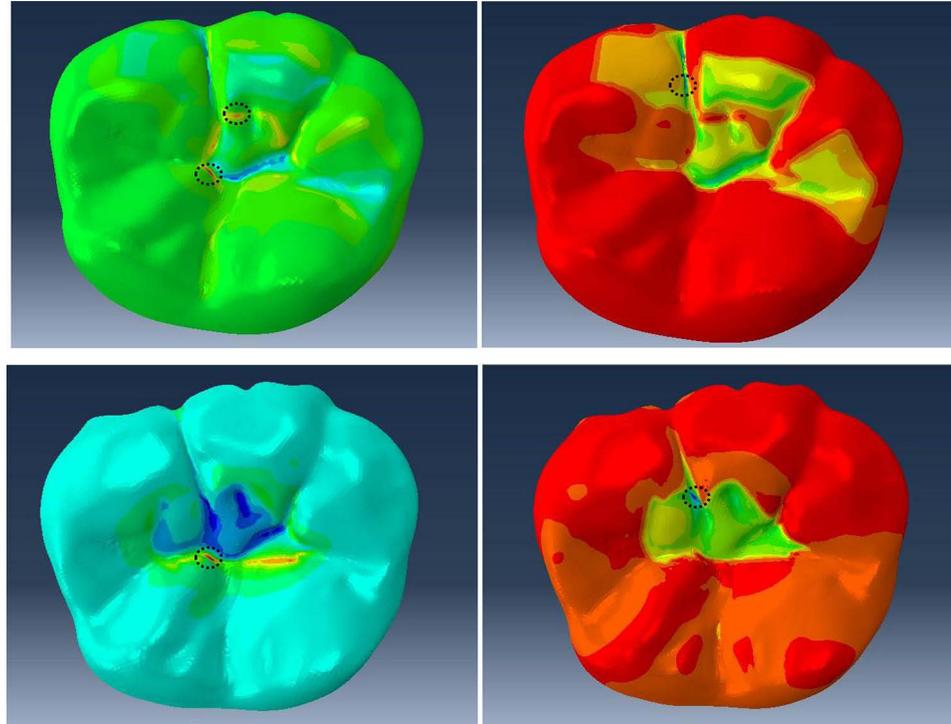
**Figure 6** The black dashed circles is the location of high-stress concentration on a fiber-reinforced composite of polyethylene cuspal coverage (PCC). The red area is the maximum principal stress on the surface of the restoration when a vertical force (above) and an oblique force (below). The blue area is the minimum principal stress on the surface of the restoration when a vertical (above) and an oblique force (below).

Stress distribution on tooth structure and restoration when vertical and lateral forces were applied are shown in Figures 4–7. Stress concentrations of restoration occurred on the distolingual cusp, marginal ridge distal, occlusal groove, and CEJ. However, in this area, there is no failure because the strength of the material is greater than the maximum principal stress and minimum principal stress. Structural failure was seen in e-glass fiber. Failure occurred on the base and circumferential fiber, whereas on the cuspal coverage group occurred at the base fiber because of compressive stress.

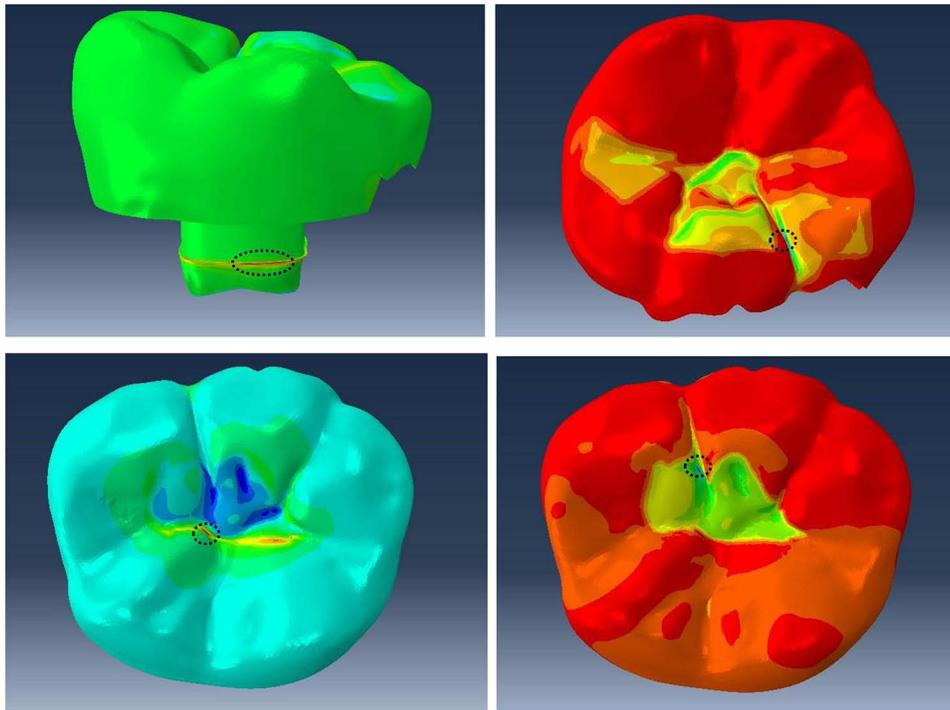
**Figure 7** The black dashed circles is the location of high-stress concentration on a fiber reinforced composite of e-glass fiber cuspal coverage (ECC). The red area is the maximum principal stress on the surface of the restoration when a vertical force (above) and an oblique force (below). The blue area is the minimum principal stress on the surface of the restoration when a vertical (above) and an oblique force (below).

Figure 7 shows the location of high-stress concentration on a fiber-reinforced composite of e-glass fiber cuspal coverage (ECC) occurs on the fissure and base fiber. The failure occurred on the base fiber when vertical force was applied due to the minimum principal stress exceeding the compressive strength of the fiber (Table 8).

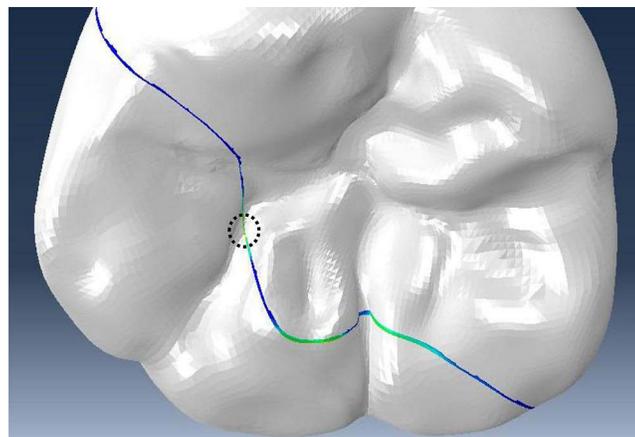
**Figure 8** Shows where high-stress concentrations are found on the PNCC interfacial surface. The restoration underwent a debonding initiation, as indicated by the dashed black circle, wherein the contact stress ratio reached a value of 1 at the enamel fissure.

Based on Equation (1), debonding initiation will occur if the contact stress ratio reaches a value of 1. **Figure 8** shows the location of high-stress concentrations in the interfacial surface of PNCC. The failure occurred on the enamel surface when vertical force was applied (**Table 9**), thus debonding between tooth and restoration. **Figure 9** shows the location of

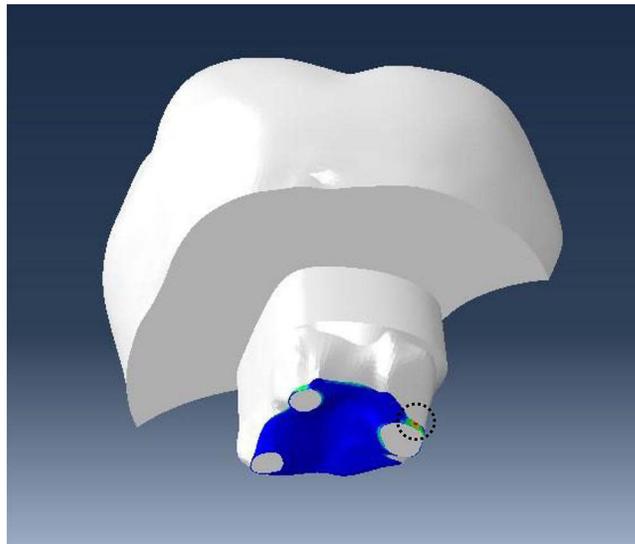
**Figure 9** Shows where high-stress concentrations are found on the ENCC interfacial surface. The restoration underwent a debonding initiation, as indicated with the dashed black circle, wherein the contact stress ratio reached a value of 1 at the distal region on the base fiber.

high-stress concentrations in the interfacial surface of ENCC, debonding between teeth and restoration occurred on the base fiber when oblique force was applied (Table 9). Figure 10 shows the stress location on the interfacial surface of PCC. Debonding occurred on the enamel surface when vertical loading was applied (Table 9). Figure 11 shows the stress location on the interfacial surface of ECC. Debonding occurs on the base surface when vertical and oblique forces are applied.

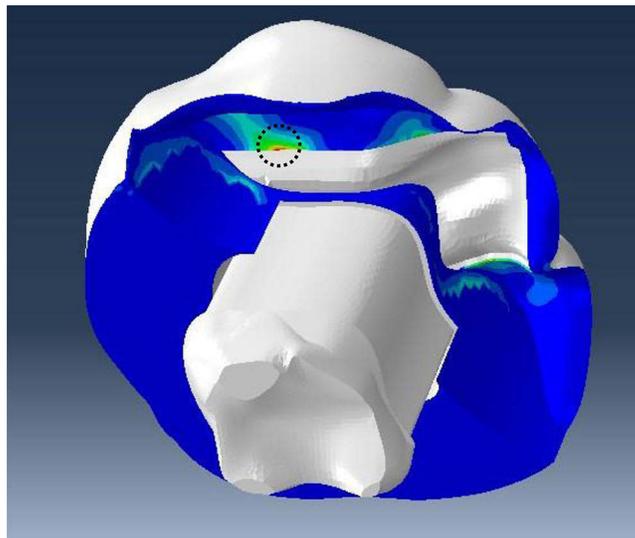
**Figure 10** Shows where high-stress concentrations are found on the PCC interfacial surface. The restoration underwent a debonding initiation, as indicated with the dashed black circle, wherein the contact stress ratio reached a value of 1 at the fiber occlusal between the enamel and the restoration.

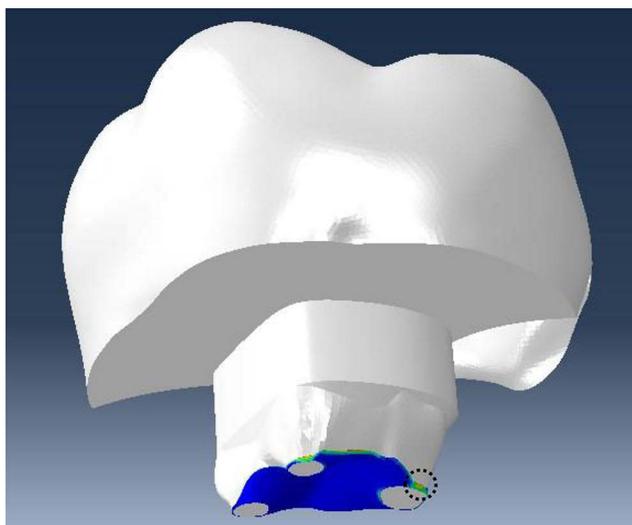
**Figure 11** Shows where high-stress concentrations are found on the ECC interfacial surface. The restoration underwent a debonding initiation, as indicated with the dashed black circle, wherein the contact stress ratio reached a value of 1 at the distal region on the base fiber.
