Case Report

Traumatic Cochlear Implant Electrode Extrusion: Considerations, Management, and Outcome

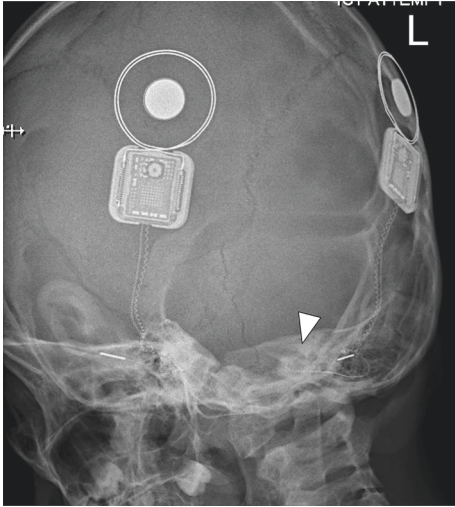
FIGURE 1: Lateral skull X-ray after trauma. The arrowhead points to the electrode which is curled in a 200-degree position. Comparing this with Figure 2 shows obvious migration of the electrode.

The patient was admitted for further evaluation. Neural response telemetry (NRT) performed showed 2 functioning midsection electrodes and normal impedance. Skull X-rays (Figure 1) showed displacement of the left implant electrode when compared to the post-CI X-ray (Figure 2). Computed tomography (CT) of the temporal bone showed ten of 22 electrodes out of the cochlear (Figure 3). The rest of the electrodes were in the basal turn with a few in the middle turn. Integrity testing of the implant was performed and indicated a normal functioning implant. Mapping was readjusted, and eight electrodes were switched off. The

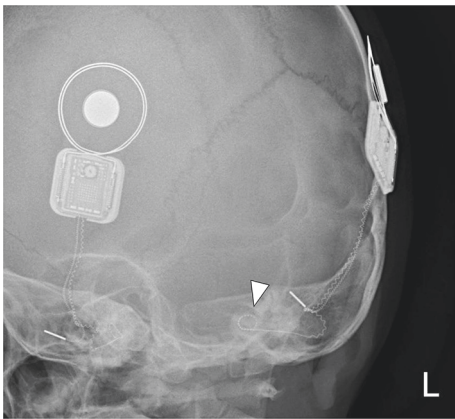
FIGURE 2: Lateral skull X-ray after initial cochlear implantation. The arrowhead points to the electrode which is curled in a 360-degree position, indicating its position in the basal and middle turn.

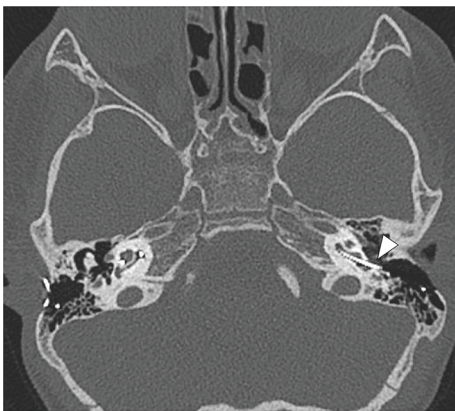
FIGURE 3: Computed tomography scan of the temporal bone with the arrowhead pointing to the electrodes outside the cochlear.

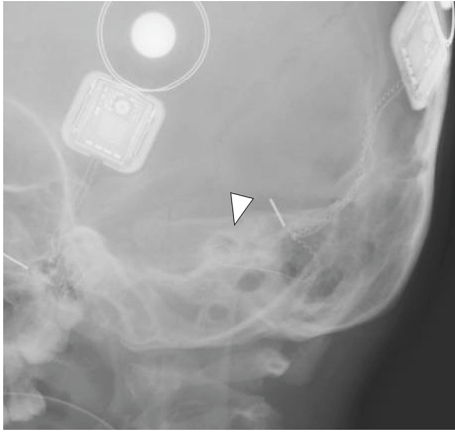
FIGURE 4: This is an intraoperative lateral skull X-ray taken after the electrode was advanced. The electrode resumed a similar position to Figure 2.

The patient was given the option of keeping the implant in the new position or undergoing surgical exploration and possible reinsertion of the implant. They decided on surgery, and this was performed 54 days after the date of injury. The patient underwent left revision mastoidectomy, exploratory tympanotomy, and reinsertion of CI under general anaesthesia. Intraoperatively, we found adhesions in the tympanic cavity around the electrode, which was partially extruded with both white markings in the tympanic cavity. The posterior tympanotomy appeared widened, suggesting shearing forces in this region leading to partial dislodgement of the electrode. We first performed adhesiolysis of the middle ear and then advanced the electrode smoothly back through the round window with jeweller's forceps and intraoperative X-rays and NRT yielded a good result (Figure 4). He was discharged after one day's observation, and switch on was performed three weeks later. All electrodes were working, and the aided thresholds were within speech range. A new map was created, and parents reported that the left hearing performance was back to baseline if only the left implant was switched on.

A functioning, incompletely extruded device requires advancement, which was performed in this scenario. The dilemma comes if the device is functioning but cannot be advanced. Should it be left in place, or removed, and reinserted, risking insertion failure? The decision to leave it or remove it and attempt reinsertion depends on the number of remnant electrodes in the cochlear—whether the new aided thresholds are satisfactory and the degree of residual hearing. As most patients have more severe high frequency than low frequency loss, electrodes in the basal turn can be adequate for amplification, and it may not be worthwhile risking losing the implant altogether. This brings us to the next point.
