Article

# Effectiveness and Compatibility of a Novel Sustainable Method for Stone Consolidation Based on Di-Ammonium Phosphate and Calcium-Based Nanomaterials

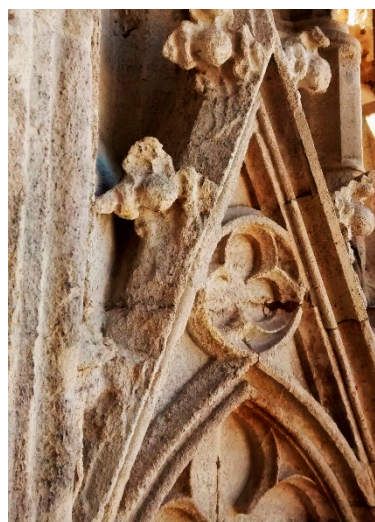
**Figure 1.** An outdoor decorated frame of Auer limestone of St. Stephen's Cathedral façade in Vienna (Austria), showing extensive erosion and loss of detail after exposure to weathering agents.

The carbonate stone used was a biogenic calcareous arenite called Auer limestone [46–48]. This stone was quarried in Au am Leithagebirge (Austria) and has been extensively used as building and ornamental material since the 14th century for its aesthetical qualities and large availability. It was used for the construction of many important buildings in Vienna, such as St. Stephen's Cathedral and Minoriten Church. Petrographic analyses revealed that Auer limestone mainly consists of skeletal fragments grains (coralline red algae, foraminifera, and bivalves) and other carbonate clasts, partially orientated parallel to the bedding planes [46]. Calcite is the dominant phase, whereas terrigenous siliceous inclusions are mainly quartz, muscovite and plagioclase. Clasts are cemented by fine-grained dogtooth calcite. The stone can be described as a light yellow-brown, coarse-grained (up to 2 mm grain size) detritic sedimentary rock with total open porosity about 40% and pores ranging from a few micrometres to millimetre size. This stone is subject to gypsum formation as surface crust by sulphation of its grain cement and to granular disintegration by exposure to freeze–thaw and salt crystallisation cycles (Figure 1) [49]. Because of its remarkably high porosity, sound limestone was used for the specimens. Unlike the sound sandstone, the number of active pores in the unaged limestone allowed for effective absorption of the consolidants, so that no artificial ageing was required.

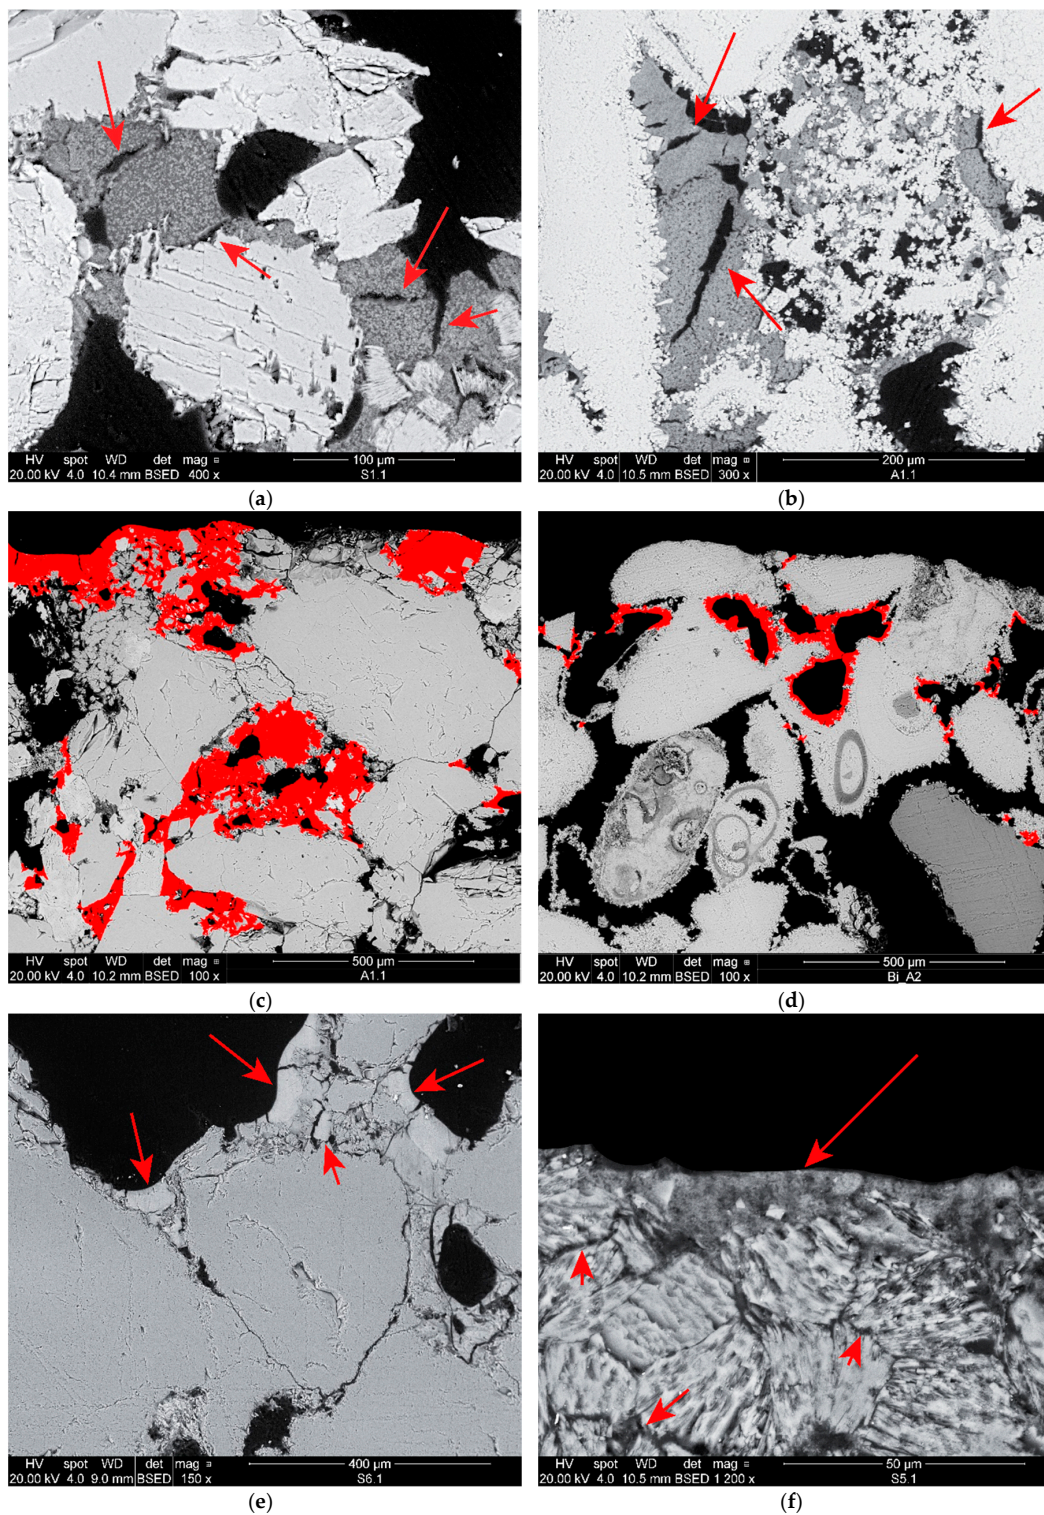
**Figure 2.** SEM micrographs of treated samples displaying some characteristics of the consolidants: adhesion, bridging capacity and porous microstructure with some shrinkage cracking (indicated by the arrows) of nanolime (NL) on (a) Schlaitdorfer sandstone and (b) Auer limestone; penetration depth (about 500  $\mu\text{m}$ ) of (c) NL on Schlaitdorfer sandstone and (d) Nanocalcite (NC) on Auer limestone with both consolidants shown in false colour; (e) adhesion and compact microstructure with some shrinkage cracks of di-ammonium phosphate-nanocalcite (DAP-NC) (see arrows) on Schlaitdorfer sandstone; and (f) adhesion of DAP-NC (see arrows) to the clayey matrix of Schlaitdorfer sandstone.

SEM micrographs showing some of the morphological characteristics of the consolidants are shown in Figure 2. The NL (Figure 2a–c) appeared unevenly distributed in the fabric of both lithotypes, as accumulations of product could be observed at the bottom and on the sides of the samples. The consolidant showed good grain adhesion in both stones, and bridges had efficiently formed between grains. Its micromorphology looked porous, with abundant shrinkage cracks (ranging 5–20  $\mu\text{m}$  width), and an interface was visible within the newly formed layer suggesting diachronic precipitation due to the two applications. On the limestone, pores in the range 100–300  $\mu\text{m}$  were partially filled with consolidant, resulting in a size reduction, whereas on the sandstone the consolidant was less evenly distributed, and the interstitial porosity of the clay matrix (<1  $\mu\text{m}$ ) was preferentially filled over bigger pores between quartz crystals.

The NC (Figure 2d) had a more compact and homogeneous micromorphology than the NL and fewer shrinkage cracks. As in the case of NL, most of the NC migrated to the evaporation surfaces, consolidating about 500  $\mu\text{m}$  in depth of both lithotypes. On the limestone, bridges had effectively formed between grains, adhesion was very good, and pores were partially filled resulting in a reduction of their diameter. On the sandstone, the NC formed a thin layer scarcely adhered to the surface of the grains, and only few small bridges had formed. Similar to NL, the pores between interstitial clay minerals were preferentially filled over bigger pores.

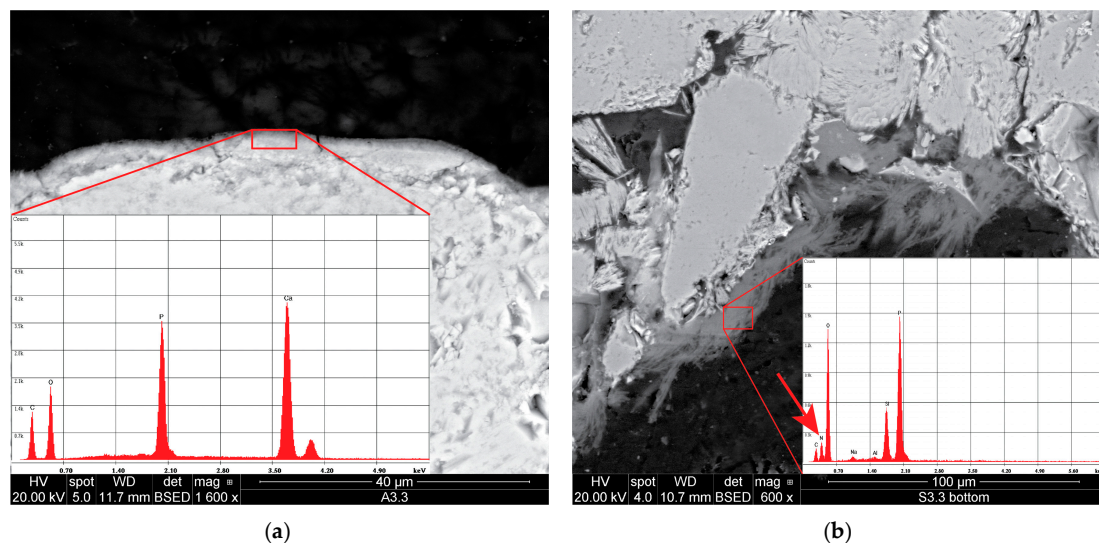
**Figure 3.** SEM micrographs of samples treated with DAP: (a) Phosphate layer formed on the surface of a limestone grain. In the inset, energy-dispersive X-ray (EDX) spectrum of such a layer showing strong P and Ca peaks. (b) Unreacted DAP found in the pores of the sandstone. In the inset, EDX spectrum showing, along with the P peak, presence of N (the relative peak is indicated by the arrow), which suggests that DAP had not converted into a Ca-P phase.

Regarding the phosphate treatments, application of DAP to the limestone resulted in the formation of a thin layer (ranging 2–5  $\mu\text{m}$  thickness, Figure 3a) around the grains, produced by the reaction of DAP with the calcareous substrate. The layer showed a compact and homogeneous microstructure and appeared tightly adhered to the substrate so that the interface between the consolidant and the stone could be hardly identified. The Ca-P consolidant was not able to build bridges between the grains and filled only the micrometre-sized pores, forming a sort of film on their surface rather than producing a proper consolidating or binding action. This is probably due to the fact that the DAP conversion took place on the surface of the grains and, once this was covered with a dense layer of newly-precipitated Ca-P phase, the remaining DAP was not able to penetrate such a layer to gain access to further  $\text{Ca}^{2+}$  ions.

The chemical composition of the phosphate-based consolidant was verified by EDX analysis, which revealed that Ca, P, and O were the dominant elements of this layer. The relative elemental maps are shown in Figure 4 together with the BSE image of the same area. The phosphate layer was found to be evenly distributed, up to about 2 cm in depth from the consolidated surface.

In the sandstone samples, unreacted DAP crystals were observed after treatment with neat DAP (Figure 3b), probably because of the limited amount of calcium ions, only available from the dolomitic fraction of the natural cement. It is possible that conversion to HAP did not reach completion and that residual DAP crystals were not completely removed by the rinsing. Differently, the combinations of DAP and nanosuspensions promoted the conversion reaction, producing a homogeneous Ca-P phase with abundant shrinkage cracks (Figure 2e,f). The consolidant formed bridges up to 20  $\mu\text{m}$  wide, as well as a tightly-adhered Ca-P layer around the surface of the grains. As for consolidation with the nanosuspensions, the porosity of the interstitial clay matrix was preferentially filled over bigger pores.

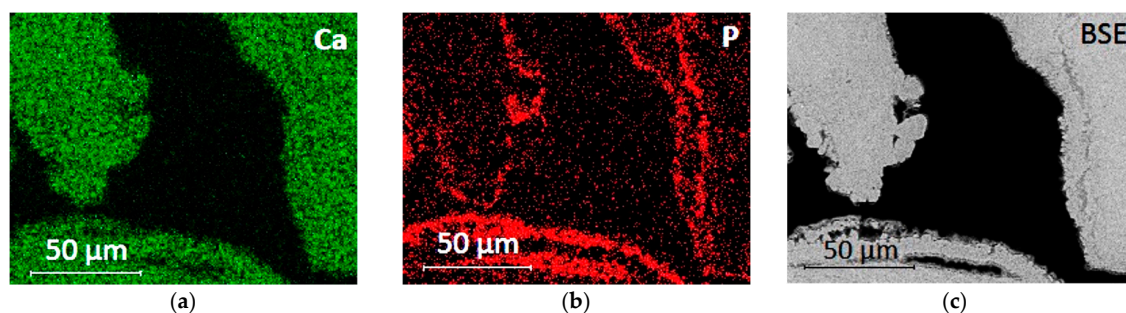
**Figure 4.** EDX elemental mapping of Auer limestone treated with DAP solution: (a) the map of calcium shows the calcareous stone; (b) the map of phosphorus shows the surface layer of the precipitated Ca-P phase; and (c) back-scattered electron image of the investigated area for comparison purpose.

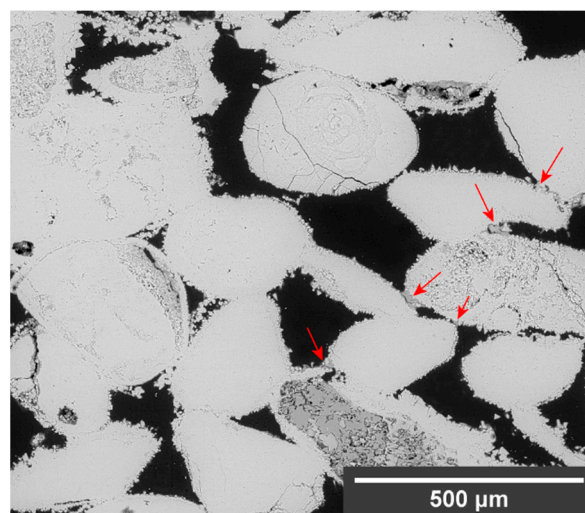
**Figure 5.** SEM micrograph of limestone treated with NL-DAP. Bridges of consolidant (indicated by the arrows) are found up to about 1 cm depth.

The combination of DAP with the nanosuspensions promoted bridges formation and penetration. The nanomaterials reached about 1 cm depth from the surface (Figure 5), in comparison with the few millimetres penetration obtained after the use of the neat products. In the treated limestone, two consolidation effects were observed: The first one entailed the formation of a layer similar to the one observed after treatment with neat DAP, characterised by a compact texture and a Ca:P ratio of about 1:1. The second one entailed the formation of small bridges with a more porous structure and a composition richer in calcium. These different consolidation effects were likely a consequence of the consolidants' distinct behaviours: while DAP required conversion into HAP to accomplish a consolidation effect and was limited by the presence of a calcium-rich substrate, the nanosuspensions tended to form toroidal bridges between the stone grains upon the carrier evaporation. Furthermore, after treatments with NC-DAP, some of the bridges showed a granular texture. This was possibly a result of the reaction between DAP and the  $\text{CaCO}_3$  nanoparticles that, being dispersed in an aqueous medium, may have acted as nucleation centres for the newly formed Ca-P phase [60].

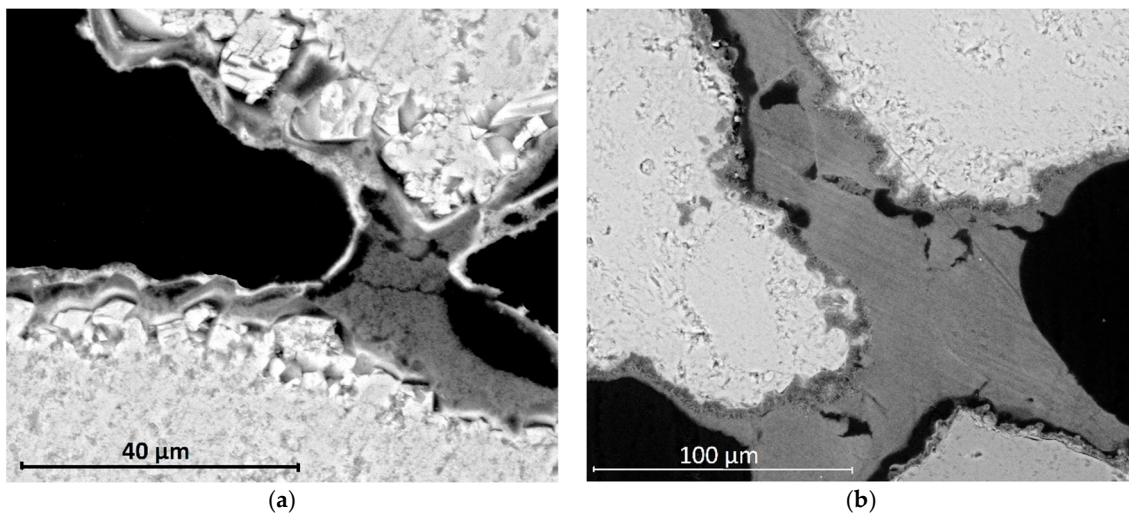
**Figure 6.** SEM micrographs displaying the effect of the order of application of the consolidants in the limestone: (a) after treatment NL-DAP, stone grains are linked by a bridge of nanolime, surrounded by a detached, compact phosphate layer; and (b) after treatment DAP-NL, stone grains are surrounded by a well-adhered phosphate layer and linked by a bridge of nanolime.

The effect of the application sequence (e.g., NL-P and P-NL) was also taken into consideration, and similar results were observed between the two lithotypes. When a nanomaterial was applied before DAP, the typical morphology observed is shown in Figure 6a. In these cases, bridges between the stone grains were probably formed during the first step and the subsequent application of the DAP resulted in a detached layer which unlikely added a consolidation effect to the treatment. Conversely, after the treatments initiated with the DAP, the phosphate layer covered the stone grains, and the toroidal bridges that formed in the second step appeared better adhered to the grains (Figure 6b).

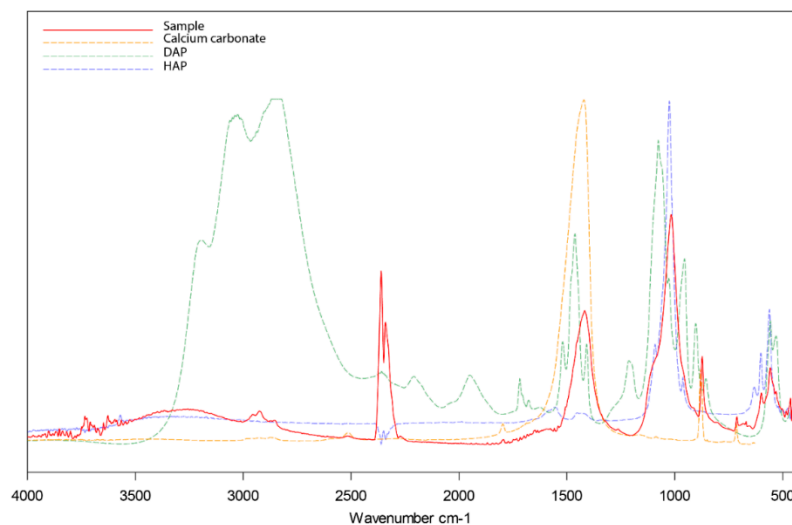
**Figure 7.** Fourier-transform infrared (FT-IR) spectra of sample of limestone treated with DAP (solid red line), pure calcium carbonate (dashed yellow line), pure DAP (dashed green line), and hydroxyapatite (dashed blue line).

To corroborate the conversion of the applied DAP into HAP, the spectra were compared with the reference spectra of calcium carbonate, DAP and hydroxyapatite, as shown in Figure 7. Although the results suggest that the DAP conversion took place in all analysed samples, previous studies suggested that the reaction products were most probably a mixture of HAP, octacalcium phosphate and other insoluble precursors [10,32]. According to the same studies, these compounds are expected to eventually transform into the most thermodynamically stable HAP through a series of dissolution and reprecipitation processes. Clear identification of these phases was hindered by the wide overlapping of their characteristic bands with those of the substrate. Furthermore, the precipitation mechanisms of hydroxyapatite and related precursors are complex and not yet fully understood, and their identification can be challenging not only by FT-IR spectroscopy but also using other techniques [32].
