## Case report

## Pseudotumor in ceramic-on-metal total hip arthroplasty

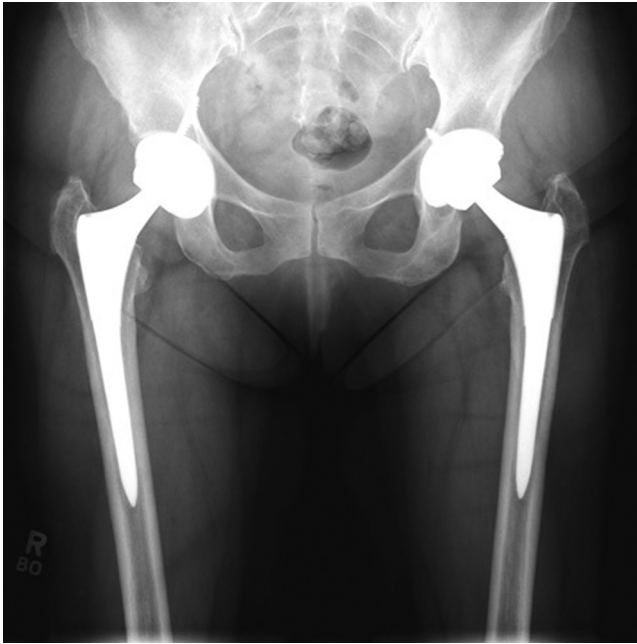
**Figure 1.** Anteroposterior (AP) pelvis radiograph at time of presentation to our clinic (7 years s/p simultaneous bilateral CoM THA) without signs of osteolysis or loosening.

A 69-year-old woman 7 years after simultaneous bilateral THAs initially presented to our clinic in August 2015. Symptoms included right worse than left lower back and gluteal pain for over 1 year. She experienced a popping sensation in her right hip. Radiographs demonstrated bilateral THAs with hard-on-hard bearings. Implant positioning appeared adequate, and there was no osteolysis or radiographic signs of loosening (Fig. 1). She had a body mass index (BMI) of 26.2 kg/m<sup>2</sup>, walked with a normal gait (no Trendelenburg), demonstrated painless full range of motion of both hips, and had mild tenderness of bilateral greater trochanters. Her neurovascular examination was normal. Radiographs and magnetic resonance imaging (MRI) of her spine revealed degenerative scoliosis of the lumbar spine, facet arthropathy, and foraminal stenosis of L4–L5 and L5–S1. She continued with intermittent symptoms and returned in February 2016. A metal artifact reduction sequence/multi-acquisition variable-resonance image combination MRI of bilateral hips and serum cobalt and chromium ion levels were ordered. When the patient returned in August 2016, her pain had worsened and now included persistent right groin pain, which was associated with nontender, palpable swelling. A copy of the operative report, which was provided by the patient, revealed bilateral DePuy Pinnacle Sector II acetabular shells with Pinnacle cobalt-chrome (CoCr) inserts and DePuy Summit Stems with BioloX Delta ceramic heads (DePuy Synthes Joint Reconstruction, Warsaw, IN). The multi-acquisition variable-resonance image combination MRI

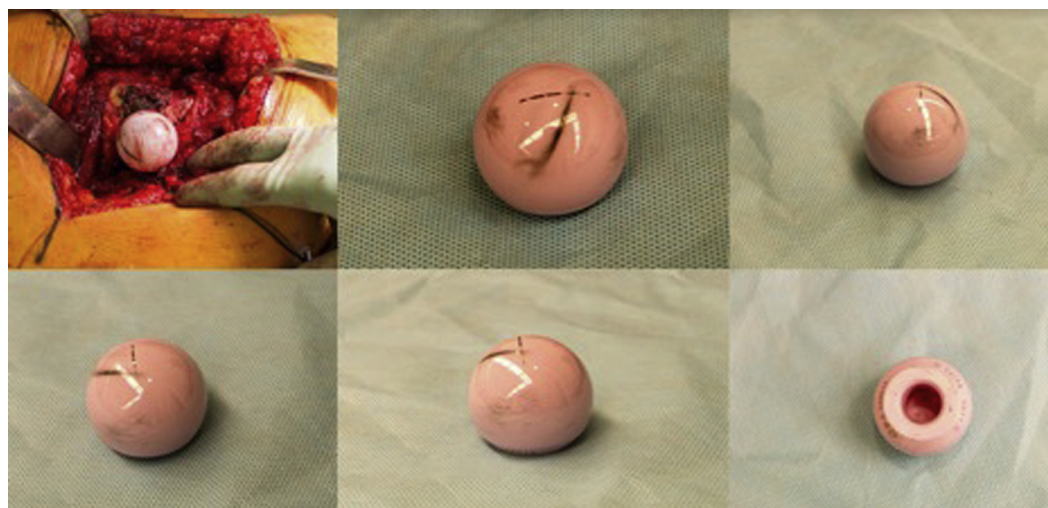
**Figure 4.** Intraoperative photographs of ceramic head with marked metal transfer on articulating surface and no significant corrosion/transfer noted in bore.

In our case, the patient had simultaneous bilateral CoM THAs. There were potentially multiple sources of metal corrosion that could have contributed to the ALTR in the right hip. Although trunnionosis occurs with ceramic heads, this corrosion should not have caused an increase in cobalt and chromium serum levels given that the stem was titanium [20,27]. The corrosion products from a titanium stem are thought to be much less cytotoxic than cobalt and chromium ions and therefore less of a contributor to ALTR formation [28]. Other potential sources of cobalt and chromium ions were from backside corrosion of the metal acetabular liner and the ceramic on CoCr bearing surface itself [19,23–26,29]. Agne et al. [19] demonstrated that CoCr acetabular liners had quantifiable material loss from backside corrosion and this could be a potential

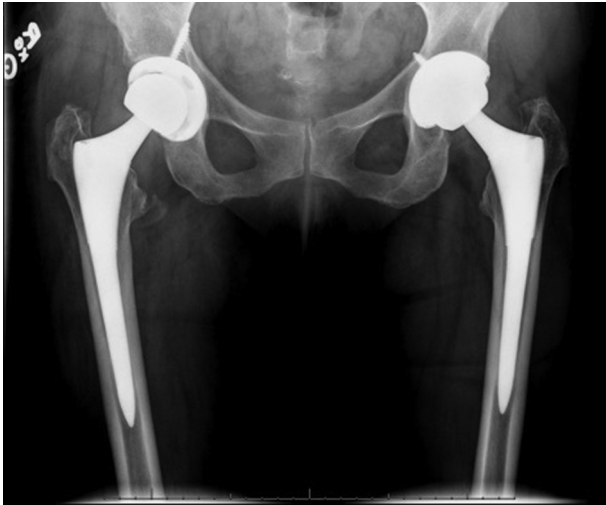
**Figure 5.** AP pelvis radiograph at 6 weeks s/p revision right THA with no obvious complication.

as sclerotic fibrous tissue with abundant fibrin, pigmented macrophages, and focal foreign body giant cell reaction. At 6 weeks postoperatively, the patient's pain was improved from her pre-revision level and radiograph was within normal limits (Fig. 5). At 3-month follow-up, she continued to do well but still reported lower back pain with intermittent radiation into her right groin. A computed tomography (CT) scan of the pelvis was obtained to better evaluate the radiologic position of the components in bilateral hips. The inclination angles of the right and left acetabular cups were 52° and 40°, respectively (Fig. 6), and the anteversion angles were 45° and 27°, respectively (Fig. 7). At 6 months postoperatively, she obtained another MRI of the pelvis which demonstrated a small residual right hip pseudotumor sheath with minimal fluid. The left hip effusion was slightly larger in size compared to her prior MRI but there was no sign of pseudotumor formation, muscle atrophy, or destruction (Fig. 8). At nearly one year after her right hip revision (June 2017), the serum cobalt and chromium levels had decreased to 2.0 and 5.9 ppb, respectively. At this most recent visit, the patient was notified of merits of present report and provided informed consent for participation.
