CASE REPORT

Nagoya J. Med. Sci. **81**, 159–163, 2019
doi:10.18999/nagjms.81.1.159

Computed tomography evaluation of the periacetabular gap of a porous tantalum acetabular component

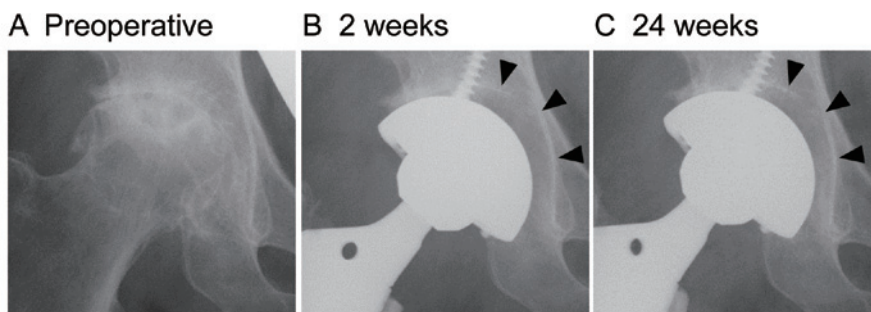
Fig. 1 Plain anteroposterior radiographs of the hip

(A) before surgery, (B) 2 weeks after surgery, and (C) 24 weeks after surgery. Arrowheads: periacetabular gap

A 70-year-old woman who had a 5-year history of rheumatoid arthritis and sustained clinical remission had been treated with methotrexate, sulfasalazine, and glucocorticoids. She complained of right hip pain that began 6 months before surgery. She experienced night pain and her pain-free walking distance was 200 metres. On physical examination, the right hip demonstrated a slightly limited range of motion. Pain was exacerbated by hyperflexion and flexion-internal rotation. The manual muscle test grade of the right hip abductor and right knee extensor was 4/5. There were no symptoms in joints other than the right hip. Plain anteroposterior radiograph of the hip demonstrated the lack of joint space, osteophyte formation on the femoral head and acetabulum, and partial collapse of the femoral head (Fig. 1A).

In radiographic evaluation, the periacetabular gap was defined as an area in which the porous surface of the acetabular component did not contact acetabular bone. The depth of the gap was corrected for magnification using the known diameter of the equator of the acetabular component. The periacetabular gap was suspected by plain anteroposterior radiographs of the hip 2 weeks postoperatively (Fig. 1B). Further radiographic evaluation was performed using CT because the quality of plain radiography was insufficient for evaluating the gap. CT scan was performed on

bone and bone ingrowth into the porous surface were observed by CT images with SEMAR (Fig. 2E, F), but not by plain radiography (Fig. 1C).

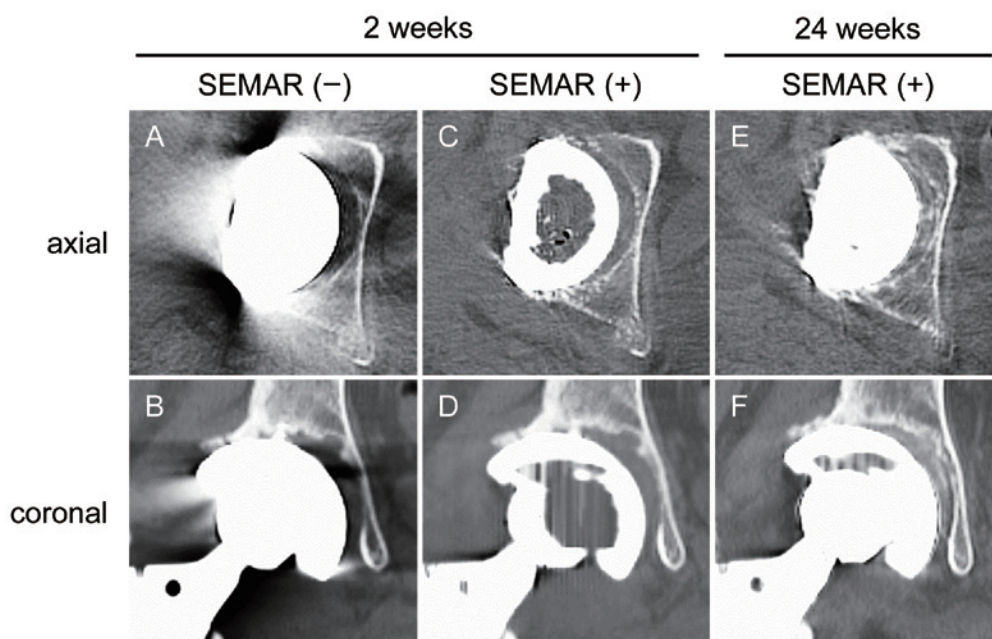
Fig. 2 T images without SEMAR

(A, B) 2 weeks after surgery, and with SEMAR (C, D) 2 weeks after surgery and (E, F) 24 weeks after surgery. SEMAR: single-energy metal artefact reduction.

Metal artefacts rendered evaluation of the circumference of the acetabular component difficult in CT images acquired without SEMAR (Fig. 2A, B). In contrast, metal artefacts were reduced, and the periacetabular gap was clearly depicted, in CT images with SEMAR 2 weeks postoperatively (Fig. 2C, D). The gap had a maximum depth of 6.5 mm in DeLee and Charnley zone 2. The porous surface of the acetabular component was in contact with anterior, posterior, and superior rims of the acetabulum (Fig. 2C, D). At 24 weeks postoperatively, gap filling with
