Residual Properties in Damaged Laminated Composites through Nondestructive Testing: A Review

Carlo Boursier Niutta ^{*}, Andrea Tridello

Citation: Boursier Niutta, C.; Tridello, A.; Paolino, D.S.; Belingardi, G. Residual Properties in Damaged Laminated Composites through Nondestructive Testing: A Review. *Materials* **2021**, *14*, 4513. <https://doi.org/10.3390/ma14164513>

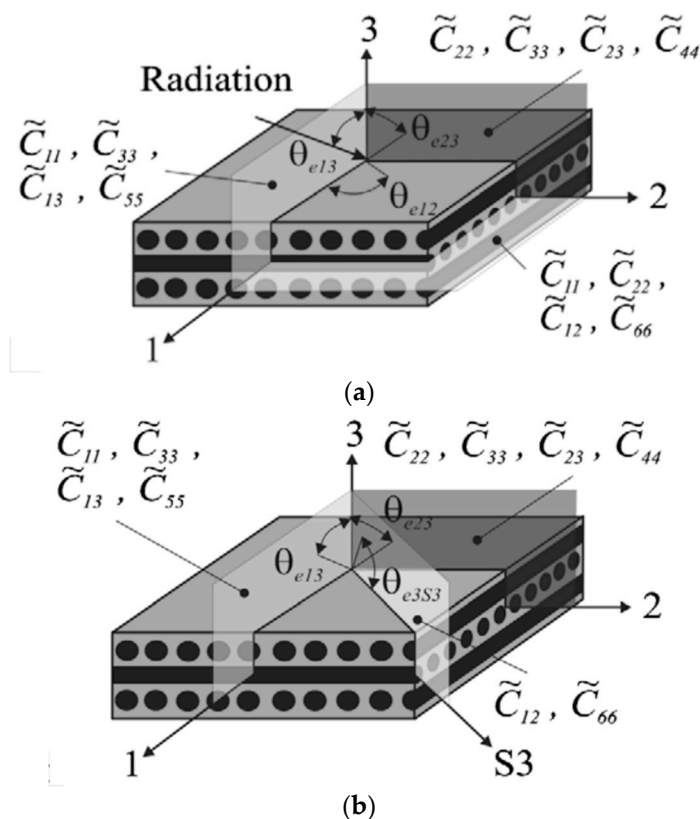
Figure 1. Determination of stiffness matrix coefficients by measurement in (a) symmetry planes and (b) non-symmetry planes [26].

Measurements in non-symmetry planes are, however, controversial due to practical problems [26]. Indeed, the determination of the time-of-flight data is complicated by the severe distinction between the phase velocity and the group velocity, i.e., the velocity of propagation of the wave packet, in non-principal planes [24]. Further, it is worth noticing

that the methodology assumes an orthorhombic symmetry in the material [25]. Therefore, apart from the special case of cross-ply symmetric laminates, material constants of angle-ply laminates cannot be determined.

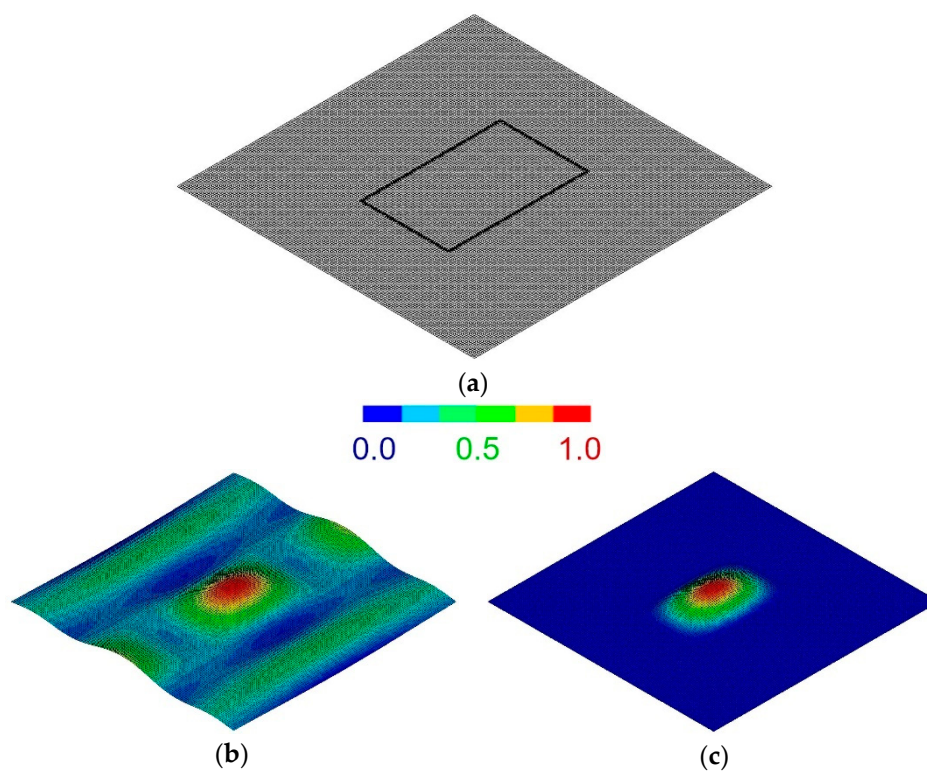
Figure 3. Comparison of local simply supported and clamped boundaries: (a) finite element model with highlighted path of constrained nodes; (b) modal analysis results with simply supported boundaries; (c) modal analysis results with clamped boundaries [55,56].

The technique is able to localize the vibrational response of the system by adopting the proper equipment. In particular, the boundaries of the region under investigation are nondestructively clamped. By clamping the boundaries of the region, the Authors showed that a vibrational mode which is specific of the retained region can be excited. The resultant first resonant frequency is thus only a function of the elastic characteristics of the inspected region. Figure 3, taken from [56], shows the results of a finite element modal analysis where simply supported (Figure 3b) and clamped (Figure 3c) boundaries are alternatively

retained for the path of nodes highlighted in Figure 3a. When fully clamped boundaries are adopted, a specific mode which involves only the inspected region can be excited.

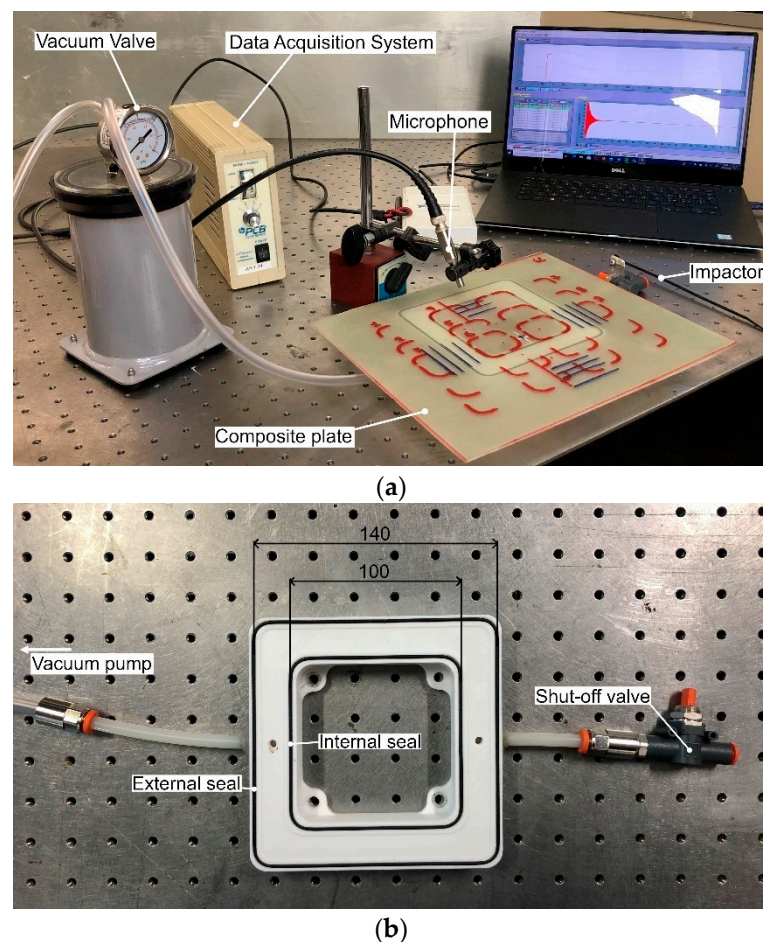
Figure 4. Experimental setup (a) and clamping device (b) of the local vibrational analysis technique.

The technique has been recently extended to the analysis of damaged laminates. In particular, as the observations performed within the nondestructive testing are usually limited to only the exposed surface of the component, an innovative clamping system has been proposed, which adopted a vacuum to obtain the clamping effect. As shown in Figure 4, the inspected region is framed by a vacuum chamber whose air is aspirated through a vacuum pump. The frame chamber is delimited by internal and external rubber seals, which prevent any air escape.

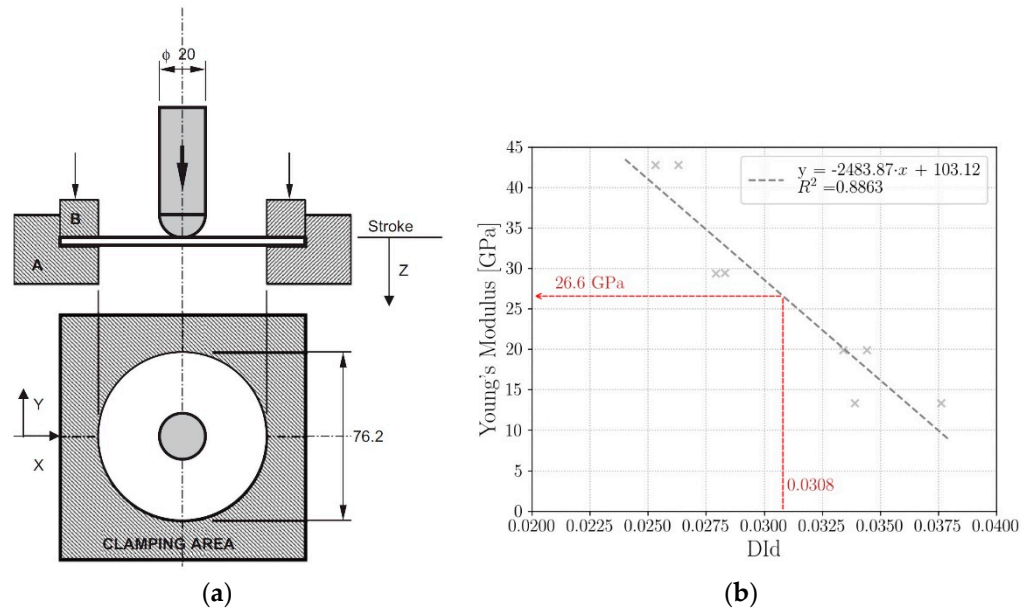
Figure 5. (a) Scheme of the testing fixture of the DI_d technique [61]; (b) relationship between the residual elastic properties and the DI_d parameter [64].

As the residual energy absorption aptitude is evaluated for a circumscribed region of the component, local elastic constants are assessed. Figure 5a shows the testing fixture. By clamping the boundaries through a properly provided uniform pressure, the impact response concerns only the circumferential region whose diameter is 76.2 mm.

The double impact set involves two impact tests on each plate. A new set of composite plates is initially impacted at increasing energy levels and then impacted again on the damaged area at the threshold impact energy E_{th} . The damage index parameter DI_d is thus calculated according to Equation (6). The double impact set allows to correlate the DI_d parameter to the impact energy. Combining this information with the results of the single impact set, where the residual elastic properties are correlated to the incident energy, the residual elastic properties can be expressed as a function of the DI_d parameter, as shown in Figure 5b.

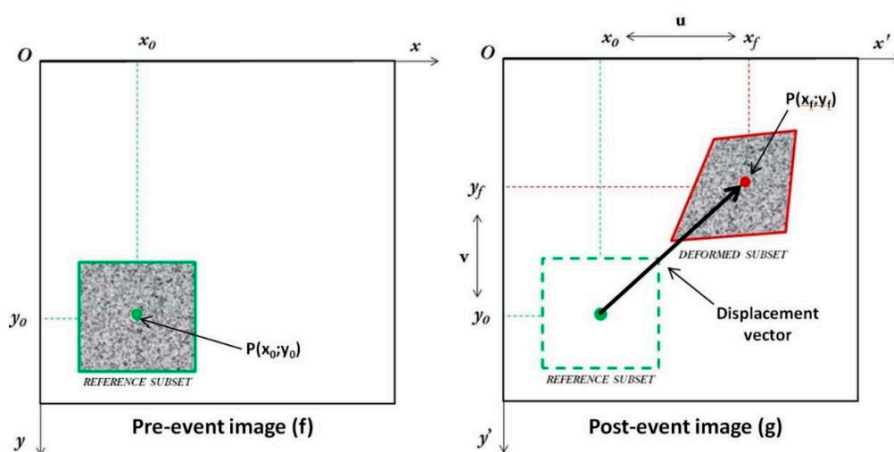
Figure 6. Scheme of DIC basic principle [70].

images under the application of external loads. In this way the DIC allows also to locally capture deformation originated by material inhomogeneities [68]. In particular, in the post-processing phase, a virtual mesh is generated on the surface of the component whose main parameters are the subset size and the step size. The surface of the component is divided into squared subsets whose dimension is defined by the subset size. With the step size parameter, the distance between the subset centers, i.e., the shift between subsets, is assumed. Generally, each subset should contain at least three speckles and step size should be at least 1/3 of the subset size [69]. Both the step size and the subset size are measured in pixels. As shown in Figure 6, taken from [70], subset displacements are sequentially tracked with reference to their center.

Indeed, DIC assumes that the deformation within the subset is constant. The position of each subset is determined in each digital image by minimizing a correlation function. Several correlation functions have been proposed in the literature and the reader can refer to [69] for a comprehensive description.

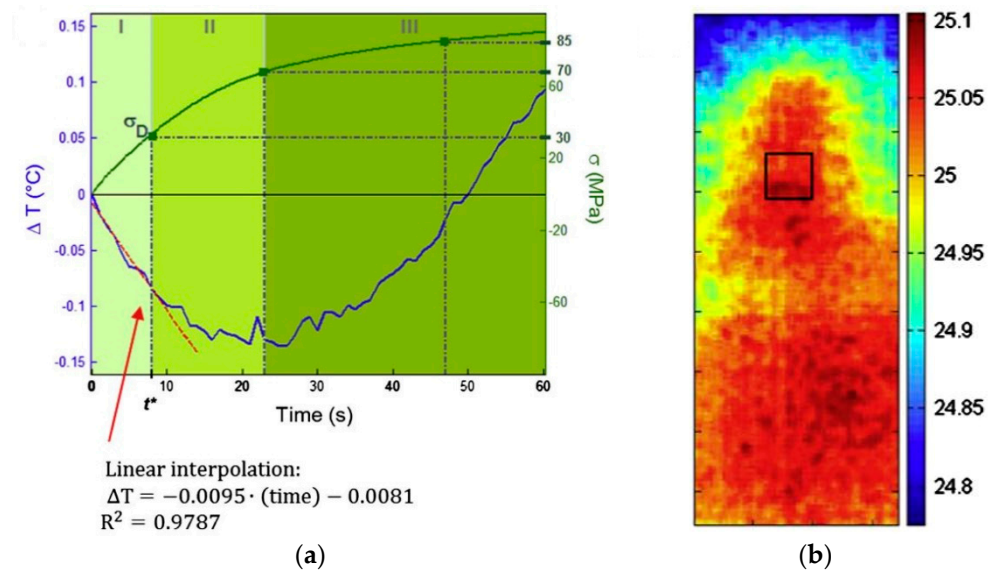
Figure 7. (a) Temperature trend and stress trend of the $[+45^\circ, -45^\circ]_s$ specimen. Deviation from linearity indicates the damage onset, specifically at time t^* and stress σ_D ; (b) thermal map of the specimen at t^* . The black box is the region where the average temperature is calculated [79].

Damage evolution in static tests has been investigated with passive thermography. In [79], the Authors performed quasi-static tests on glass-fiber reinforced specimens. Three configurations were retained: unidirectional laminate loaded in the fiber direction, unidirectional laminate transversely loaded, and symmetric laminates with stacking sequence $[+45^\circ, -45^\circ]_s$. The temperature profiles showed three distinct phases. An example, taken from [79], is reported in Figure 7.

In the first phase a linear decrement of the surface temperature with the applied stress is observed, in accordance with the Kelvin's law, Equation (10). The second phase is characterized by a nonlinear decrement of the temperature, as the damage has onset. At the end of the second phase a minimum in the temperature decrease is reached. The minimum might also represent the high cycle fatigue limit of the material [80], while the true endurance limit is represented by the damage initiation stress. However, the definition of a fatigue limit for composites is still discussed [81]. Finally, the third phase is characterized by an almost linear increment of the temperature. Indeed, as the damage proceeds, the mechanical energy stored in the material is released leading to an increment of the temperature. The slope of the third-phase temperature profile seems correlated with the damage development: the more the damage expands before the final fracture, the higher the slope of the temperature increase [79].
