Article

# Dampness and Moisture Problems in Norwegian Homes

Rune Becher <sup>1,\*</sup>, Anja Hortemo Høie <sup>1,†</sup>, Jan Vilhelm Bakke <sup>2</sup>, Sverre Bjørn Holøs <sup>3</sup> and Johan Øvrevik <sup>1</sup>

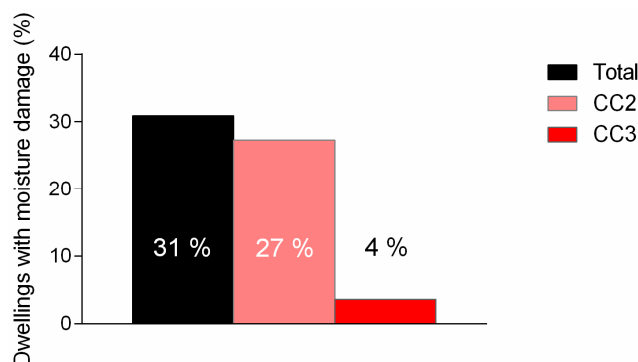
**Figure 1.** Percentage of Norwegian dwellings with different levels of moisture damage (CC2 or CC3). CC2: structural elements have clearly signs of damage, excessive wear or have poor functionality; there is a need for remediation/the building component is estimated to have a short remaining life. CC3: substantial wear and damage/total malfunction, requiring urgent action.

mold damage categorized at CC2 or CC3 levels. This amounts to 31% of the surveyed dwellings. Of these, the majority (27%) had CC2 as the worst grade in the residence, while 4% had CC 3 as the worst grade level in the residence (Figure 1).

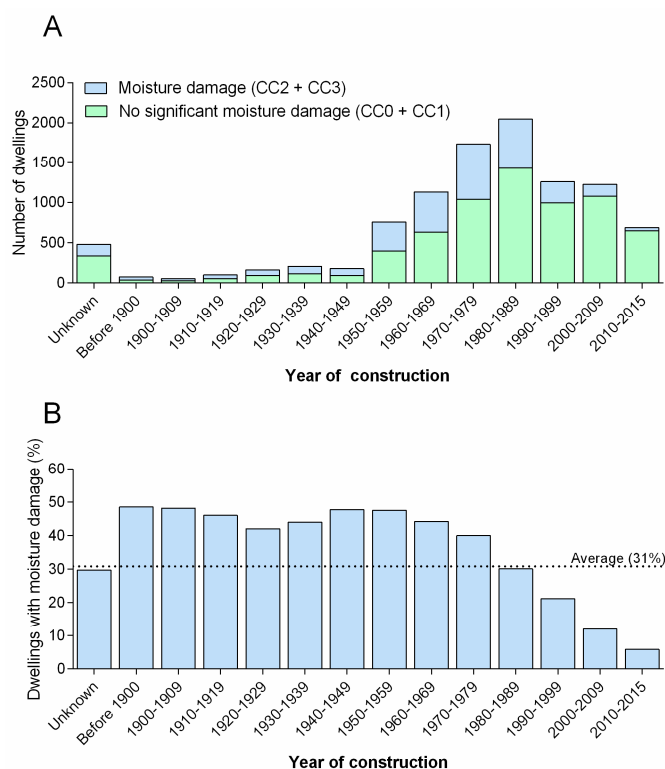
**Figure 2.** Dwellings with moisture damage distributed by year of construction. The figure shows total number of Norwegian dwellings in this study with and without moisture damage (A) and share of dwellings with moisture damage (B) grouped after year of construction.

The majority of the dwellings surveyed were built between 1950 and 2015 with the highest number from 1970 to 1989. Dwellings built before 1980 had the highest proportion of moisture damage. The share of homes with moisture damages then declined gradually the newer the dwellings were (Figure 2).

The results indicate a continuous decline in moisture damage and moisture risk from the 1960s to present with a sharper decline from the 1980s. Several distinct factors may have contributed to this.

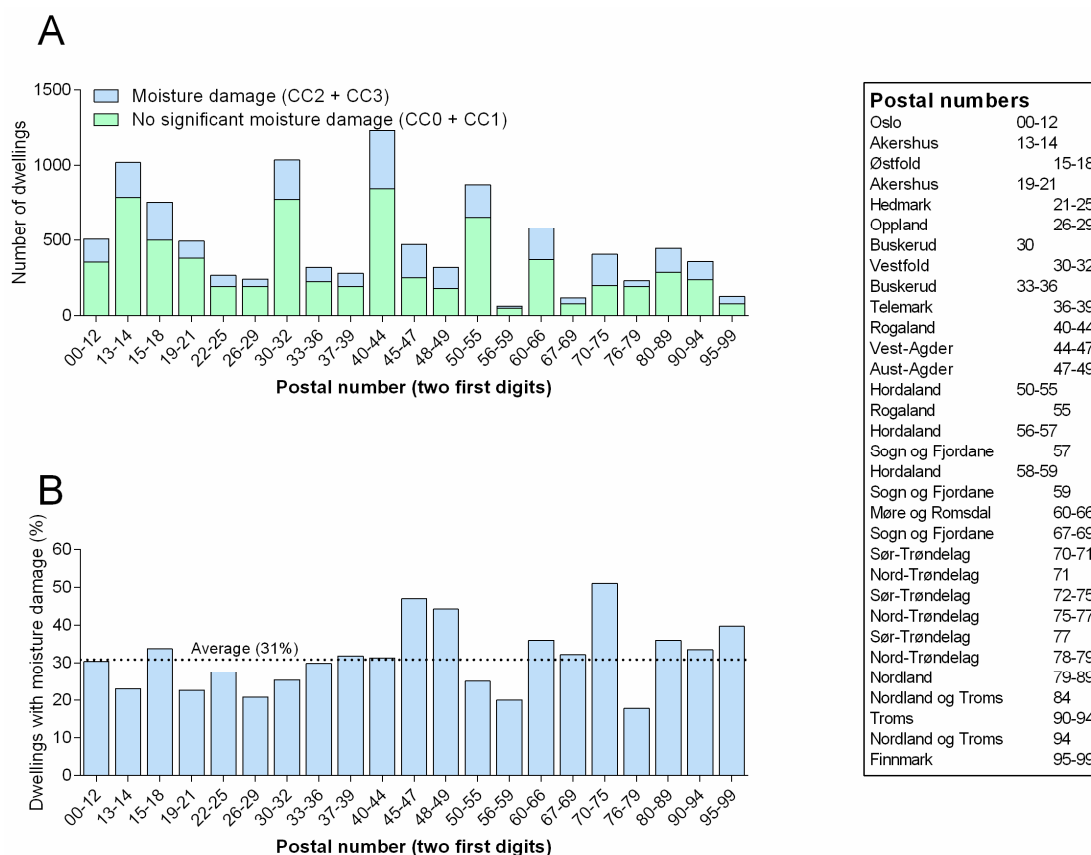
**Figure 3.** Dwellings with moisture damage distributed by geographical location. The figure shows total number of Norwegian dwellings in this study with and without moisture damage (A) and share of dwellings with moisture damage grouped after location/postal code (B).

Some geographical variations in moisture problems, ranging from 18 to 51% were reported in different regions of Norway. The southern counties West- and East Agder (Vest- og Aust Agder) and the mid Norway county of South Trøndelag (Sør Trøndelag) stand out with the highest proportion of homes with moisture damage (44%, 47%, and 51%, respectively), while North Trøndelag has the lowest (Figure 3). However, no obvious geographical pattern was observed.

There are striking differences between regions in our material. This could have several possible explanations. One obvious possibility would be climatic differences, as there are great local and regional differences in temperature, precipitation, and wind in Norway. However, it seems somewhat suspect that the Hordaland region, with normal annual precipitation typically exceeding 2100 mm, has a considerably lower than average proportion of moisture damage, while South Trøndelag (Sør Trøndelag) with normal annual precipitation typically well below 1000 mm has the highest rate of moisture problems in this study.

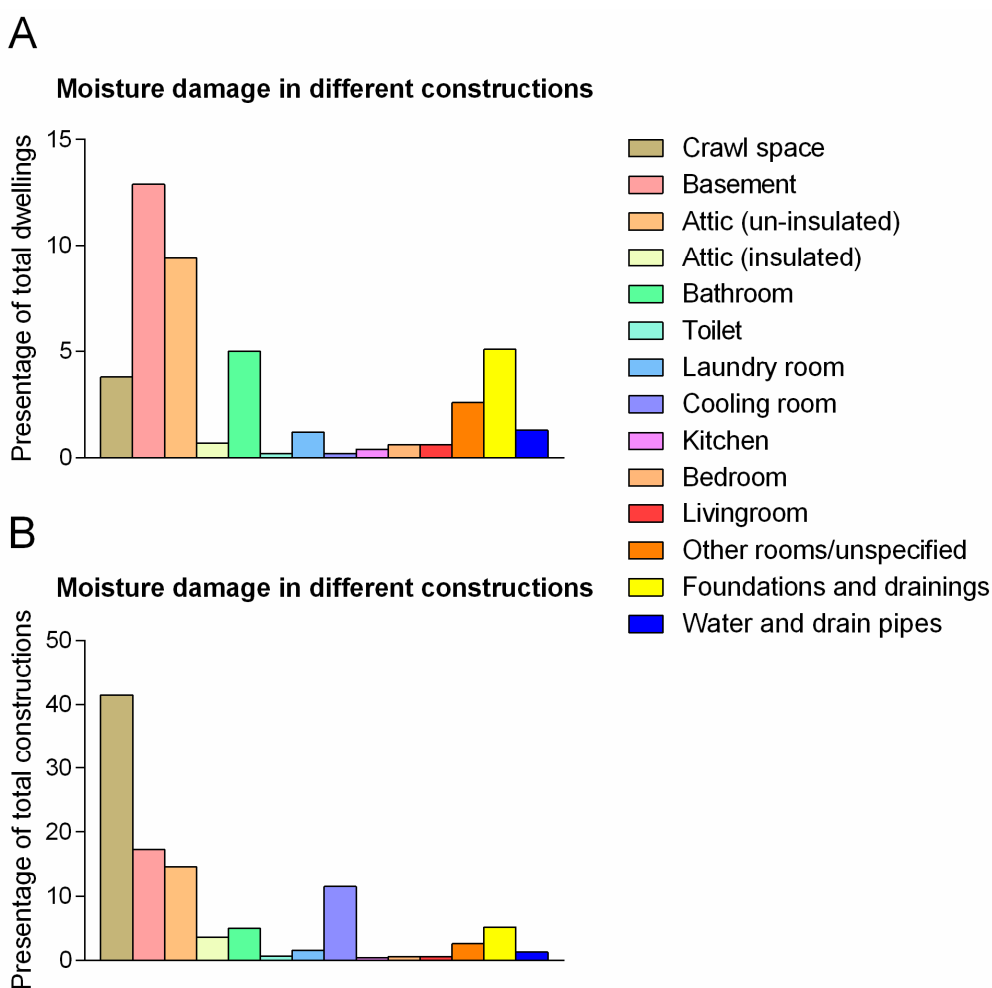
**Figure 4.** Moisture damage distributed by construction/room type. The figure display percentage of Norwegian dwellings with moisture damage in the different rooms (A) and the percent of the respective rooms with moisture damage (B). For instance, only a few inspected dwellings had crawl spaces or cooling rooms. Thus, while moisture damaged crawl spaces and cooling rooms were reported in less than 5% and 1% of all dwellings respectively, more than 40% of all crawl spaces and more than 10% of all cooling rooms were moisture damaged.

The building parts having the largest total numbers of moisture damages were in rank order: basements, unfurnished attics, foundations and drainage, bathrooms, and crawl spaces (Figure 4A). Notably, 41.5% of all crawl spaces had moisture problems, but these constituted only 4% of all the inspected homes, as only some houses had crawl spaces. Thus, adjusting for the relative occurrence of different rooms and constructions, the building parts with highest proportion of moisture problems (CC2 and CC3) are crawl spaces, basements, attics (unfurnished), cooling/refrigerated rooms (cold rooms for storing food), and areas in association with foundations and drainage (Figure 4B).

Moisture problems in living room made up less than 1%, the same as found in bedrooms and kitchens (Figure 4A).

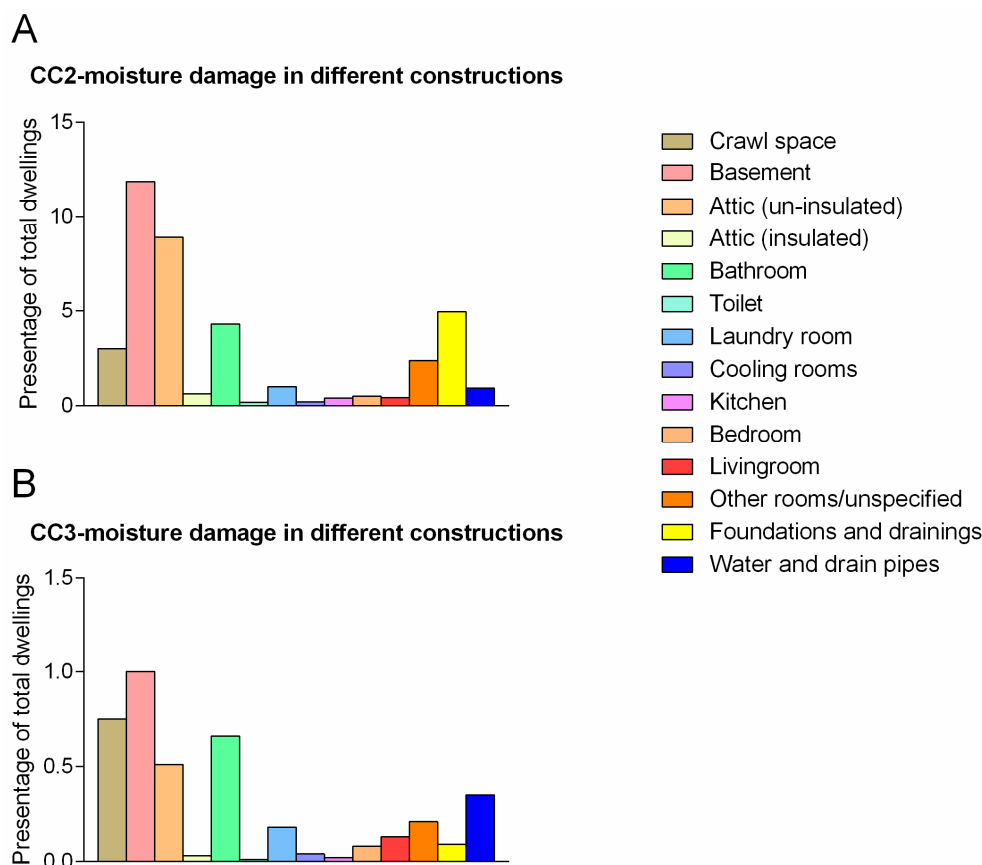
**Figure 5.** Grade of moisture damage distributed by construction/room type. The figure shows percentage of Norwegian dwellings with CC2 (A) and CC3 (B) moisture damage in the various rooms.

Approximately 12% of the basements and 9% of the unfurnished attics had CC2 grade. Other rooms and/or constructions with CC2 were drainage (5%), bathrooms (4%) and crawl space (3%), and damages associated with foundation (Figure 5A). CC3 classified damages were most frequently observed in the crawl space, bathroom and unfurnished attic (0.75%, 0.7% and 0.5%, respectively). About 0.35% of the homes had a CC3 associated with water pipes/drainage (Figure 5B).
