Polyurethane-Coated Breast Implants Revisited: A 30-Year Follow-Up

Original Article

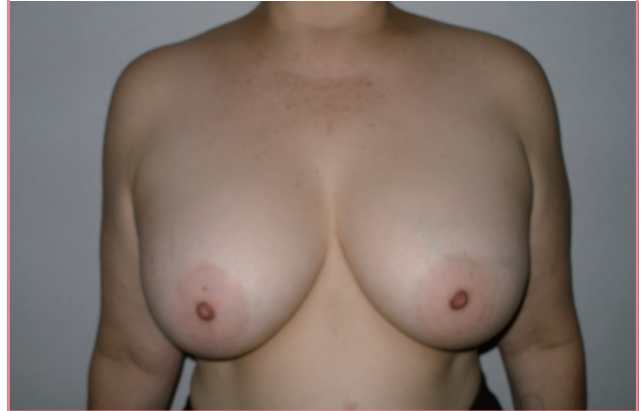
Fig. 3. Anterior view 29 years post-surgery with grade III contracture

A patient is shown demonstrating grade III contracture 29 years after subglandular augmentation with 400 mL Replicon implants, placed through inframammary incisions.

Among the 288 patients (75.4%) who returned for their six-month follow-up visit, soft breasts (Baker I) were noted in all patients. Of the 76 patients who eventually underwent reoperation, as described in Table 1, all patients demonstrated soft breasts with no contracture (Baker I) at their six-month follow-up visit. After this period, 67 patients continued to show no contracture (Baker I) and nine patients experienced capsular contracture of different degrees. Baker II/III contracture was noted in two of the nine patients at nine and 10 years after surgery. One of the patients with grade III contracture is shown 29 years after surgery in Figs.

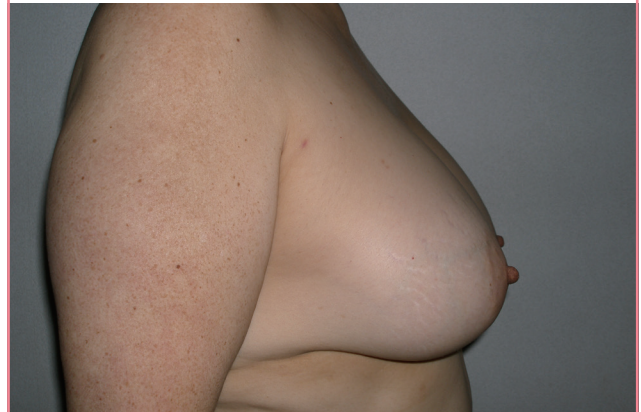
**Fig. 4. Lateral view 29 years post-surgery**

A lateral view is shown of the same patient as in Fig. 3.

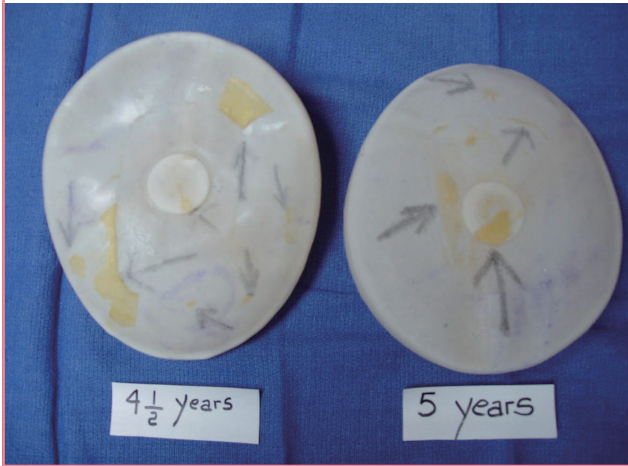
Fig. 5. Polyurethane implants four to five years post-surgery

Explantation up to five years after breast augmentation surgery demonstrates that macroscopic remnants of polyurethane are present on the surface of all implants.

Macroscopic evidence of polyurethane was noted on the surface of implants upon explantation up to five years after the original operation (Fig. 5). Beginning at six years after the operation, the polyurethane gradually disintegrated and eventually disappeared, as shown in Fig. 6. In contrast, polyurethane was present microscopically within all capsules during the entire observation period of 30 years.

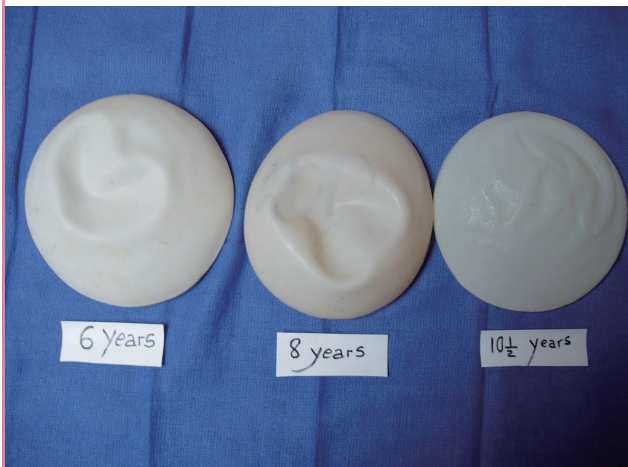
Fig. 6. Polyurethane implants six to 10 years post-surgery

Beginning at six years after the operation, no macroscopic presence of polyurethane on the surface of implants can be observed. This is also demonstrated at eight and 10 years after the operation.

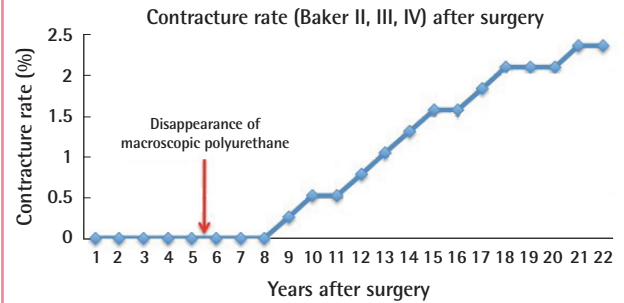
Fig. 10. Capsular contracture after surgery

Before the disappearance of macroscopic polyurethane, no cases of capsular contracture were noted. Beginning at three to four years after the disappearance of macroscopic polyurethane, Baker II, III, and IV contractures developed, with increasing incidence thereafter.

The polyurethane coating was examined macroscopically after explantation up to five years after surgery. The earliest incidence of capsular contracture (Baker II/III) was noted nine years after surgery. This observation correlates with our overall observation that polyurethane gradually degrades from five to nine years after implantation. Beyond nine years after implantation, no coating was present in any patient, which is when we noted an increasing incidence and severity of contracture. This observation demonstrates a distinct correlation between the gradual disappearance of polyurethane coating and both the occurrence and severity of capsular contracture (Fig. 10).
