# Evaluation of the effect of dentin surface treatment by air abrasion and Er:YAG laser on the retention of metal crowns luted with glass ionomer cement in teeth with reduced crown height: An *in vitro* study

**Keywords:** Air abrasion, complete metal crown, Er:YAG laser, glass ionomer cement, reduced crown height, tensile bond strength

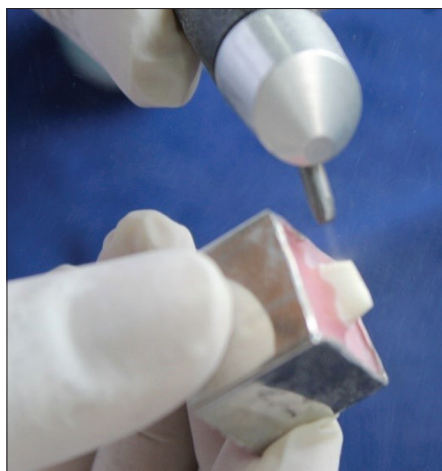
**Figure 2:** Dentin surface treatment by aluminum oxide air abrasion

Dentin surface was air abraded using a MicroJato intraoral microblaster (Bio-art Equipamentos Odontologicos Ltd., Brazil), with aluminum oxide particles of  $50 \mu\text{m}$  under 60 psi pressure and delivered by a 0.46 mm diameter and  $60^\circ$  angulated tip [Figure 2]. Jet intensity was kept 5 g/min, applied at a focal distance of 5 mm with a  $45^\circ$  angle to the tooth surface to avoid particle reflection. Air abrasion was followed by rinsing with water for 40 s.<sup>[18]</sup>

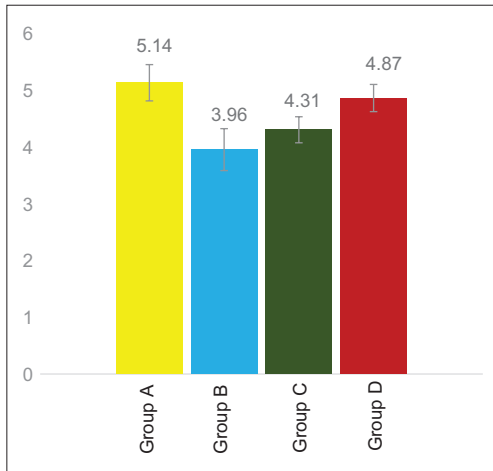
**Graph 1:** Graphical representation of mean tensile bond strength (MPa) of four groups

Group	Mean tensile bond strength (MPa)
Group A	5.14±0.33
Group B	3.97±0.37
Group C	4.31±0.24
Group D	4.88±0.24

with Er:YAG laser irradiation (Group D) ( $P < 0.001$ ) while aluminum oxide air abrasion showed no statistically significant improvement in tensile bond strength of GIC (Group C) ( $P = 0.033$ ). Graphical representation of mean tensile bond strength of four groups is shown in Graph 1. After tensile bond strength testing, all the specimens were evaluated for the modes of failure which are presented in Table 6.
