CASE REPORT

Accidental fracture of EBUS-TBNA needle during sampling of an enlarged mediastinal lymph node

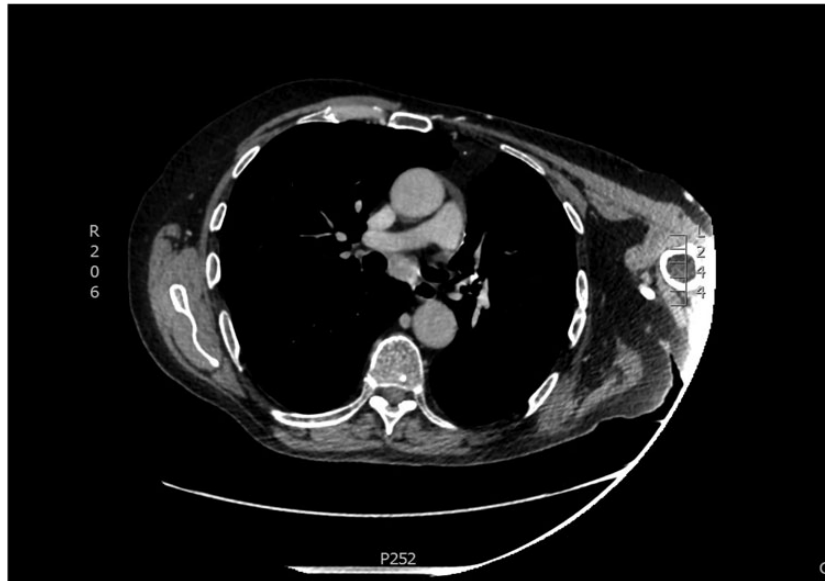
In November 2015, his surveillance contrast-enhanced computed tomography (CT) scan of chest, abdomen and pelvis revealed enlarged pre-carinal and sub-carinal lymph nodes, with the sub-carinal node showing central necrosis (Fig. 1).

Figure 1: CT scan image showing the enlarged subcarinal lymph nodes with central necrosis.

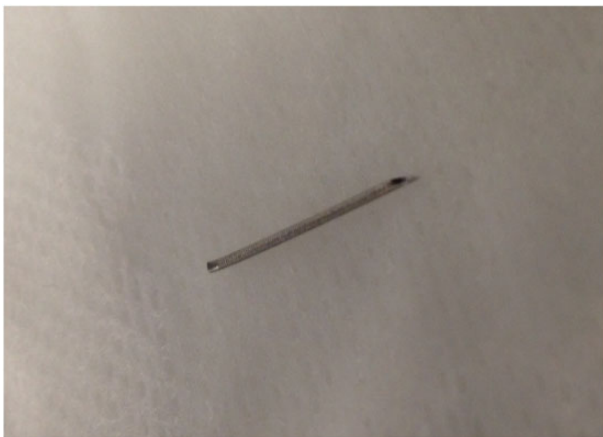
Figure 2: The 15 mm tip of the EBUS-TBNA needle showing the site of fracture close to the junction between the long, shiny electroplated section and the coarse distal end.

The bronchoscopist subsequently noted that the needle had snapped very close to the junction between the long, shiny electroplated portion and the coarse end of the needle (Fig. 2), and wondered whether this junction is a relatively weak point along the length of the needle. Özgül *et al.* in their report had also noted the site of breakage close to the junction between the shiny long portion and the coarse short end of the needle [5].

This unexpected event was discussed in the lung cancer multi-disciplinary team meeting and a report was filed on hospital's dedicated incident reporting website. The needle identifier number and batch number were noted and forwarded to the company supplying EBUS-TBNA needles to our endoscopy unit. The fact the needle had snapped close to the junction between the long shiny part and the coarse end bit was also highlighted, as this may represent a weak point in the needle's structure requiring further investigation.
