Case Report

An Interesting Case and Literature Review of a Coronary Stent Fracture in a Current Generation Platinum Chromium Everolimus-Eluting Stent

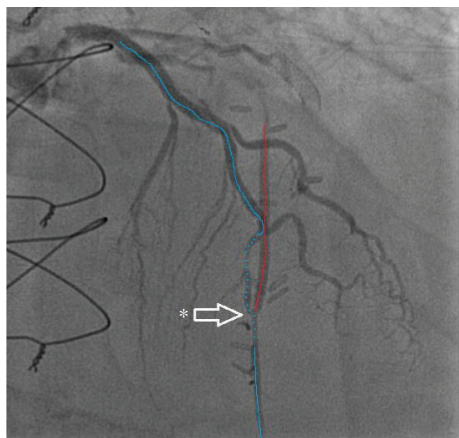
FIGURE 1: Coronary angiogram showing a long mid-LAD stenosis of 95%, extending from the mid-LAD (dotted blue line) to an area just below the anastomosis with LIMA (white asterisk), with retrograde filling into LIMA (red line).

stenosis in the mid-LAD. The stenosis extended from the mid-LAD to a bit passed the LIMA anastomosis, with retrograde flow into the LIMA (Figure 1). Some tenting of the LAD at the anastomotic site was also noted. Several predilatations were performed at 8 and 10 atmospheres with no significant improvement to the stenosis. A 2.25×28 mm Synergy drug-eluting stent (Boston Scientific) was then deployed at 12 atmospheres and postdilated with 2.25×20 mm noncompliant balloon at 14 atmospheres. The stent was successfully deployed in the mid-LAD with no residual stenosis. A slight kink in the distal one-third of the stent at the LIMA insertion point was noted (Figure 2). Figure 3 further demonstrates the movement of the intact stent during diastole and systole. The patient's symptoms temporarily improved.

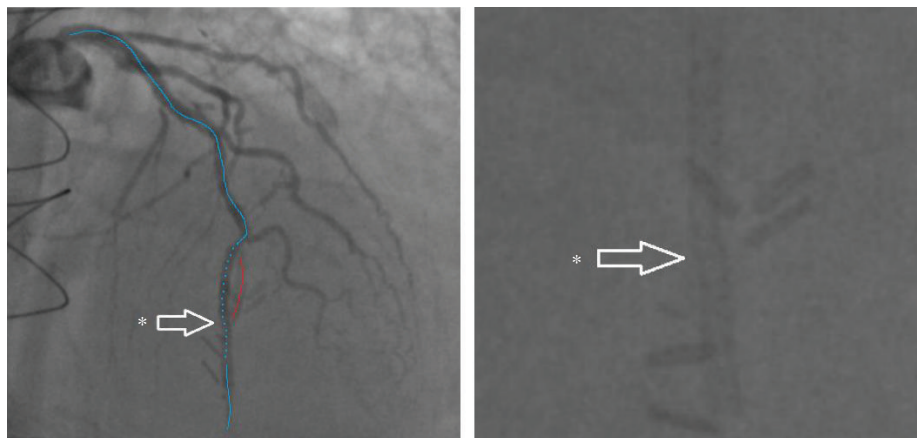
FIGURE 2: Coronary angiogram showing TIMI III flow over mid-LAD (dotted blue line) and the point of anastomosis (asterisk) after the deployment of Synergy PtCr EES. Note that there is a mild deformity of the stent, which conforms to the coronary anatomy and anastomotic site.

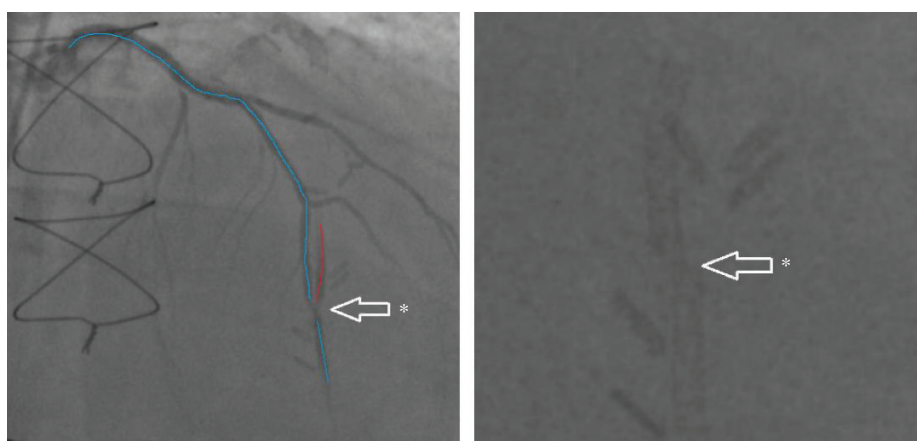
In our case, the SF occurred at the mid-LAD, in the vicinity of the LIMA anastomosis (Figure 4). We believe that the Synergy EES came under a lot of external mechanical strain due to the vessel curvature, as well as the additional tenting force generated by the anastomosis with the LIMA. With each cardiac cycle, the hinge motion (Figure 3), created by the vessel's tortuosity, lead to the eventual metal fatigue and fracture.

FIGURE 4: Repeat coronary angiogram showing mid-LAD stent fracture with 70% in-stent restenosis at the site of anastomosis between LAD and LIMA (asterisk).

Based on this, our case would be considered a type IV fracture, the most severe form. There is no formal management guideline for treating coronary SF. In a single-center study by Lee et al., they proposed to treat SF with no signs of ISR with dual or triple antiplatelet therapy for an unknown duration of time. Significant ISR with severe SF (type II to type IV) warranted coronary intervention [15]. DES use in the treatment of SF was shown to have lower rates of target vessel revascularization than plain old balloon angioplasty [17]. Our patient was managed in a way consistent with the recommendations above. We treated our patient with a repeated coronary intervention using the Xience Alpine EES. Although overlapping stents are known to be a risk factor for further SF, it was important that such a severe stent fracture and in-stent restenosis be amended in an attempt to return maximal perfusion to distal tissues.

A short time after, he presented again with rest pain. His vital signs were stable. Physical examinations, including cardiac exams, were unimpressive. Electrocardiogram (EKG) showed normal sinus rhythm without significant ST/T changes. Two troponin levels drawn 12-hour apart were both normal. Repeat coronary angiography was performed. It revealed a mid-LAD stent fracture with 70% in-stent restenosis (fractional flow reserve of 0.78) (Figure 4). Coronary intervention was performed and a Xience Alpine DES was deployed inside the fractured Synergy DES with TIMI III flow and no residual stenosis (Figure 5). The patient tolerated the procedure and was discharged in stable condition.

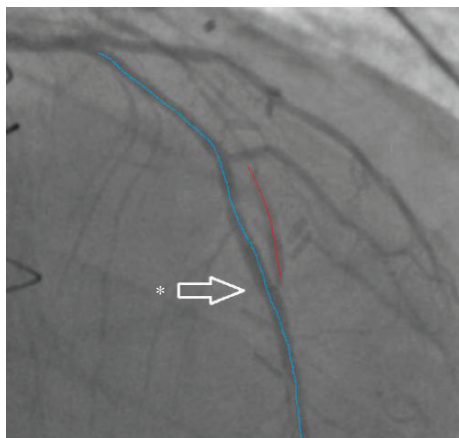
FIGURE 5: Repeat coronary angiogram showing TIMI III flow in mid-LAD at the point of anastomosis with LIMA (asterisk) after Xience Alpine DES was deployed inside the fractured Synergy DES.
