Cite this: *RSC Adv.*, 2019, 9, 26817

A study on the properties and working mechanism of a waterborne polyurethane-modified silicate-based coating

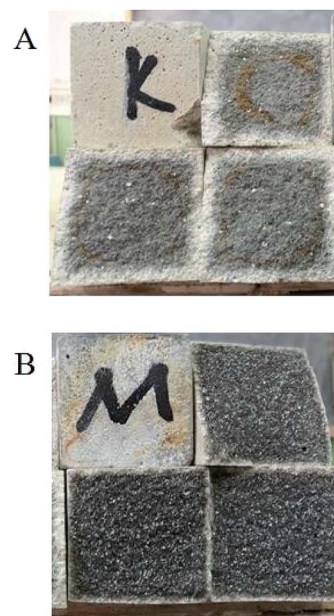
Fig. 1 Sectional view of the coatings after acid storage: (A) blank group and (B) modified group.

show any signs of corrosion, peeling, cracks, expansion and partial bubbling. Therefore, the acid resistance performance of the modified coating was stable.

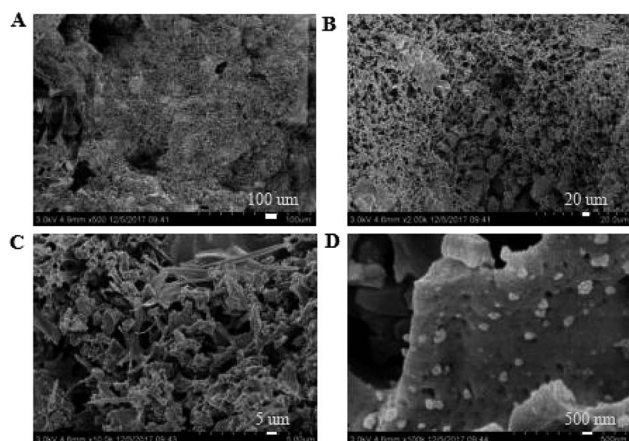
Fig. 6 SEM images of the coating belonging to the blank group at resistance temperature at the magnifications of $\times 500$ (A), $\times 2000$ (B), $\times 10\,000$ (C) and $\times 100\,000$ (D).

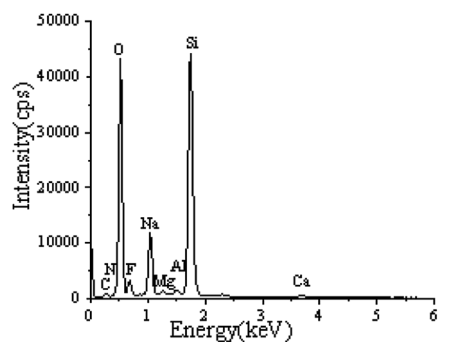
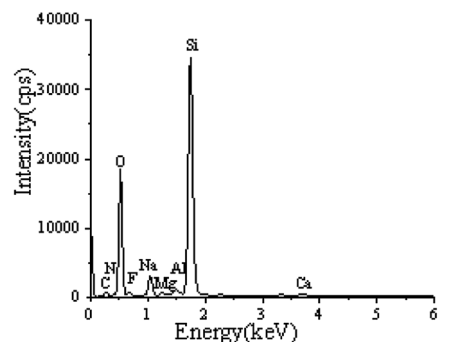
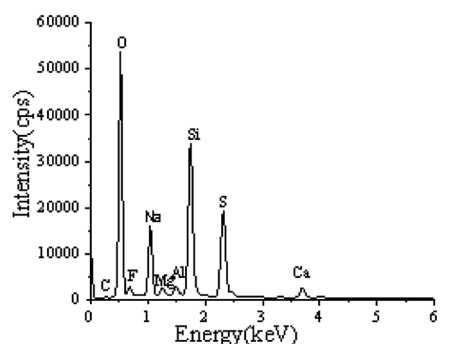
(a) Modified group at room temperature

(b) Modified group after acid resistance

(c) Blank group after acid storage

(d) Blank group at room temperature

Fig. 8 Energy spectra of the coatings at normal temperature and after the acid resistance test.

3.3.2. Composition analysis. EDS tests were carried out in the red area marked in the (d) chart in Fig. 2, 4, 5 and 7. It could be observed from Fig. 8 and Table 3 that after storage in sulfuric acid at a 50% concentration for 30 days, no sulfur atom was detected in the modified group coating. However, the sulfur atom percentage of the unmodified group coating was 6.73%. Moreover, the coating sample was 10 mm away from the surface of the test piece; this indicated that the corrosive substance had not intruded into the interior of the modified group but had intruded into the blank group coating. In Table 3, it is shown that the total mass percentage of silicon and oxygen in the modified group increases

from 76.28% to 79.26%. However, the total mass percentage of silicon in the blank group decreases from 81.39% to 72.13%. Moreover, it was shown that the modified group obviously resisted

corrosion, whereas the unmodified coating was subjected to more severe corrosion in the corrosive solution, resulting in a decrease in the quality of the main bonding element silicon oxide. This was in line with the findings of previous immersion acid strength test, whereby the blank group coating strength decreased significantly and the modified group coating strength remained stable.

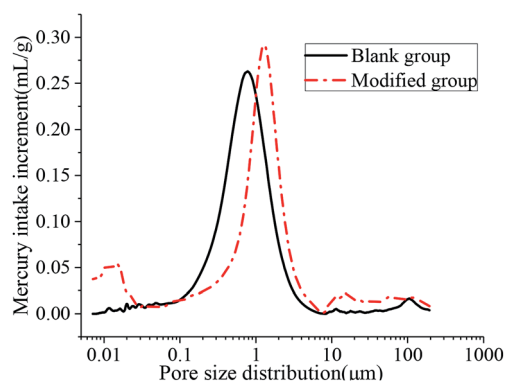
Fig. 9 Aperture differential distribution curve.

The aperture differential distribution curve and the pore cumulative distribution curve are shown in Fig. 9 and 10, respectively. As observed from Fig. 9, the coating pores were mainly provided by the pores with diameters between 0.1 μm and 3 μm . The peak value of the coatings in the modified group was obvious at the pore diameters between 8 nm and 12 nm, which indicated that waterborne polyurethane could refine the

macro-porous structure of the modified group coating to a certain extent and increase the number of the medium holes. However, the porosity of the blank group and the modified group was 33.91% and 33.78%, respectively, and was not significantly changed. The porosities of the blank group and the modified group did not change significantly, and the porosities were 33.91% and 33.78% respectively. Due to the addition of polyurethane, micro-bubbles were produced during the preparation of the coating. The pore size between 10 μm and 100 μm for the modified coating was more than that of the blank coating, resulting in no significant change in the final porosity. Therefore, defoaming agents should be added appropriately during the preparation of the coating. Fig. 10 shows that the cumulative pore size distribution curve of the blank group coating does not change significantly when the pore diameter is less than 100 nm. However, the volume of the modified coating changed obviously; this indicated that the addition of polyurethane reduced the pore size and increased the content of the medium holes; this resulted in higher content of pores with sizes less than 100 nm in the modified coating as compared to that in the blank coating.

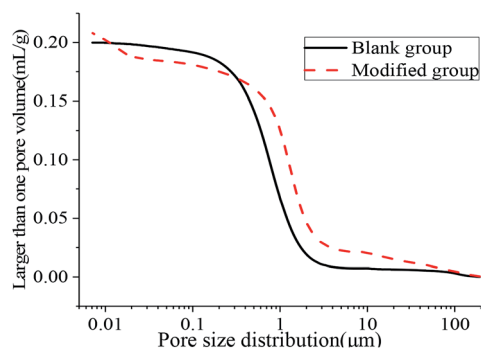
Fig. 10 Cumulative pore size distribution curve.

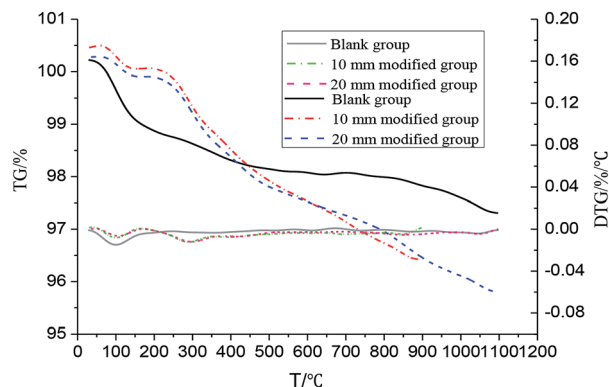
Fig. 11 The TG and DTG curves of the coating.

The TG and DTG curves of the coatings are shown in Fig. 11. As observed from Fig. 11, the coating had an obvious weight loss at 70–140 $^{\circ}\text{C}$. This may be due to the evaporation of trace amount of free water from the sample and the condensation reaction of water in the water glass when the residual portion of the silicic acid gel is increased during curing; in addition, the moisture is further removed, resulting in an obvious weight loss step. However, the weight loss of the modified coating was less obvious than that of the blank coating; this might be because

the addition of polyurethane to a certain extent limited the removal of water. The coating of the blank group tended to be stable, and no obvious weight loss phenomenon was found; this was because the coating of the blank group was composed of a filler with excellent temperature resistance and an inorganic adhesive. However, the weight loss of the modified coating at different depths was obvious in the range of 260–380 °C; this was mainly due to the decomposition of polyurethane in the coating. The weight loss curves of the two groups almost coincided; this indicated that polyurethane was evenly distributed in the coating. The weight loss of the modified coating occurred slightly below 250 °C, and the performance of the coating was stable. The results indicated that the modified coating could fully meet the requirement of temperature resistance at 250 °C.
