Debonding mechanism of zirconia and lithium disilicate resin cemented to dentin

Mina Aker Sagen^a, Ketil Kvam^b, Eystein Ivar Ruyter^b and Hans Jacob Rønold^a

^aInstitute of Clinical Dentistry, University of Oslo, Oslo, Norway; ^bNIOM, Oslo, Norway

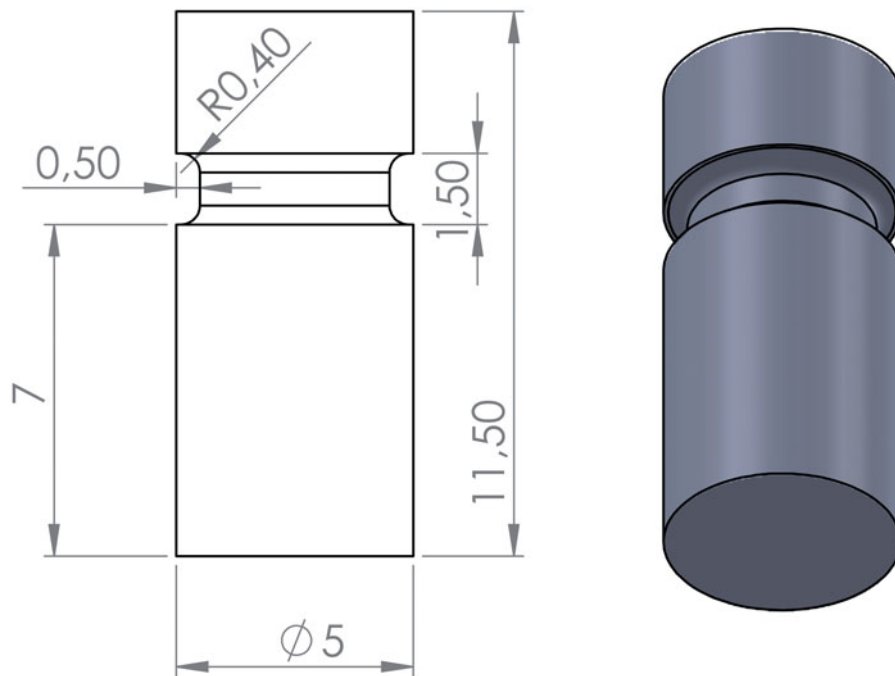
Figure 1. Design of ceramic rod. The illustration shows the dimensions in mm and a copy of the computer aided design (CAD).

Circular zirconia ($n = 100$, Starceram Z, H.C. Starck Ceramics GmbH, Germany) and lithium disilicate ($n = 50$, IPS e.max CAD, Ivoclar Vivadent, Lichtensein) rods with diameter of 5 mm and length of 11.5 mm were produced by CAD/CAM technique. Rods were produced with a notch in the circumference (Figure 1) facilitating the grip during tensile testing.

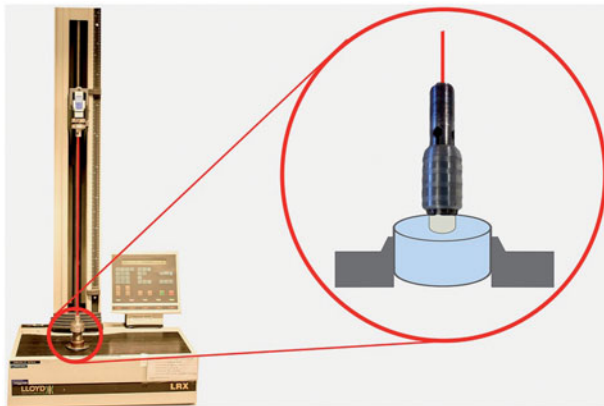
Figure 2. Experimental design of tensile bond strength test. A metallic jig enclosed the ceramic rod at the notch in the circumference for adequate grip. The rod was cemented onto the dentin surface of bovine tooth embedded in epoxy resin.

Specimens were mounted in a universal mechanical test machine (Lloyd LRX, Lloyd Instruments Ltd, Leicester, UK). Tensile force was applied until break using a centered wire with a cross head speed of 1 mm/min. Figure 2 illustrates the experimental design of tensile bond strength test. Tension force (N) at break was recorded and tensile bond strength

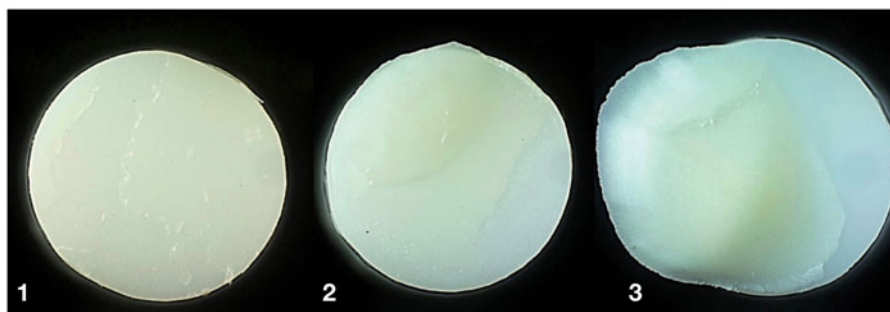
Figure 3. Examples of fracture morphology observed in light microscope (diameter 5 mm). 1: combination of cohesive fracture in cement and adhesive fracture between cement-zirconia; 2: combination of cohesive fracture in dentin and adhesive fracture between cement-dentin and cement-zirconia; 3: combination of cohesive fracture in dentin and cement, and adhesive fracture cement-zirconia.

Cohesive fracture in cement was the most common fracture morphology visualized by light microscope, as presented in Table 2. Duo-Link cement showed exclusively cohesive fractures in cement, regardless of test group. Combination of adhesive and cohesive fractures were second most common. Figure 3 show examples of fracture morphology observed in light microscope. Fracture characterized as adhesive between rod and cement was not observed for KHF₂ etched zirconia.

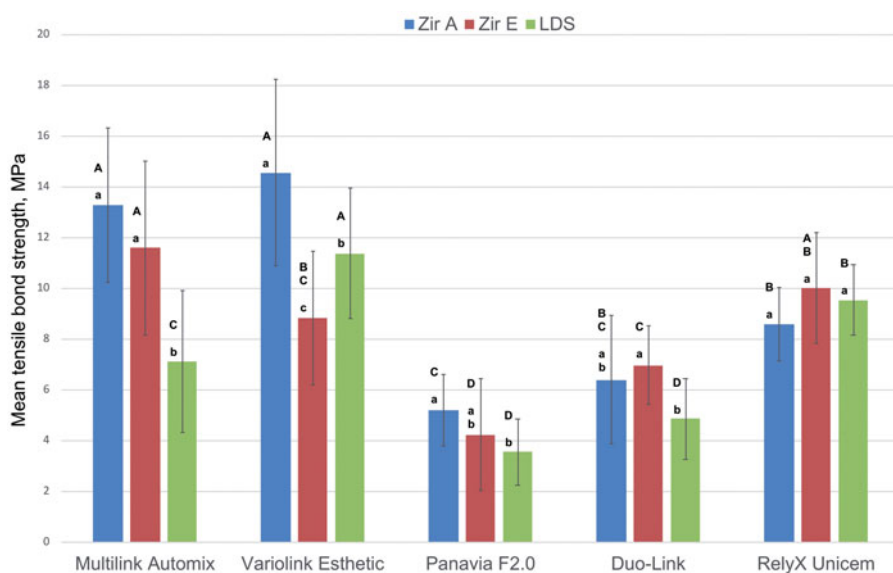
Figure 4. Mean tensile bond strength and standard deviation. Zir A: air borne particle abraded zirconia; Zir E: KHF_2 etched zirconia; LDS: hydrofluorid acid etched lithium disilicate. Different lowercase letters illustrate significant difference ($p < .05$) between Zir A, Zir E, and LDS for each cement. Different uppercase letters illustrate significant differences ($p < .05$) between cements for each rod material.

Adhesive fracture between cement and dentin and cohesive fracture in dentin was observed for Multilink Automix, Variolink Esthetic and RelyX Unicem. This was also the cements with the highest tensile bond strength, as shown in Figure 4.

Mean tensile bond strength and standard deviation for the three test groups cemented with different dual cure resin cements are illustrated in Figure 4. Results of ANOVA and Tukey's HSD tests calculated for differences between test rods for each cement and between cements for each rod material are also given in Figure 4. Highest mean tensile bond strength was observed when cementing air borne particle abraded zirconia with Variolink Esthetic and Multilink Automix cement. The lowest bond strengths were obtained with Panavia F2.0 and Duo-Link. There were no differences regarding the effects of the different surface treatments of the zirconia rods for all cements, except for Variolink Esthetic where air

borne particle abraded zirconia showed higher bond strength. Compared to both zirconia rod types, lithium disilicate rods had lower or similar mean tensile bond strength to all cements except Variolink Esthetic.

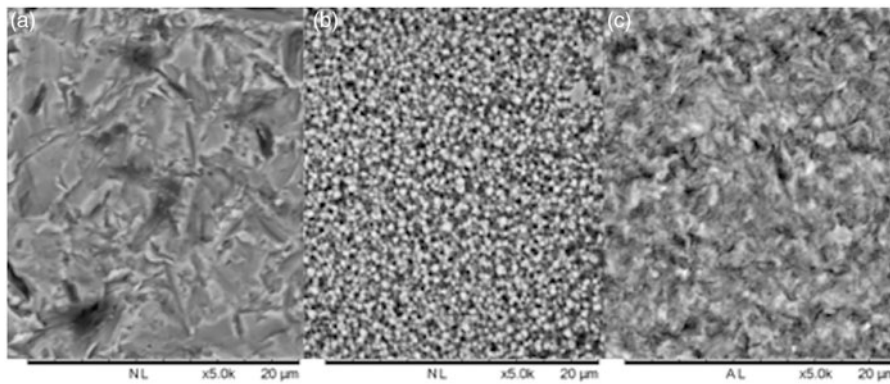
Figure 5. Representative SEM images of air borne particle abraded zirconia (a), KHF₂ etched zirconia (b), and hydrofluoric acid etched lithium disilicate (c). Bar represents 20 μm.

resulted in Sa values that were significant different from each other. The marked differences in surface morphology of the three test groups are visualized in SEM images (Figure 5).
