# Clinical characteristics of patients with the hardware failure after surgical stabilization of rib fractures in Korea: a case series

**Purpose:** Surgical stabilization of rib fractures (SSRF) is widely used in patients with flail chests, and several studies have reported the efficacy of SSRF even in multiple rib fractures. However, few reports have discussed the hardware failure (HF) of implanted plates. We aimed to evaluate the clinical characteristics of patients with HF after SSRF and further investigate the related factors.

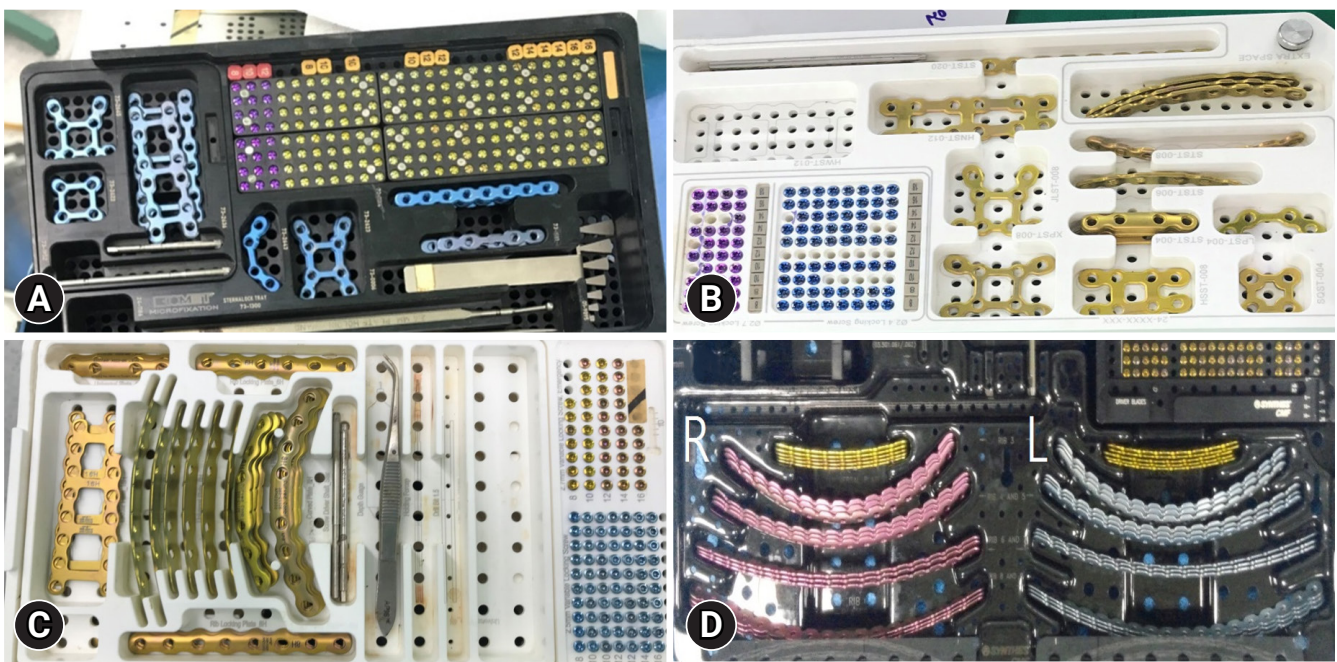
**Fig. 2.** Type of chest wall plating system. (A) SternaLock Blu Plate (Zimmer Biomet Inc). (B) ARIX Sternal & Rib System (Jeil Medical Corp). (C) APIS Rib Locking Plate System (TDM Corp). (D) MatrixRIB Plate (Depuy Synthes).

During the study period, four thoracic surgeons performed SSRF using at least one of four commercially available plating systems, all of which were anterior bicortical screw locking systems: SternaLock Blu Plate (Zimmer Biomet Inc), ARIX Sternal & Rib System (Jeil Medical Corp), APIS Rib Locking Plate System (TDM Corp), and MatrixRIB Fixation System (Depuy Synthes) (Fig. 2). All the systems included straight or precontoured titanium plates and self-drilling and self-tapping screws, except for the Matrix-RIB Plate. The choice of plating system was at the discretion of the surgeon.

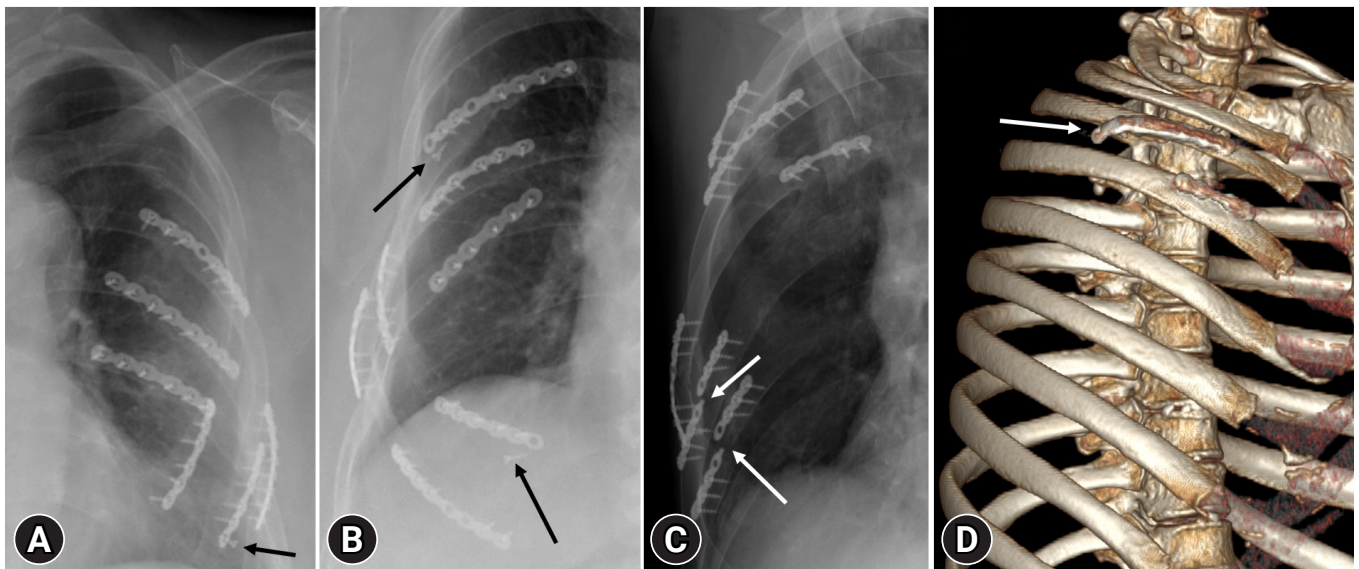
**Fig. 3.** Failure modes of the implanted plates and screws. (A) Screw loosening: protrusion of the screw from the screw hole (black arrow) but does not pull out completely. (B) Screw migration: completely pulled out the screw from the screw hole and moved away to different positions (black arrows). (C) Plate fracture: breakage of implanted plates (white arrows). (D) Plate dislocation: displacement of a plate in the superior or inferior direction from normal alignment (white arrow).

HF was defined as follows: (1) screw loosening, defined as a screw that protrudes from the screw hole but does not pull out completely; (2) screw migration, defined as a screw being pulled out of a screw hole and moved to a completely different position; (3) plate fracture, defined as breakage of implanted plates; and (4) plate dislocation, defined as the displacement of a plate superiorly or inferiorly (Fig. 3).

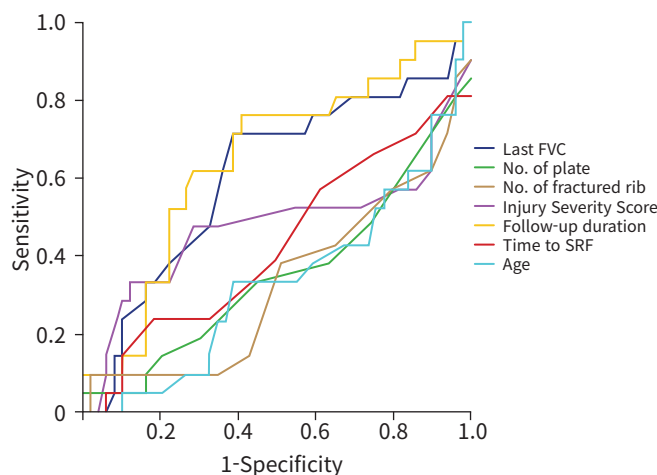
**Fig. 5.** Receiver operating characteristics curve analysis for the prediction of plate removal surgery in patients with hardware failure. The area under the curve for follow-up duration was 0.65 (0.5≤95% confidence interval≤0.79), but not statistically significant. FVC, functional vital capacity; SRF, surgical rib fixation.

ROC curve analyses were performed on the variables that identified differences according to the plate removal surgery. Using a single-factor evaluation, AUC was low: follow-up duration, last functional vital capacity (FVC), time to SSRF, ISS, number of fractured ribs, number of implanted plates, and age showed AUCs of 0.647, 0.609, 0.431, 0.477, 0.331, 0.354, and 0.337, respectively (Fig. 5).
