Influence of modification in core building procedure on fracture strength and failure patterns of premolars restored with fiber post and composite core

PURPOSE. The influence of the modified process in the fiber-reinforced post and resin core foundation treatment on the fracture resistance and failure pattern of premolar was tested in this study. **MATERIALS AND METHODS.** Thirty-six human mandibular premolars were divided into 4 groups (n = 9). In group DCT, the quartz fibre post (D.T. Light-post) was cemented with resin cement (DUO-LINK) and a core foundation was formed with composite resin (LIGHT-CORE). In group DMO and DMT, resin cement (DUO-LINK) was used for post (D.T. Light-post) cementation and core foundation; in group DMO, these procedures were performed simultaneously in one step, while DMT group was accomplished in separated two steps. In group LCT, the glass fiber post (LuxaPost) cementation and core foundation was accomplished with composite resin (LuxaCore-Dual) in separated procedures. Tooth were prepared with 2 mm ferrule and restored with nickel-chromium crowns. A static loading test was carried out and loads were applied to the buccal surface of the buccal cusp

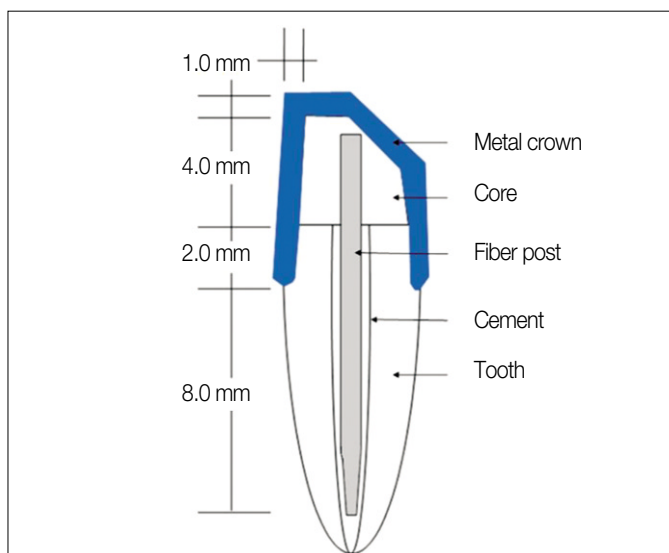
Fig. 1. Schematic design of specimen.

All specimens were prepared for full coverage metal cast crowns with milling machine; axial reduction was performed to obtain an approximate 6 degree total convergence angle, and

a 45 degree bevel was made at the buccal inclination of buccal cusp (Fig. 1). The finish line was designed for a chamfer margin with 0.5 mm depth and placed 2 mm apically from core/dentin junction to provide proper ferrule effect.¹³⁻¹⁵ The total length of the core and residual coronal structure from the margin was 6.0 mm.

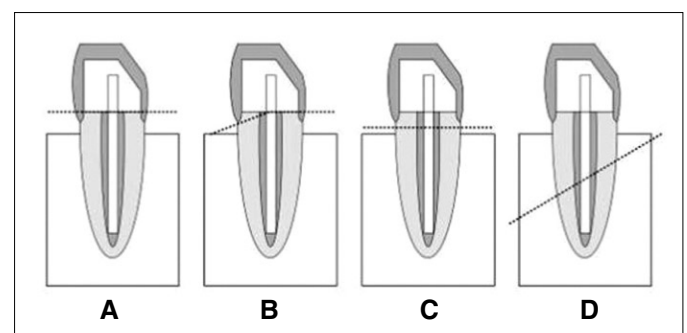
Fig. 2. Failure patterns of specimens. A: Core fracture, B: Core-root fracture, C: Favorable root fracture, D: Unfavorable root fracture.

The specimens were fixed in the universal testing machine (Instron 8871; Instron Ltd, High Wycombe, Bucks, UK) and loaded with a compressive force applied at a crosshead speed of 1 mm/min until specimen failure occurred. The loading force was directed perpendicular to the buccal inclination of buccal cusp of the crown and 135 degrees to specimen's long axis. The measurements were recorded in Newtons (N) and failure patterns were observed with naked eyes after the fracture strength tests. The locations of the fracture lines were confirmed by separating the fractured fragments from the acrylic resin blocks. As illustrated in Fig. 2, core fracture (A), core-root fracture (B), and root fracture superior to the resin block (C)

were classified as favorable fractures which allow repair. Root fractures inferior to the resin block (D) were regarded as unfavorable ones which does not allow repair. The correlation between tooth size (B-L, M-D diameter) and fracture aspects (fracture strength and pattern) were evaluated statistically to find any significant influencing factors.

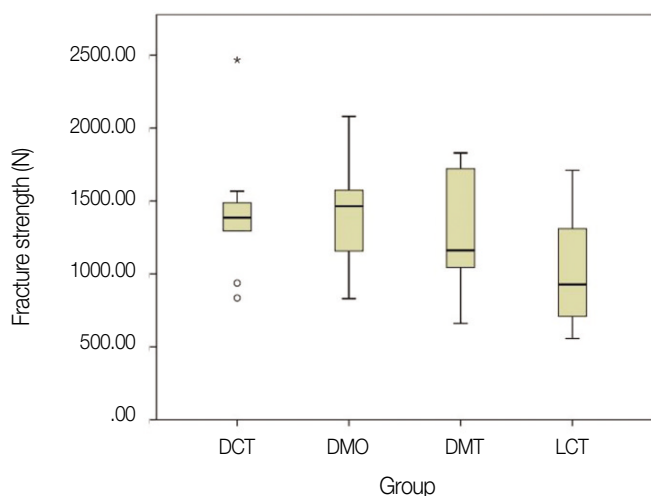
Fig. 3. Box plot of the fracture strength of the test groups.

The mean fracture strength was highest in group DCT

(1420.7 ± 464.1 N) followed in descending order by groups DMO (1381.9 ± 386.7 N), DMT (1307.6 ± 451.1 N), and LCT (1050.1 ± 438.8 N). However, there was no significant difference in fracture strength between the groups. Groups DCT, DMT and DMO, which used the quartz fiber posts (D.T. Light-post), showed higher fracture resistance than group LCT, in which the glass fiber posts (LuxaPost) were used. However, the differences were not significant (Table 2) (Fig. 3).

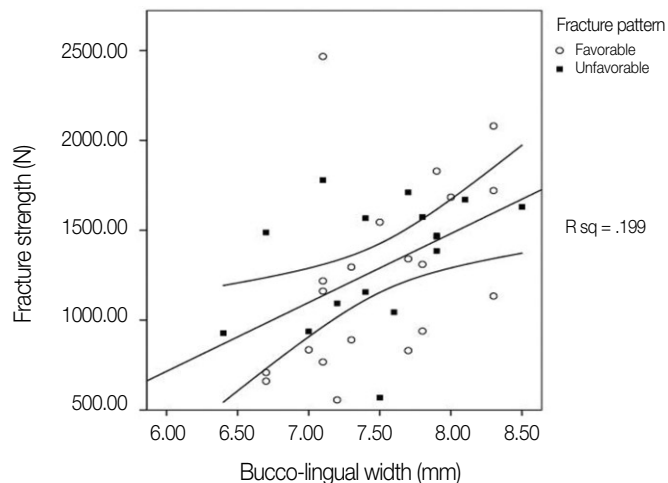
Fig. 4. Fracture strength and fracture patterns according to the bucco-lingual diameter of the teeth.

The multivariate analysis of variance result showed there was a significant interaction between fracture strength and bucco-lingual diameter ($P < .05$) (Fig. 4); although, there was no significant interaction to the fracture pattern.
