Characterization and Control of the Microbial Community Affiliated with Copper or Aluminum Heat Exchangers of HVAC Systems

Michael G. Schmidt · Hubert H. Attaway · Silva Terzieva · Anna Marshall ·
Lisa L. Steed · Deborah Salzberg · Hameed A. Hamoodi · Jamil A. Khan ·
Charles E. Feigley · Harold. T. Michels

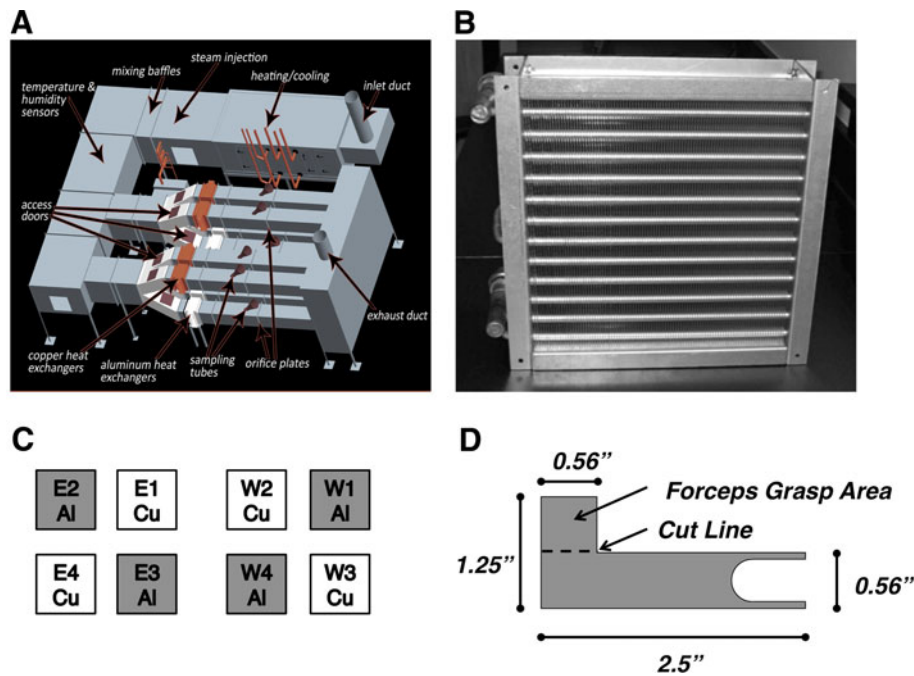
Fig. 1 Schematic representation of full-scale HVAC test system used in this study. **a** General illustration of the test system; **b** Photographic representation of typical aluminum (control) heat exchanger ($30.5 \times 3.5 \times 6.6 \text{ cm}^3$ fin area dimensions) used in the full-scale HVAC test system; **c** orientation of copper and aluminum heat exchangers within the test system visualized from the perspective of the inflow side of the exchangers. *E* and *W* designations represent the east or west side of system; **d** schematic representation of the

L-shaped coupons placed within each of the heat exchangers and retrieved weekly throughout the study. Coupons were manufactured from the same aluminum or copper alloy as the corresponding heat exchanger, were placed accordingly, and retrieved at selected time-points by grasping the top portion with sterile forceps. The coupons were deposited into sterile processing vials by cutting the upper L-portion of the coupon off with sterile scissors. The resident biofilm on each coupon was determined as described in the “Methods”

A full-scale test HVAC system, constructed at the University of South Carolina Public Health Research Center, was used to characterize the deposition and establishment of the microbial communities associated with copper and aluminum heat exchangers. The test system obtains its makeup air from the roof of the building, passes it through a primary heat exchanger where its temperature and humidity were adjusted to levels routinely encountered in air conditioning systems upstream of the heat exchangers. The delivery of this pre-conditioned makeup air was then sent to a parallel array of eight 1-ton capacity heat exchangers (Fig. 1a). Downstream of the heat exchangers, the air streams passed through Class II high efficiency, particulate, air (HEPA) filters (Flanders Pre-pleat 40, Washington, NC) and were subsequently discharged to the roof. The experimental heat exchangers, manufactured by Luvata Genada, LLC were made from either UNS A91100 aluminum or UNS C11000 copper and were $30.5 \times 3.5 \times 6.6$ cm^3 ($12'' \times 12'' \times 2.6''$ (finned area dimensions)) in a standard cross-flow, finned-tube configuration (Fig. 1b). Four copper and four aluminum exchangers were installed in the system in an alternating pattern (Fig. 1c). The system was operated, on average, at

L-shaped coupons (Fig. 1d) were fabricated out of either aluminum or copper fin stock that was used to manufacture the corresponding heat exchangers. Ninety-nine sterile coupons were placed with the U-shaped portion of each coupon around the chilled-water tube. A plan for coupon placement and removal was developed to facilitate comparison of the microbial loads on the copper and aluminum coupons while balancing other variables which might exert some effect on loading. This removal plan was validated by numerical simulation assuming various differences between copper and aluminum coupon loadings. Aseptic removal of three coupons from each exchanger was performed on a weekly basis in order to assess the biofilm present. The L-shaped design of the coupon facilitated easy

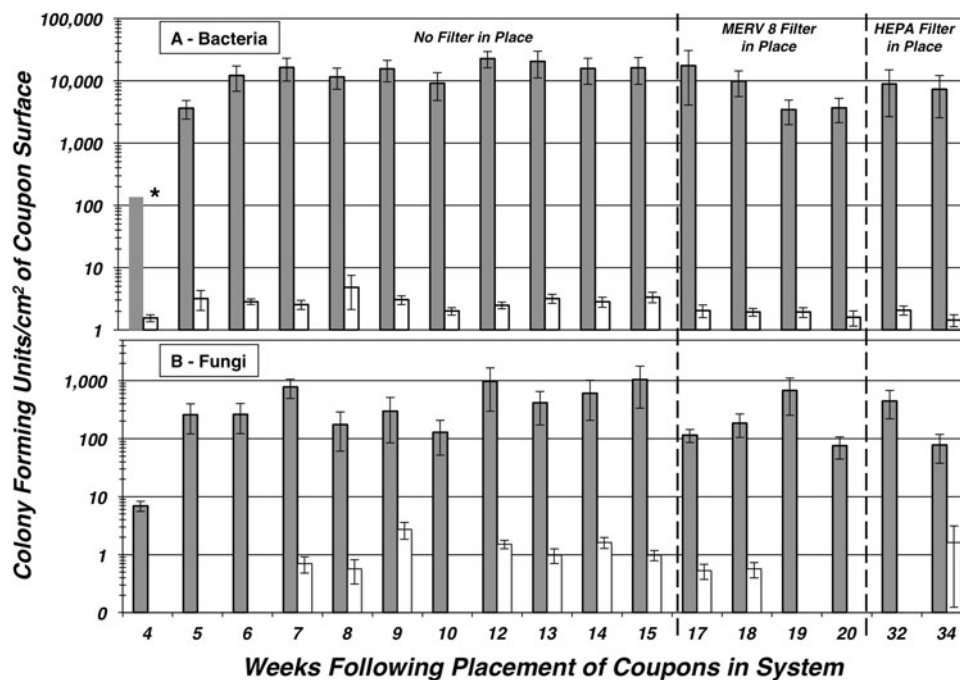
Fig. 2 Intrinsic concentration of bacteria (a) or fungi (b) resident on copper (white columns) or aluminum coupons (solid gray columns) retrieved from their respective heat exchangers over a 30-week test period. Bacterial CFU cm⁻² of coupon surface were determined from direct plate counts as assessed by growth on TSA + CE plates. Fungal CFU cm⁻² of coupon surface were determined from direct

plate counts as assessed by growth on SB + CL plates. The HVAC test system was initiated on week 1 and test coupons were inserted on week 3 with sampling beginning on week 4. The bacterial concentrations reported for week 4 exceeded levels that could reliably be determined using the dilutions used and were reported as >136 CFU cm⁻²

The HVAC test system was initiated with parameters associated with conditions used during the cooling season. Chilled water was circulated through the experimental heat exchangers. After 1 week of operation the system was temporarily stopped and 99 coupons of either copper or aluminum were installed into four equivalent copper and aluminum heat exchangers. Triplicate sets of coupons were removed from each exchanger commencing the fourth week after their installation. A robust biofilm was established on the aluminum heat exchanger within 4 weeks of system startup (Fig. 2). In contrast, the viable fungi and bacteria biofilms on the copper exchangers were at least one order of magnitude lower than the ones found on the aluminum exchangers. The average concentration of bacteria detected from the aluminum coupons was 11,411 CFU cm⁻² and the values observed were consistently 3–4 orders of magnitude greater than the concentrations of bacteria recovered from

the copper coupons, which averaged 3 CFU cm^{-2} . The maximum and minimum concentration detected was $163,081$ and 0 CFU cm^{-2} , respectively. The range in the concentrations detected from copper coupons was significantly less with a maximum of 34 CFU cm^{-2} and a minimum of 0 CFU cm^{-2} being detected.

The concentration of viable fungi isolated from the aluminum coupons was lower than that of the bacteria recovered. The average coupon yielded 378 CFU cm^{-2} over the course of the 30-week study. Similar to the observations for bacteria, the fungal bioburden on the aluminum coupons was 2–3 orders of magnitude higher than that seen on copper coupons. The maximum fungal value recovered from aluminum coupons was $8,381 \text{ CFU cm}^{-2}$ while the minimum was 0 CFU cm^{-2} . The concentrations of fungi recovered from the copper coupons were on average $<1 \text{ CFU cm}^{-2}$ with maximum and minimums of 19 and 0 CFU cm^{-2} , respectively.

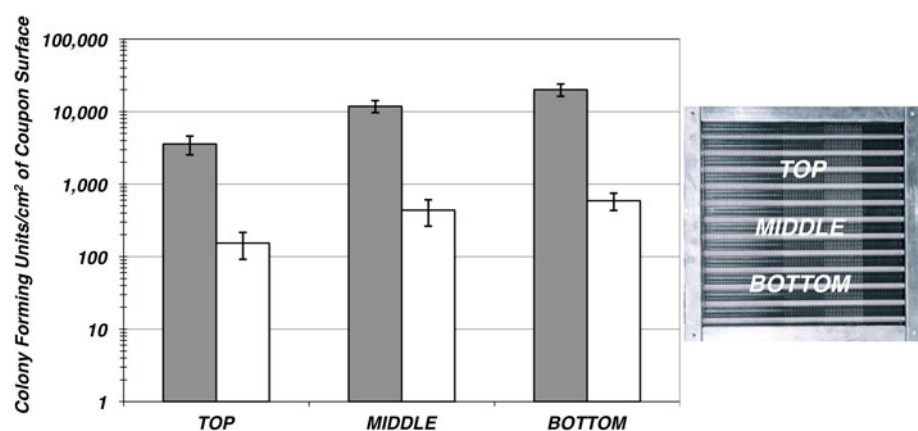
Fig. 3 Comparison of the bacteria and fungi found on aluminum heat exchangers based on vertical location within the heat exchanger. Bacterial (CFU cm^{-2} , solid gray columns) were determined from direct plate counts as assessed by growth on TSA + CE plates. Fungal (CFU cm^{-2}) were determined from direct plate counts as assessed by growth on SB + CL plates (white columns)

Quantitative analysis of the distribution of the viable bacteria and fungi within the heat exchangers revealed that the concentration of viable biomass was incrementally greater towards the bottom of the aluminum heat exchangers (Fig. 3). This was presumably due to the constant condensation formed on the fins washing the biofilm material downward through gravity. Similar analysis of the distribution of the viable bacteria and fungi within the copper exchanger revealed that the viable biomass was distributed uniformly through out the exchanger at concentrations $<2 \text{ CFU cm}^{-2}$.

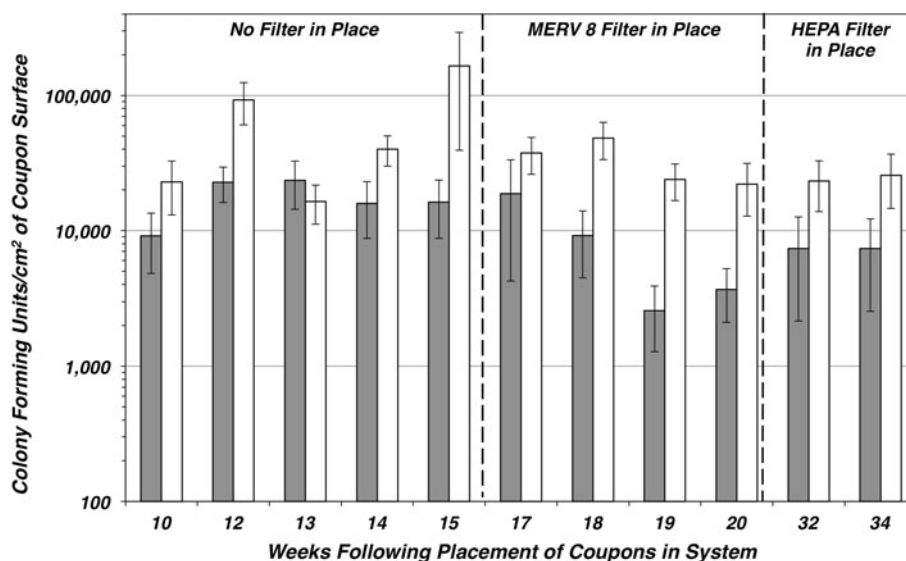
Fig. 4 Recovery of viable bacteria from coupons is more efficient when using R2A + CE agar. The average concentration of bacteria (CFU cm^{-2}) recovered from a subset of aluminum coupons was determined by plating each sample onto either TSA + CE agar (solid gray columns) or R2A + CE plates (white columns)

The type of medium used to measure the concentration of bacteria present on the coupons was found to be significant. A substantial increase in the number of viable bacteria recovered were observed when R2A + CE rather than TSA + CE was used as the primary plating medium for enumerating the viable bacteria present. Enhanced recovery using R2A + CE has been observed by others sampling liquid environments in which methylobacteria were isolated [1, 17, 21]. Enhanced recovery was not

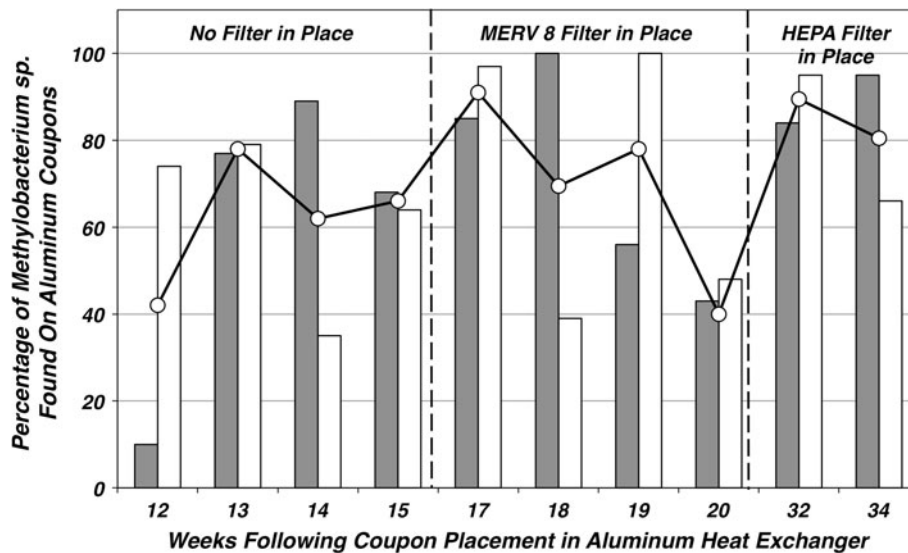
Fig. 5 Representation of the population distribution of *Methylobacterium* spp. recovered from the selected aluminum coupons taken from the W1 and E3 heat exchangers during weeks 12–34. Bacterial CFU cm⁻² of coupon surface were determined from direct plate counts as assessed by growth on R2A + CE plates. Solid gray columns represent the percentage of *Methylobacterium* spp. recovered

from the total population of microbes isolated from the coupons recovered from E3 heat exchanger while the white columns represent the percentage of *Methylobacterium* spp. resident within the population of microbes isolated from the coupons recovered from the W1 heat exchanger. The average distribution is plotted as the open circles

A quantitative assessment of the number of methylobacteria present in the biofilm associated with the aluminum heat exchangers was determined by counting the number of the total isolates recovered on the R2A + CE medium from coupons taken from the aluminum heat exchanger sites W1 and E3 between weeks 12 and 34 and then contrasting that number against the ratio of the number of red/pink colonies present within the sample. The average and individual percentage of *Methylobacterium* spp. represented in the population is described in Fig. 5. The fraction of *Methylobacterium* sp. resident in the biofilm population varied between the two samples with the variability being reflected in the average reported which was between 40 and 90 % of the recoverable population.
