Three-year follow-up of a Traumatic Hemipelvectomy Survivor: A Case Report

The management of a patient with traumatic hemipelvectomy is complex. We report the acute management and rehabilitation of a 21-year-old patient as well as her prosthesis modification. She was able to return to society as a K3 level ambulator.

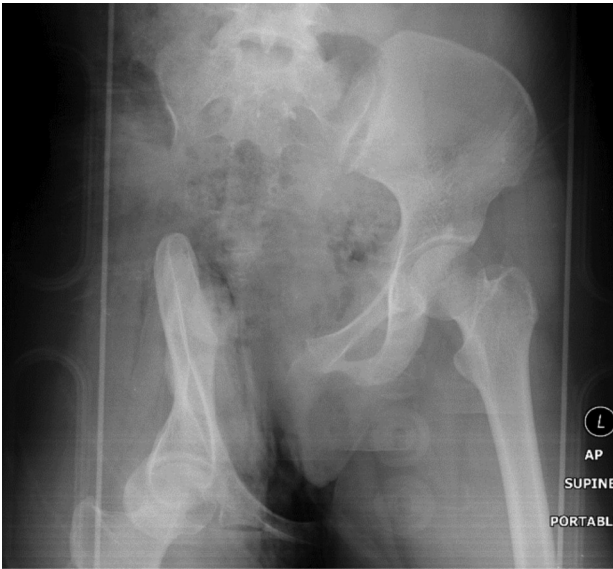
Fig. 1: Pelvic anterior-posterior radiograph showed the survivor's right hemipelvis was sheared inferiorly and malrotated.

The pelvic radiograph showed a wide distraction-separation of the right hemipelvis (Fig. 1). There was a loss of contrast flow after the right external iliac artery without contrast reconstitution distally on the computed tomography (CT) scan (Fig. 2). The ascending colon was contused and the right-sided pelvic floor muscles were disrupted with extension into the vagina wall and the rectal sphincter. CT brain showed right frontal subarachnoid haemorrhage and subdural haemorrhage with cerebral oedema. She also sustained an open comminuted fracture of the right olecranon, which was plated three weeks later.

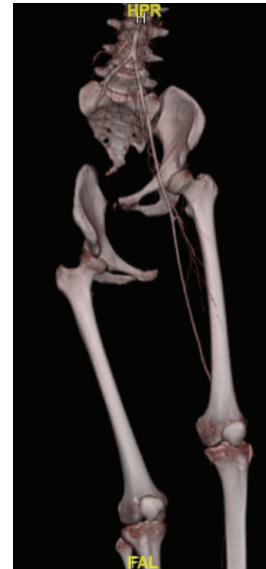
Fig. 2: 3D reconstructed Computer tomography angiogram (CTA) showed loss of arterial contrast flow at proximal right external iliac artery and right hemipelvis was sheared inferiorly.

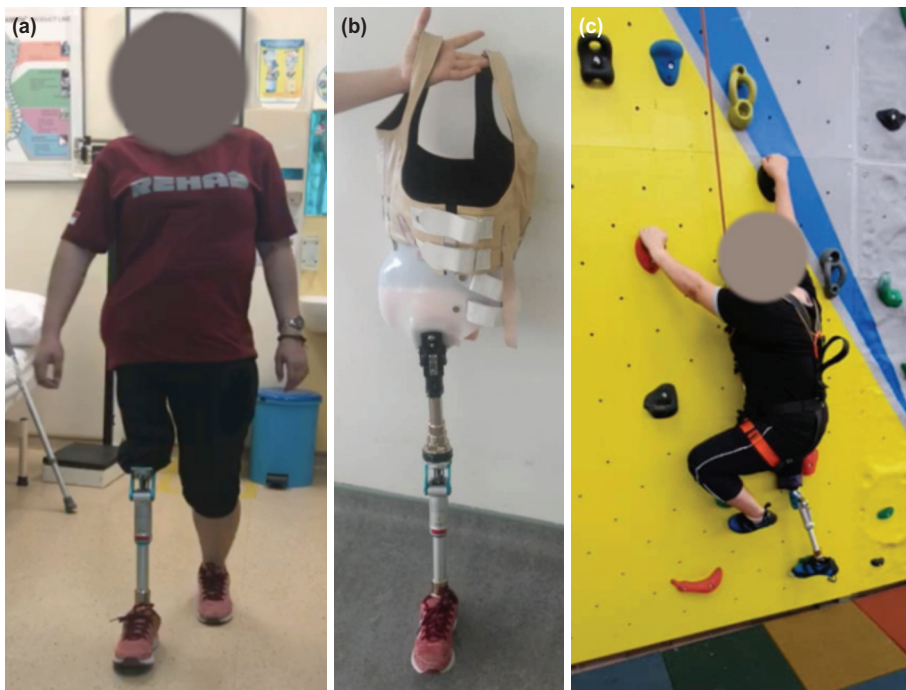
Fig. 3: (a) The survivor ambulating with the prosthesis and (b) showing the prosthesis. (c) Patient was able to scale the rock wall with the prosthesis.

For prosthesis fitting, her right hemipelvis modular prosthesis included features such as trans-pelvic socket with single-axis hip joint, double-layer socket inlet lining with perlite and plastazote materials, body-corset-jacket type of suspension, and four-bar pneumatic swing control knee joint with a motion-control foot system. The body corset jacket suspension was modified to accommodate the colostomy. At three-year follow-up, she had joined the return-to-work programme and was tolerating short distance independent ambulation as a K3 level ambulator. K3 is defined as the ability to walk at a variable speed at the individual’s own pace and to traverse most environmental barriers beyond

simple locomotion². She wore the prosthesis for about twelve hours a day and even participated in a rock-wall climb (Fig. 3c).

The initial prosthesis fitting for our patient was difficult due to poor stability with waist level fitting, soft tissue complication, and colostomy. Initial phantom limb and neuropathic pain upon weight bearing further delayed the rehabilitation. Fig. 3a shows her ambulating with the prosthesis. Modifications made are highlighted in Fig. 3b. Table 1 shows the justifications for each modification. With that, the prosthesis provided comfort and stability for her to ambulate without support. She required 18 months of prosthesis fitting and training before successfully returning to society as a K3 ambulator². Fig. 3c shows her performing rock-climbing activities.
