Giant Distal Anastomotic Pseudoaneurysm 35 Years after Bentall Operation Mimicking an “Elephant Trunk”

Aorta (Stamford) 2021;9:193–195.

Abstract

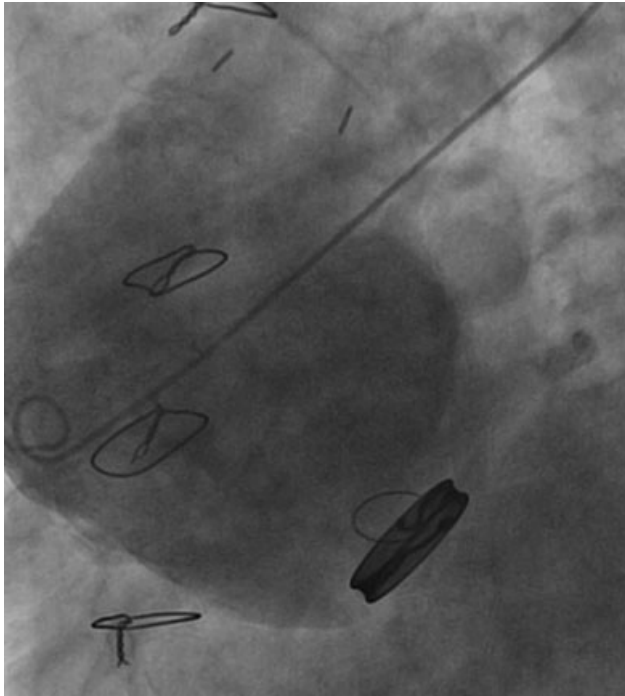
Fig. 1 Aortography with the pig-tale catheter positioned directly inside the huge pseudoaneurysmatic sac, showing the origin from the distal Dacron graft anastomosis.

A 75-year-old man was referred to our Division after evidence of a giant pseudoaneurysm of the ascending aorta was visualized during coronary angiography (CA) performed to exclude an acute coronary syndrome (▶ Fig. 1). The patient’s documentation clearly reported the classic Bentall-De Bono wrap/inclusion technique,¹ performed 35 years ago, with a

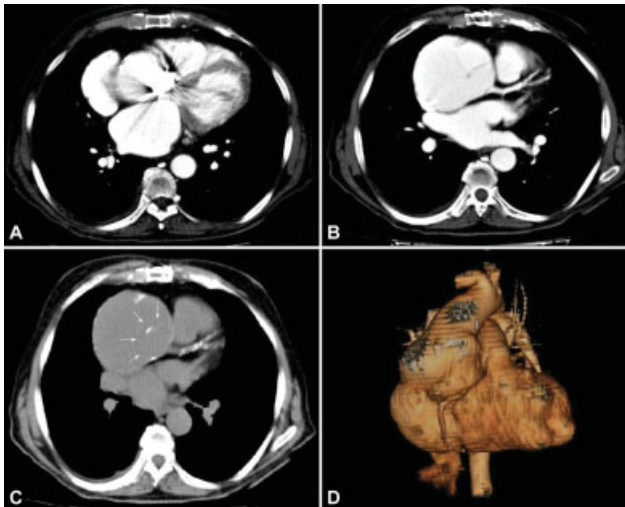
Fig. 2 Computed tomography angiography scans revealed that both the coronary arteries (A, B) originated from the graft. The contour of the Dacron graft (white arrows) surrounded by pseudoaneurysm (C). Three-dimensional reconstruction (D).

At the current admission, the main finding on chest radiograph was an abnormal cardiothoracic ratio. The echocardiographic imaging confirmed a 9-cm diameter pseudoaneurysm of the distal ascending aorta, moderate intraprosthetic regurgitation, and an ejection fraction of 40%. Infections were excluded. At CA, the right main coronary artery was not imaged, and the left main could only be seen with hand injection into the proximal part of the conduit. CTA revealed that both the main coronary arteries were attached to the graft and displayed the contour of the Dacron graft surrounded by the massive distal pseudoaneurysm, as confirmed by three-dimensional reconstruction (▶ Fig. 2).

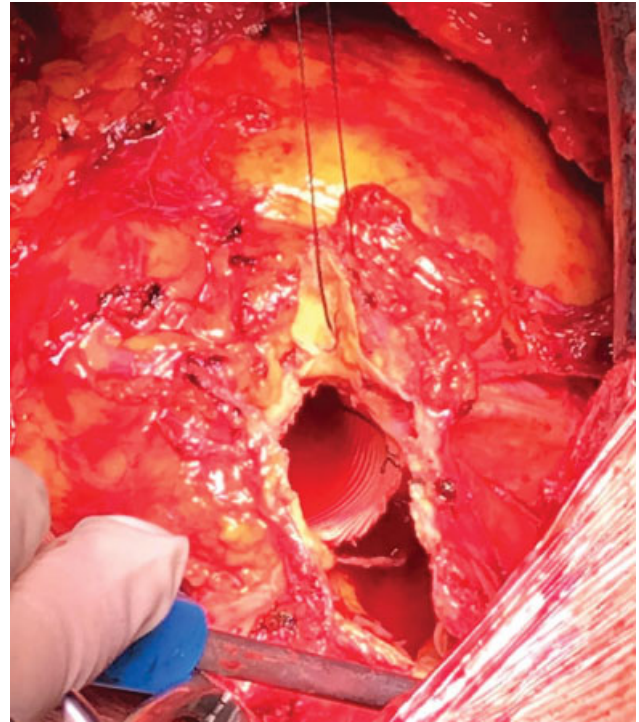
Fig. 3 Intraoperative view: distal end of the graft floating in the pseudoaneurysm sac, mimicking an “elephant trunk.”

The pseudoaneurysm sac was then opened and excised. There was evidence of an almost total circumferential dehiscence of the Dacron graft along the distal suture line. The graft was floating in the pseudoaneurysm lumen mimicking an “elephant trunk” technique (►Fig. 3), whereby excess tubular graft material is left in the distal aorta during aortic arch repair. The prosthetic valve was still secured to the aortic annulus, but pannus formation was apparently inter-
