# Syncope triggered by atrial flutter in a patient with a pacemaker: cross-stimulation—a case report

An 82-year-old man underwent dual-chamber permanent pacemaker implantation due to intermittent high-degree atrio-ventricular block (AVB) in sinus rhythm. Nine months later, the patient reported episodes of syncope. The chest X-ray showed both leads to be at their expected positions. The electrocardiography (ECG) showed common atrial flutter. Ventricular capture during pacing in atrial demand pacing (AAI) mode confirmed cross-stimulation due to the switching of the atrial and ventricular leads at the pacemaker header.

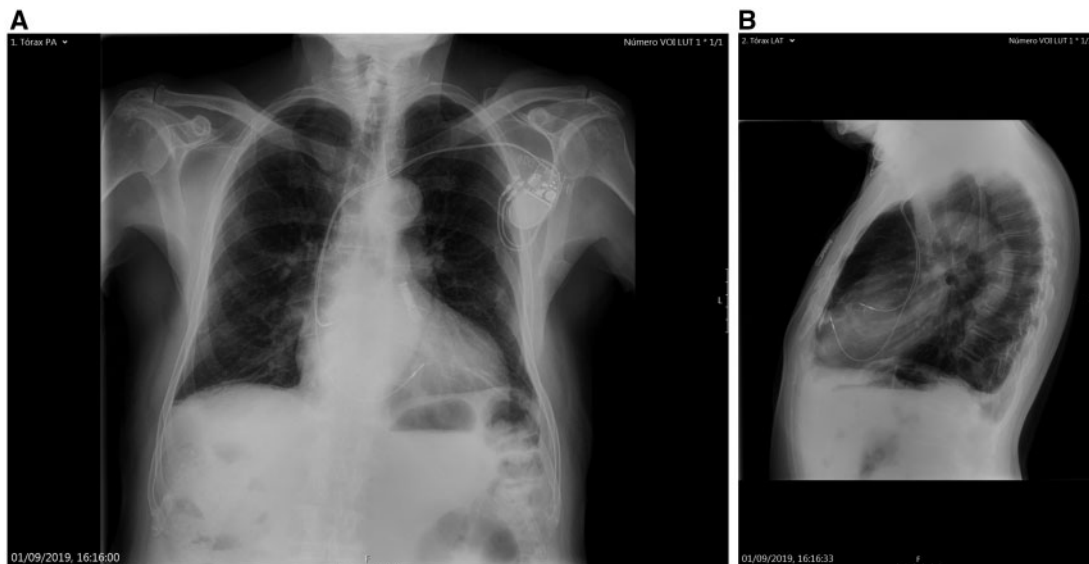
**Figure 2** (A,B) The chest X-ray showed both leads to be at their expected positions: one lead in the right atrial appendage and the other lead in the right ventricle outflow tract.

The clinical examination did not reveal any abnormality. The ECG (Figure 1) showed common atrial flutter, left bundle branch block morphology of the QRS complex, and a ventricular rate of 62 b.p.m. The chest X-ray showed both leads to be at their expected positions: one lead in the right atrial appendage and the other lead in the right ventricle outflow tract (Figure 2A,B).
