SCIENTIFIC REPORTS

Gully evolution and geomorphic adjustments of badlands to reforestation

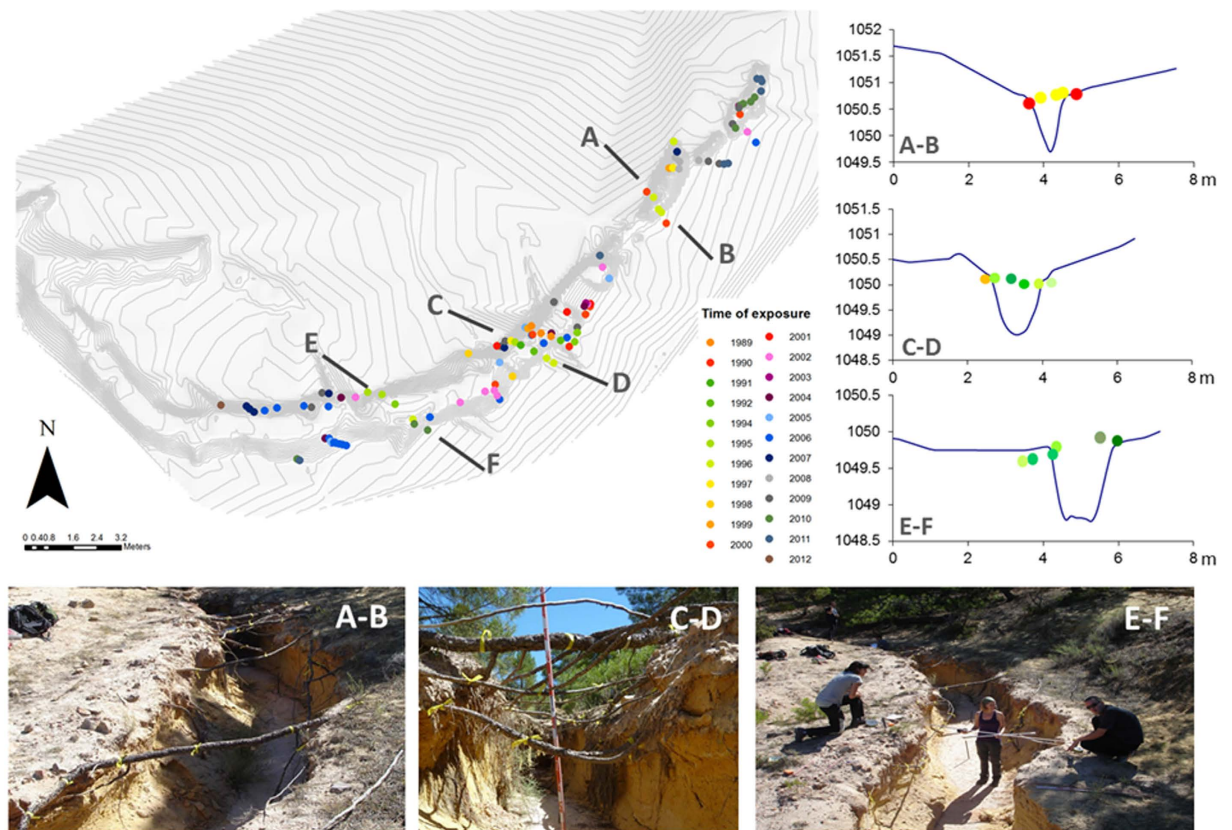
Figure 2. Distribution of the exposed roots analyzed along the channel, as well as three examples of the evolution of different profiles characterized by exposed roots. Map has been created using ArcGIS 10.1 (www.esri.com).

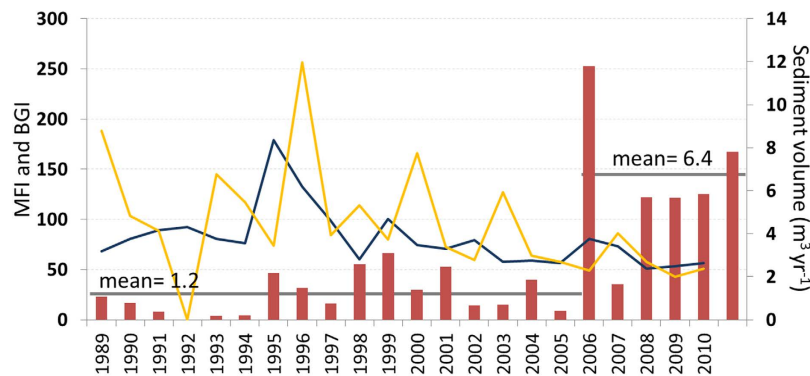
Figure 3. Estimated annual volume (m^3) of sediment eroded for the period 1990–2012 (red bars), as well as the obtained Modified Fournier index (MFI: blue line) and the Bagnouls-Gaussien index (BGI \times -I: orange line). Sediment yield data show a clear change in the trend after 2007, but are not correlated with high IF values.

The total eroded volume for the period 1989–2012 was computed to be 58.5 m^3 . From the channel reconstruction, the greatest erosion episode took place in 2007, when $\sim 11.7 \text{ m}^3$ of sand was mobilized in the system. The reconstruction also reveals a change in erosion rates after 2007. That is, the period 1989–2006 shows a mean erosion volume of $1.2 \text{ m}^3 \text{ yr}^{-1}$, but has since become more than five times larger ($6.4 \text{ m}^3 \text{ yr}^{-1}$) (Fig. 3). These findings point to an intense, recent gully retreat (above the median retreat observed worldwide- 0.89 m yr^{-1} ³⁰), although the catchment area that is delivering runoff and material to the channel is relatively small ($\sim 1.3 \text{ ha}$).
